# RWC-1022

## 2023 Inspection

### Retaining Wall Inventory Data

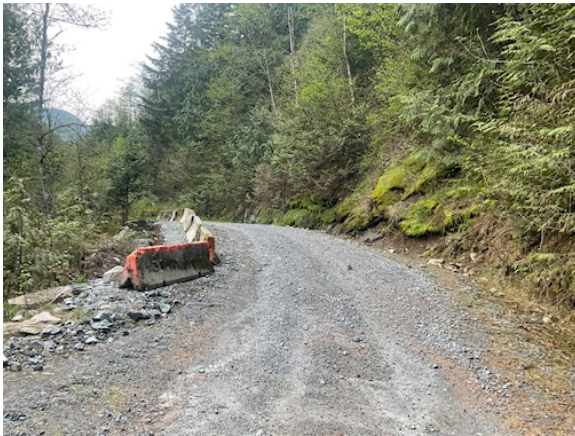
From town approach

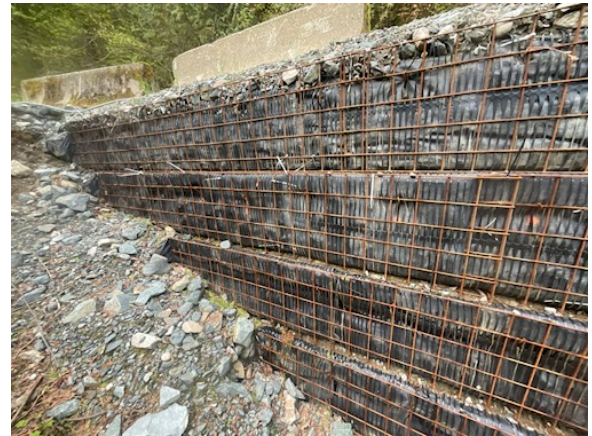
New wall and construction looks good. No holes in the geosynthetic observed, no foundation sagging or any other observed failed elements. Unclear if foundation is drilled and blasted flat or if it's sitting on the steep rock and being held by the pinned in gabions. Construction records should be acquired.

Geosynthetic and welded wire mesh

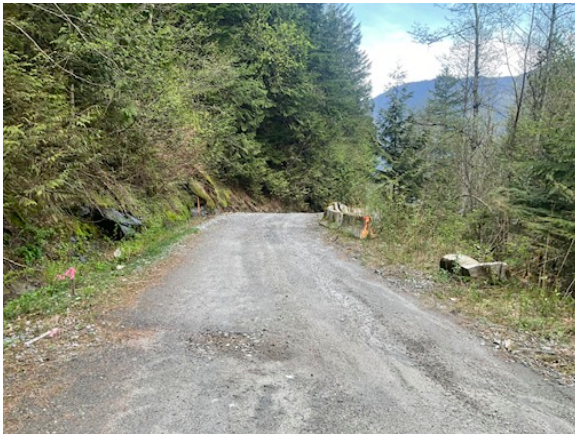
| | Rating | Comments |
|---|---|---|
| Surface Drainage | Good | Small cross ditch and road ditch. |

From woods approach and cross ditch

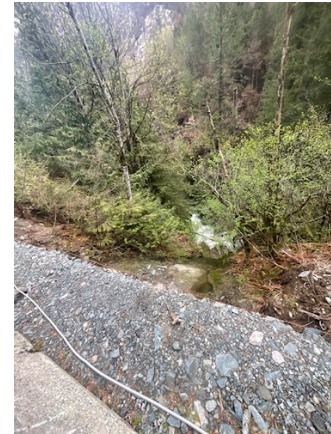
| | Rating | Comments |
|---|---|---|
| Downslope | Fair | Extremely steep dipping rock down to creek |

Steeply dipping basal plane wall is founded on

Recommending 1 year frequency until confirmation of steepness of foundation.

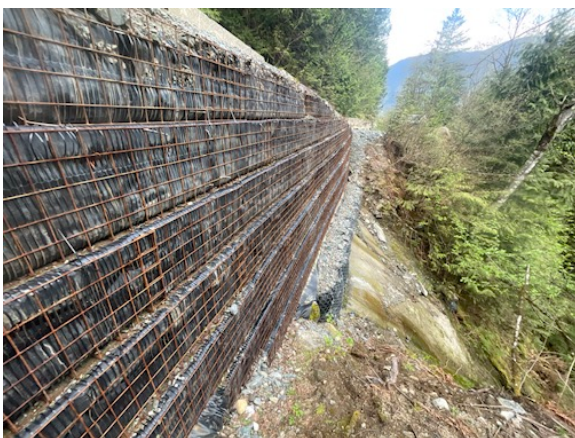
| | Rating | Comments |
|---|---|---|
| Retaining Wall Structure | Excellent | New GRS wall with all elements performing well however facing is not galvanized. |
| Foundation Material | Excellent | Gabions pinned down with #14 galvanized rebar on adverse dipping bedrock. |

Wall facing and gabion foundation
