# RWC-1024

## 2023 Inspection

### Retaining Wall Inventory Data

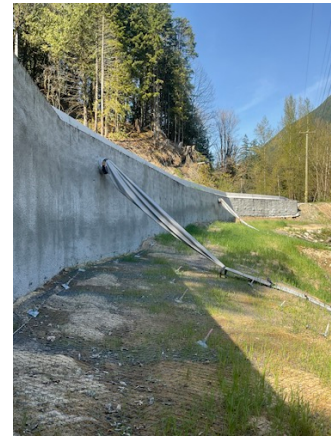
| | Rating | Comments |
|---|---|---|
| Drainage System | Excellent | Upper culvert which feed into large hoses so the poor pressures don't rise in the land slide. Small drain pipes at the toe of the wall to drain any water that gets in the wall. |

Wall and culvert outlet diversions

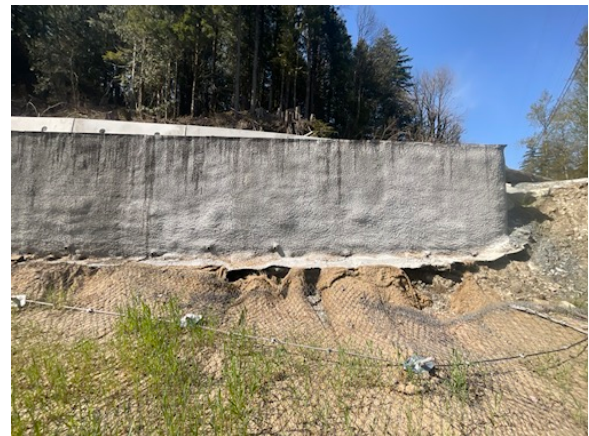
| | Rating | Comments |
|---|---|---|
| Foundation Material | Good | Wall attached to deep micro piles. Some erosion seen at base of wall. |

Minor erosion

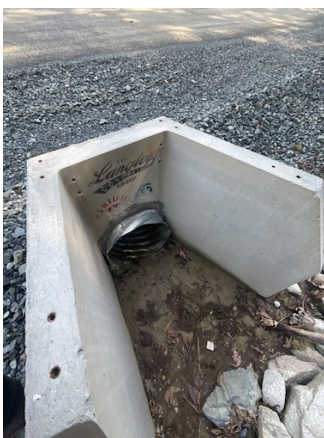
Culvert inlet

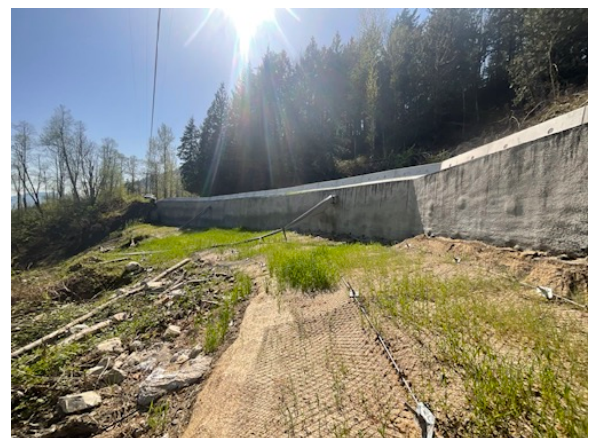
Town side of the wall from woods side
