CK-2157  
CK-2157

## HUNTER 2.2km

2023 Inspection

Crossing Name Hunter Creek

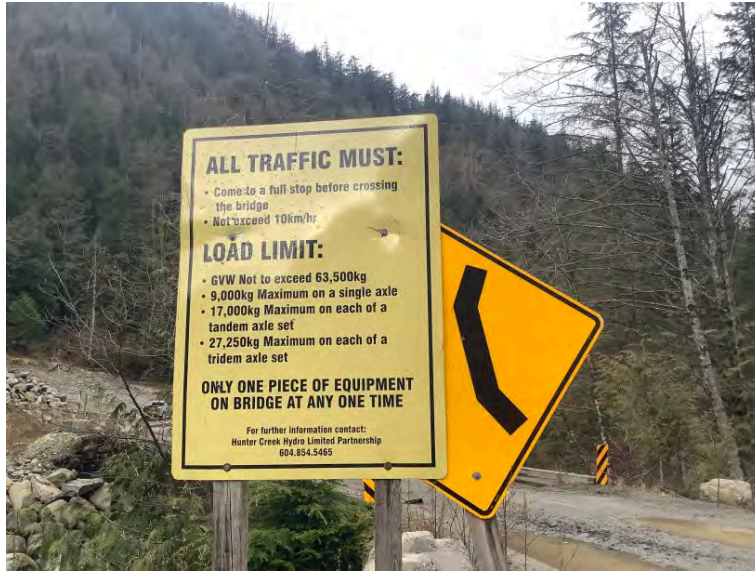
Load Rating Sign

Left approach. However bridge warning and load rating present.

| Repair Item | Repair Description |
|---|---|
| 1 Approach. Load rating signs. High | Post load rating signs |

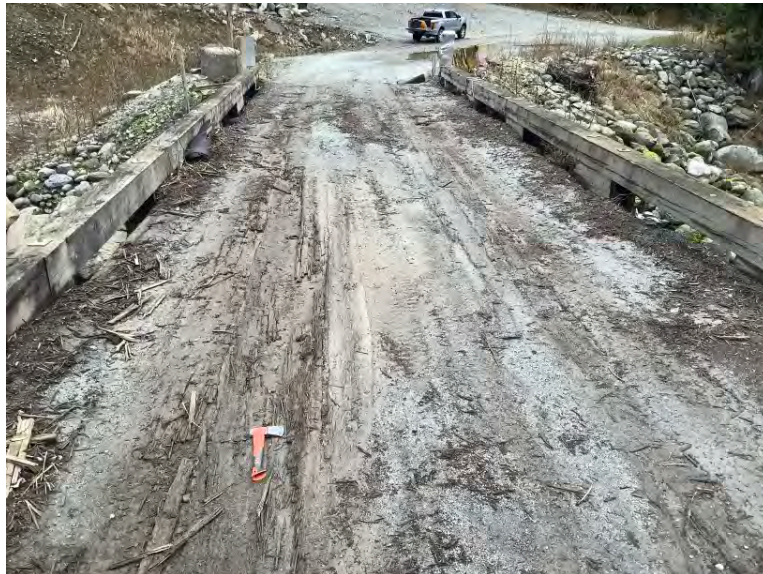
| Running Planks | Poor | Rotten |
| Overall Deck Condition | Poor | Due to timber deck condition. Deck is also covered in sediment and requires cleaning. |

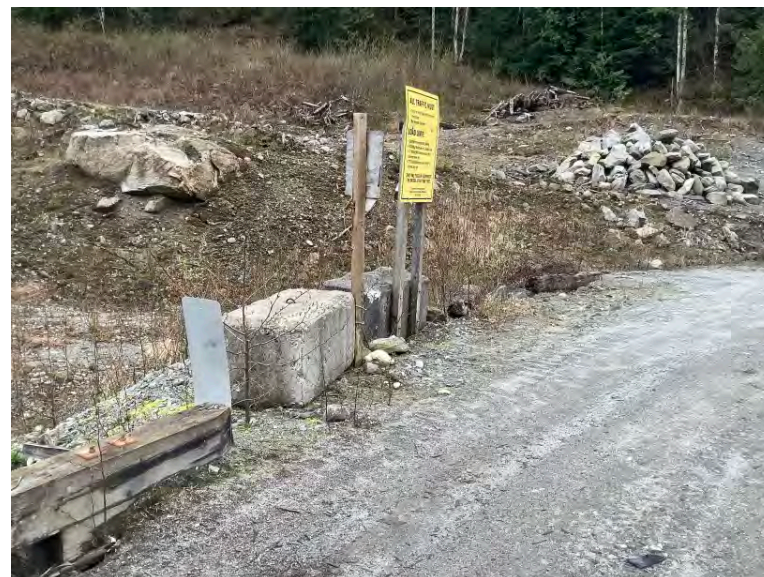
Approach Barrier, left upstream

Combo of blocks, rocks and logs. Logs are undersized and should be replaced. Right bank up and downstream require larger rocks or new guidelogs installed. Currently not functional.

| Repair Item | Repair Description |
|---|---|
| 2 Approach. Approach fenders (install). # of units. Priority:Medium | Install guidelogs on downstream right approach. Fill gap between blocks and bridge end with guide log on upstream right approach. Min 600mm x 6m |

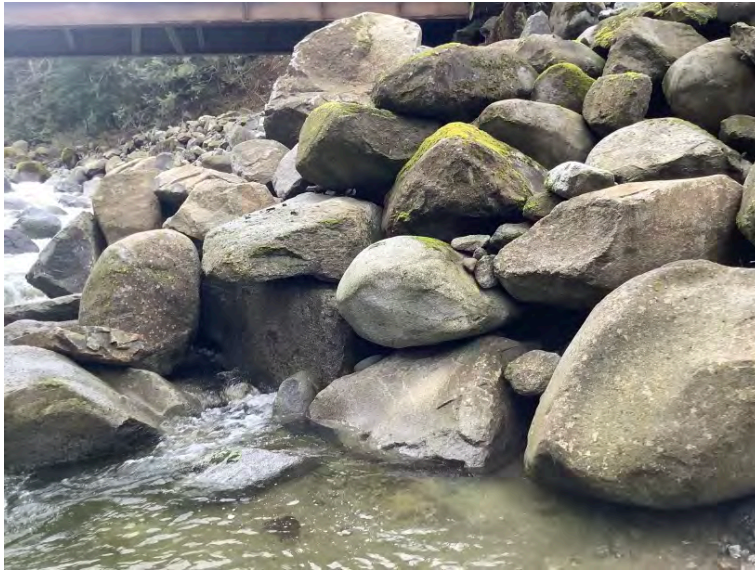
Downstream left riprap toe

Large oversteepened on left bank. Monitor downstream toe. Right bank is poor with no riprap

Comments Monitor riprap toe for scour on left bank.

| Item | Monitor Description | Frequency |
|---|---|---|
| 2 | Riprap scour and right bank erosion | Anually |

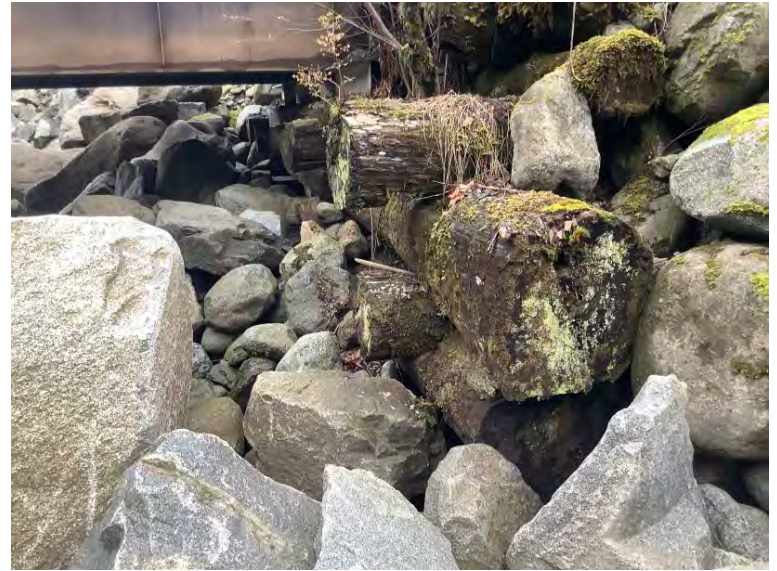
Downstream left crib end

Fair to poor. Right bank appears to have rotated into the approach fills by the angle of the visible tie backs. 50mm +/- rot.

| Item | Monitor Description | Frequency |
|---|---|---|
| 1 | Log crib condition. | Anually |

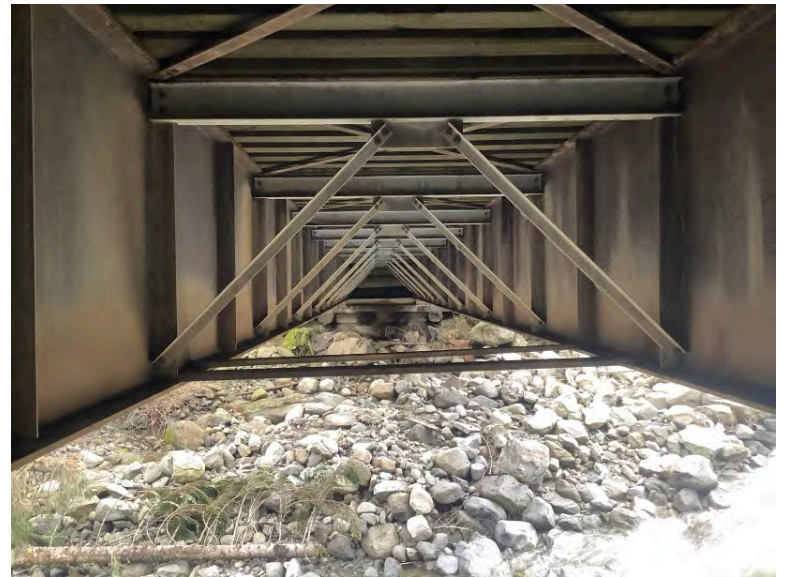
Superstructure

Minor sag in girders.

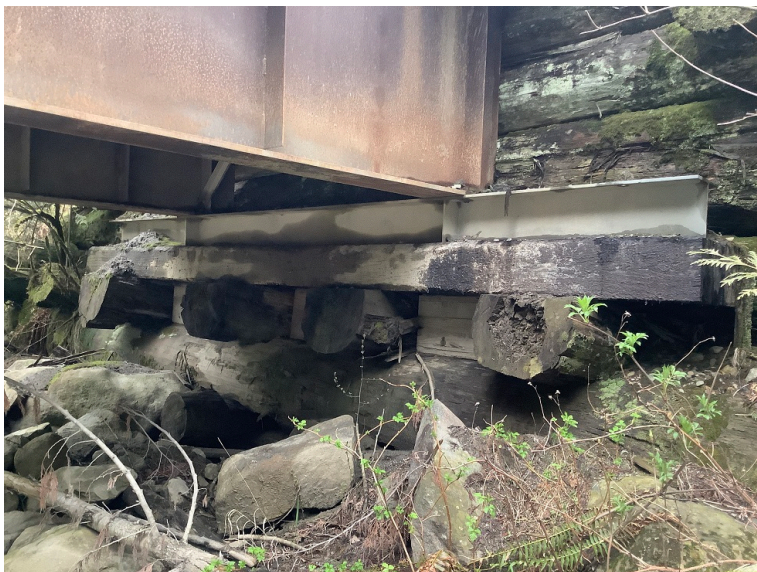
Right Bank Abutment when facing downstream

Fair to poor. Ends split, considerable rot. Right bank appears to have rotated

| Repair Item | Repair Description |
|---|---|
| 3 Approach. Area/sight line brushing. m². Priority:Low | Remove cedar trees growing around right abutment. |

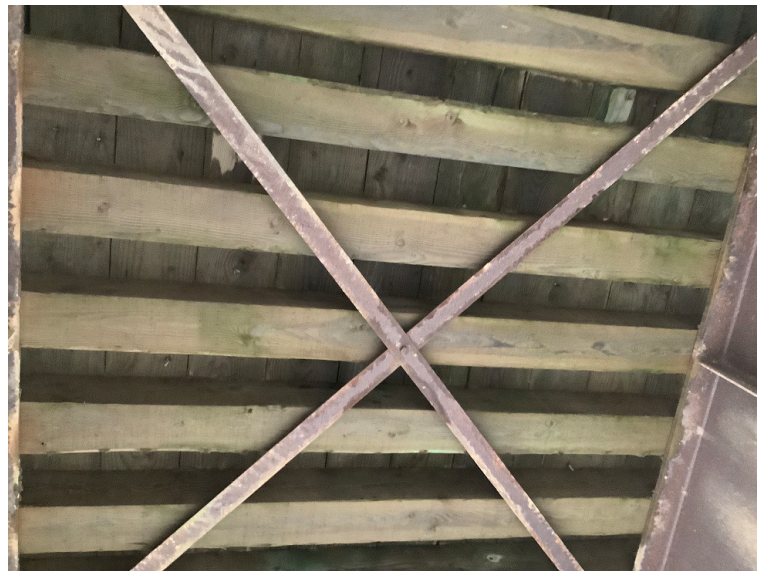
Deck condition from underneath

| Sub Deck | Poor | Rotten |
| Ties | Poor | Rotting from the top down. Spot checked 5 locations, 1 sound at interface of sub deck. Rest have over 2" of rot. 2 jammed drill 4.5-5" into tie with wet rotten wood. |

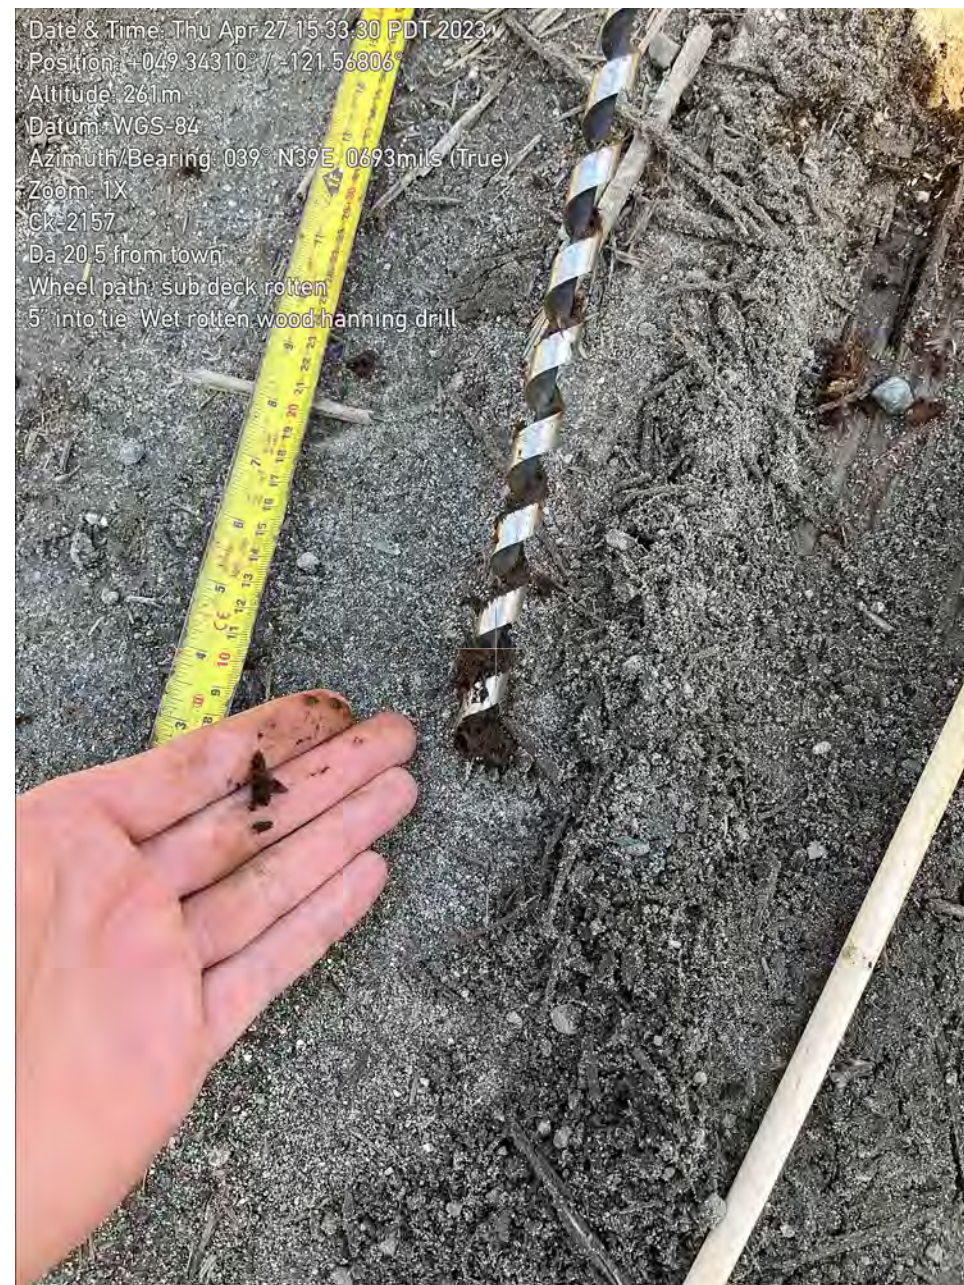
Wheel path: sub-deck rotten

4.5" into tie. Wet rotten wood jamming drill
