CK-2225  
CK-2225B

PITT RIVER 24.6km

2022 Inspection

Crossing Name Blue Creek

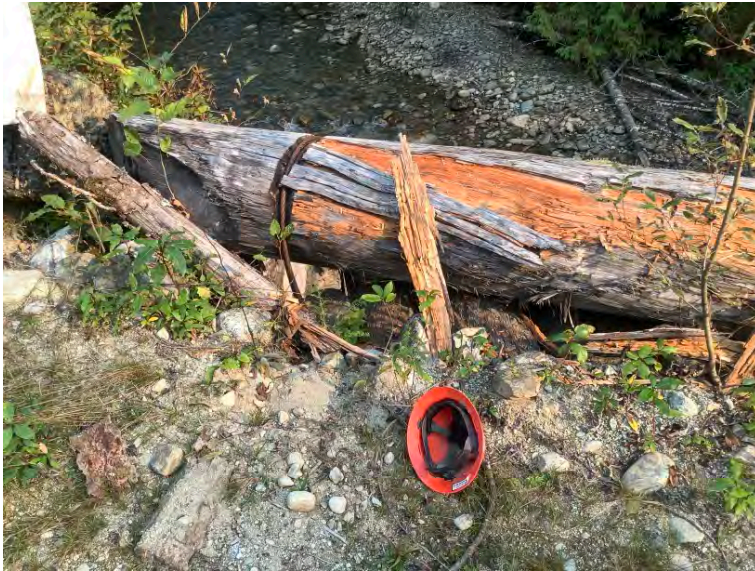
Some gravel deck material getting lost beneath curb logs through cross puncheon.

Material loss beneath curb log.

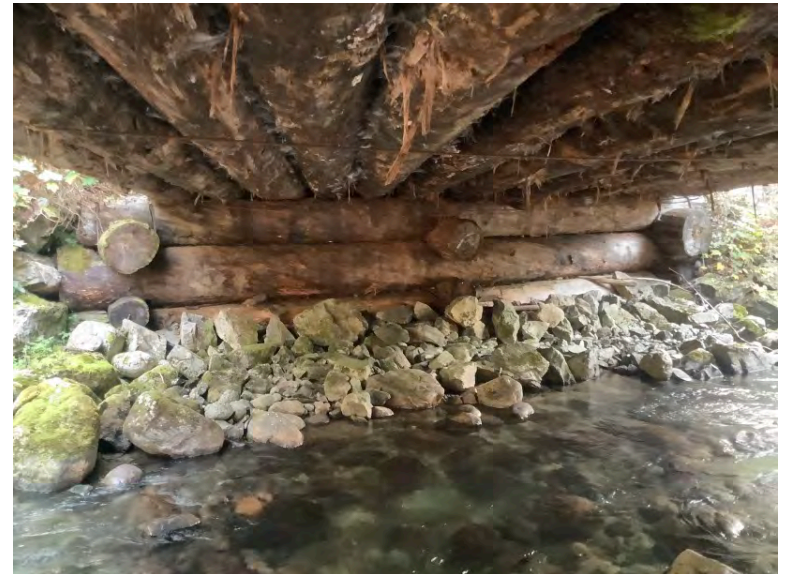
Left Bank Abutment when facing downstream

Log/Timber Cribbs Good 3 high

Tie Backs Good 3x

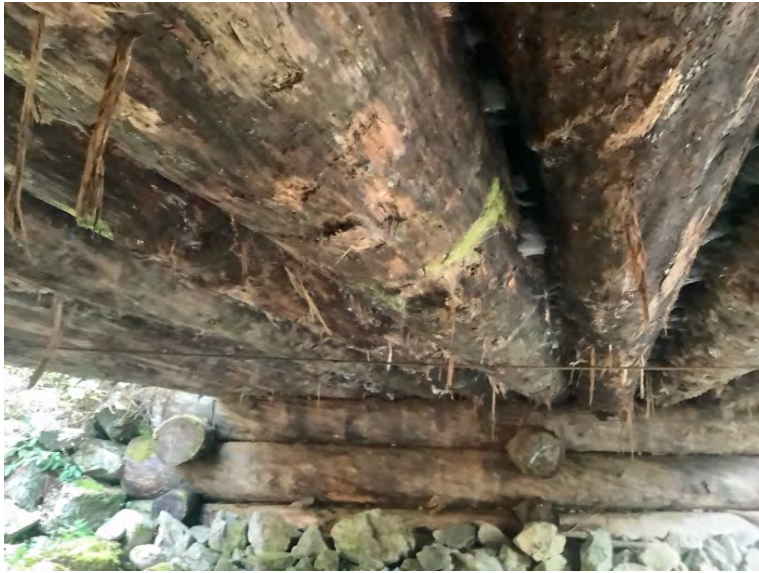
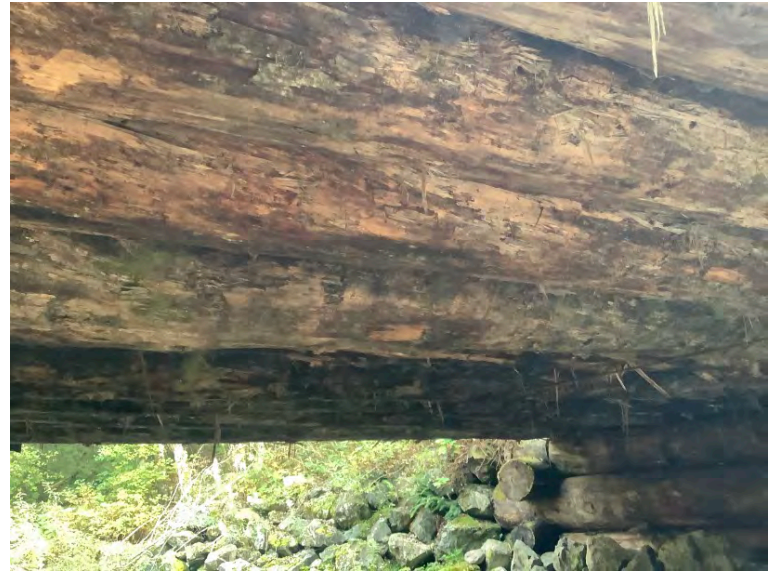
Stringers

Average between left and right bearing for mid span diameter. Drilled all stringers right bank. Pocket/dry rot throughout structure. Stringer rot depths consistent with dry rot depth where noted.

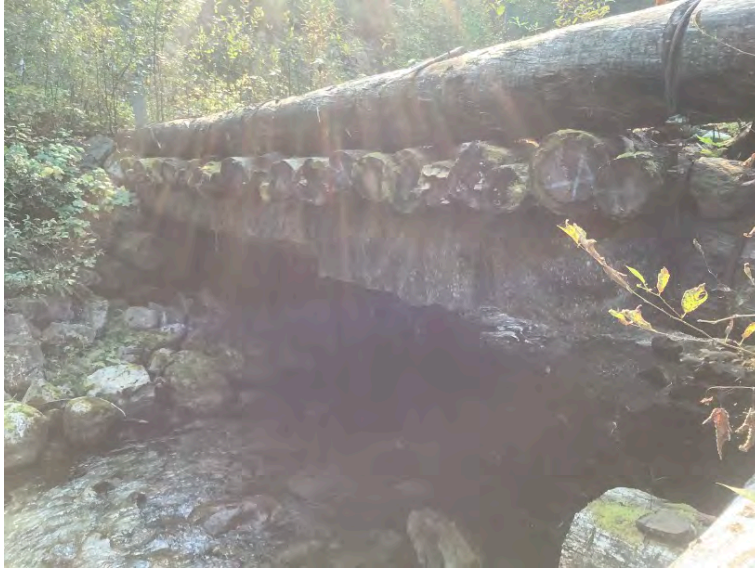
Cross puncheon

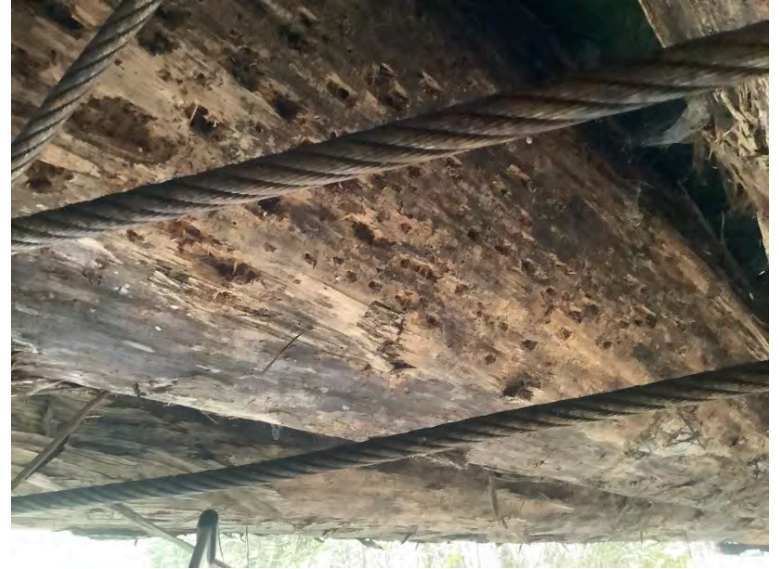
| Needle Beam to Crib (m) | | | Needle Diameter (mm) | | | |
|---|---|---|---|---|---|---|
| 11 | Fd | Y | 820 | 60 | Fair | Dry rot left end |

Stringer 11 dry rot, 1.5m inside bearing left bank
