CK-2260  
CK-2260

STAVE 3.5km

2022 Inspection

Crossing Name Roaring Creek

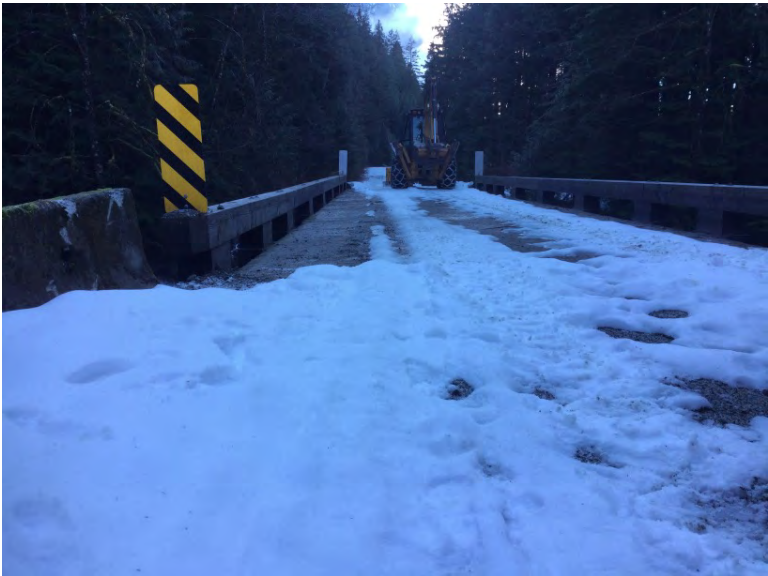
Slight misalignment due to settled footing but do not appear damaged.

Upstream woods end deck lower in elevation

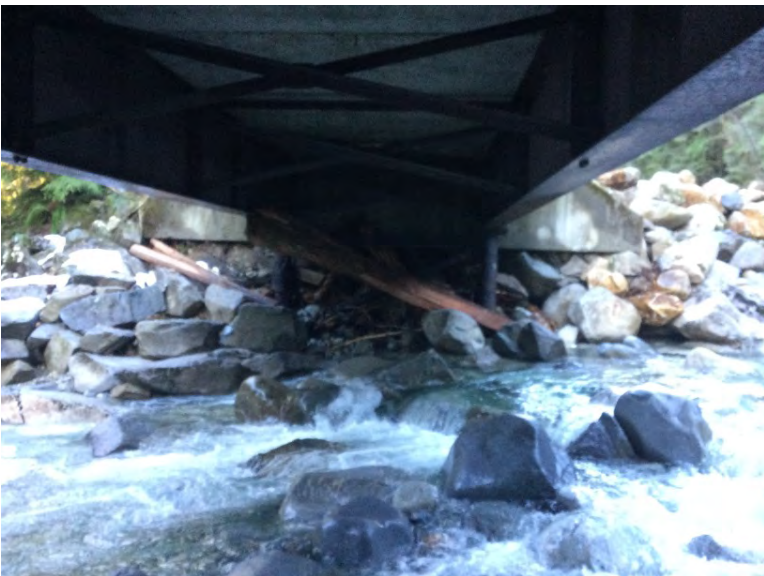
The woods abutment was damaged (scoured) in the November flood event. Material from under the upstream woods abutment footing has scoured resulting in settlement and rotation. Scour protection (riprap) has been added in front of this footing; however the footing is still exposed and further scour/settlement could occur. This needs to be monitored. A longer bridge is likely required

Upstream woods abutment has settled

Limit loading to 10 tonnes, post load rating signs. If a higher rating is required please submit a detailed plan for how the bearing material directly under the upstream woods abutment footing will be reinstated along with how the structure will be monitored during these required crossings. Irregardless of whether or not a higher rating is required, please ensure continuous monitoring of this site while the structure is in use.

| Item | Monitor Description | Frequency |
|---|---|---|
| 1 | upstream woods abutment settlement | Continuous while in use |

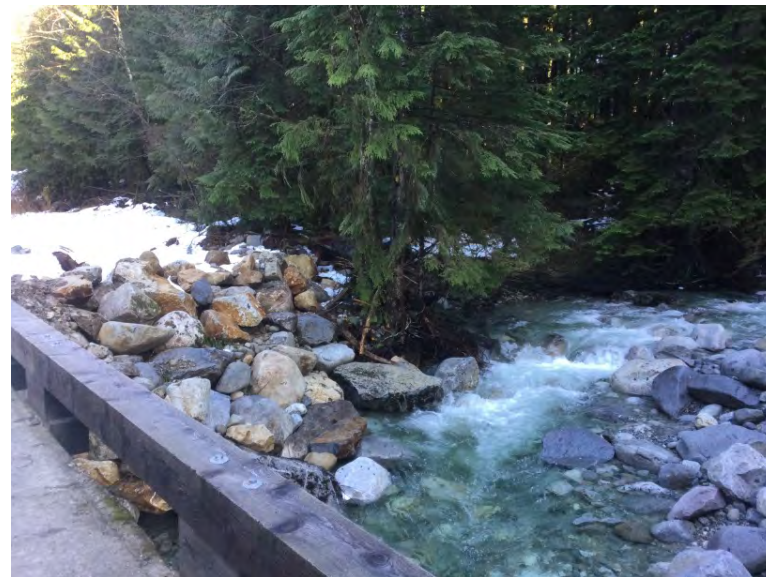
Significant erosion had occurred at the upstream woods abutment in the November flood event. Temporary repairs have been completed to this abutment

None in front of woods abutment footings

Upstream woods abutment

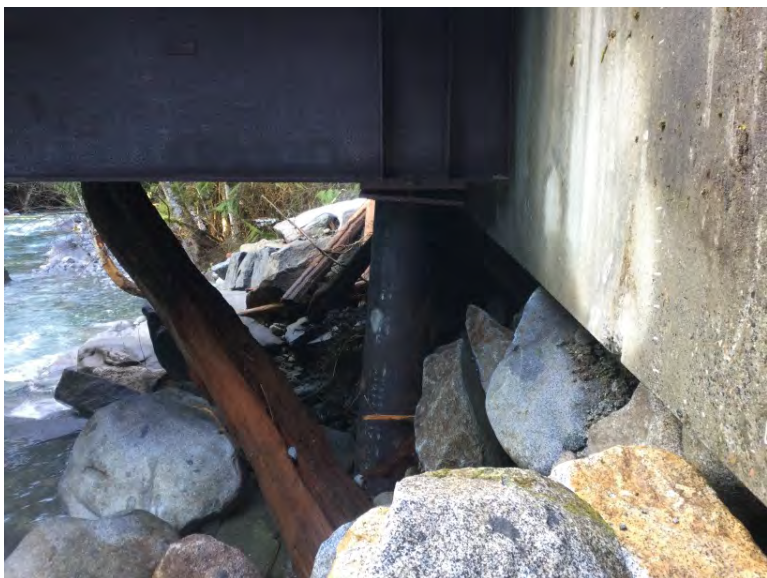
The upstream woods abutment pipe column is no longer vertical. Material from under this footing has been scoured resulting in settlement and rotation.

Upstream woods abutment pipe column leans to fill side

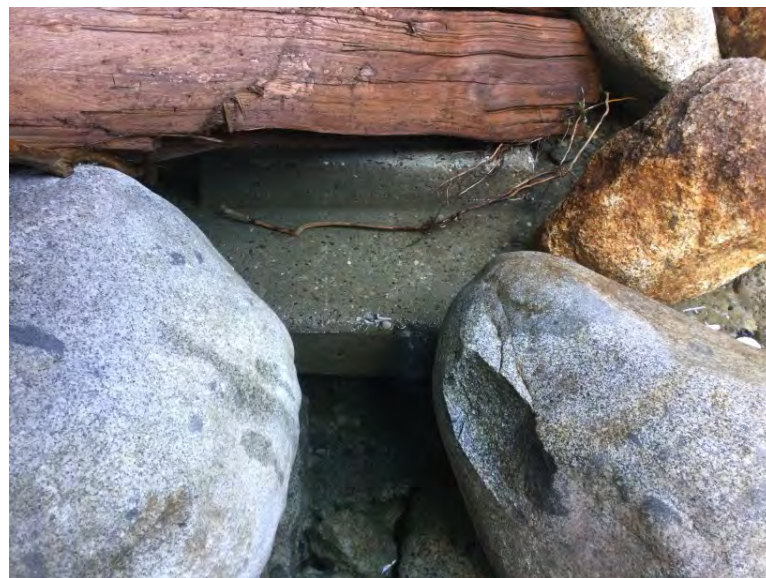
Material from under the the upstream woods abutment precast footing has been scoured. This footing has settled and rotated. The bearing plates at this location are still functioning however; likely under significant stress. Monitor their condition.

Upstream woods footing scour

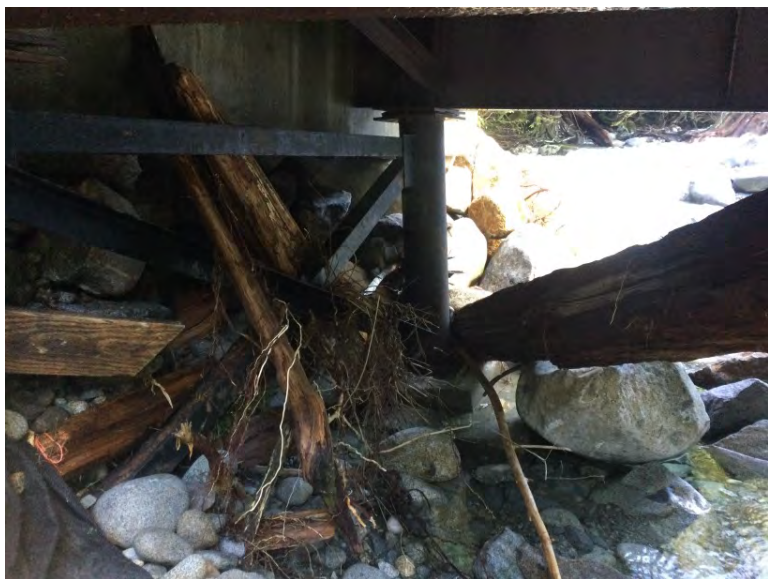
Upstream woods pipe column condition
