CK-2267  
CK-2267

STAVE 17.8km

2023 Inspection

Crossing Name Ole Creek

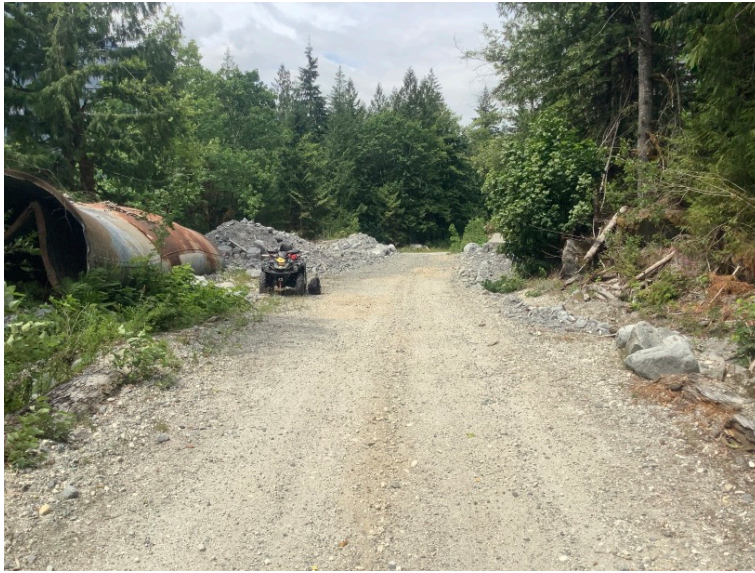
Bridge deck, viewing to right approach

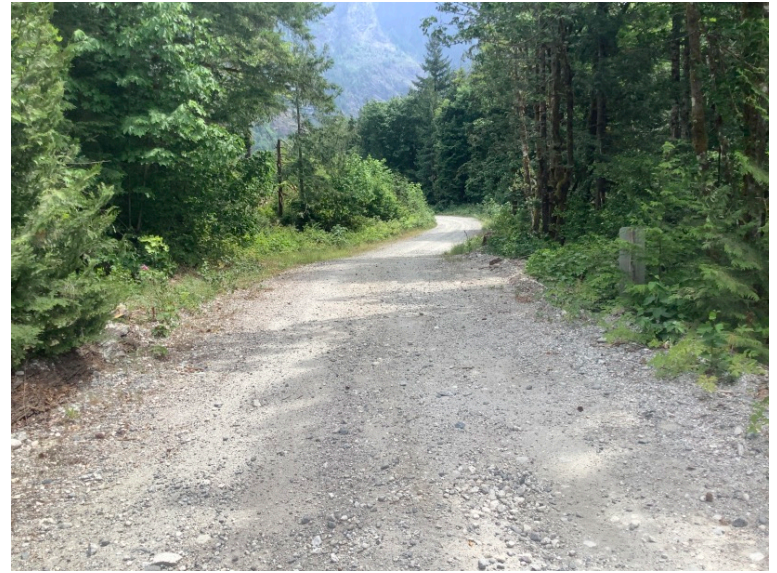
Bridge deck, viewing to left approach

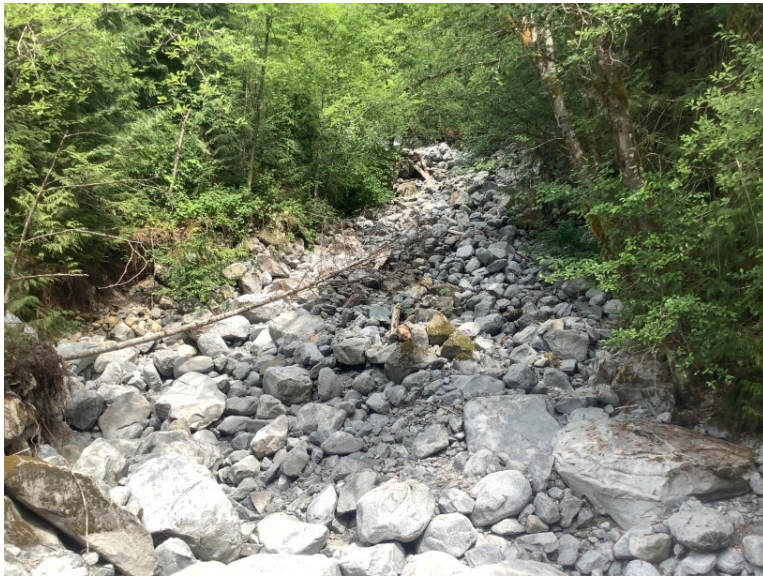
Upstream from Crossing

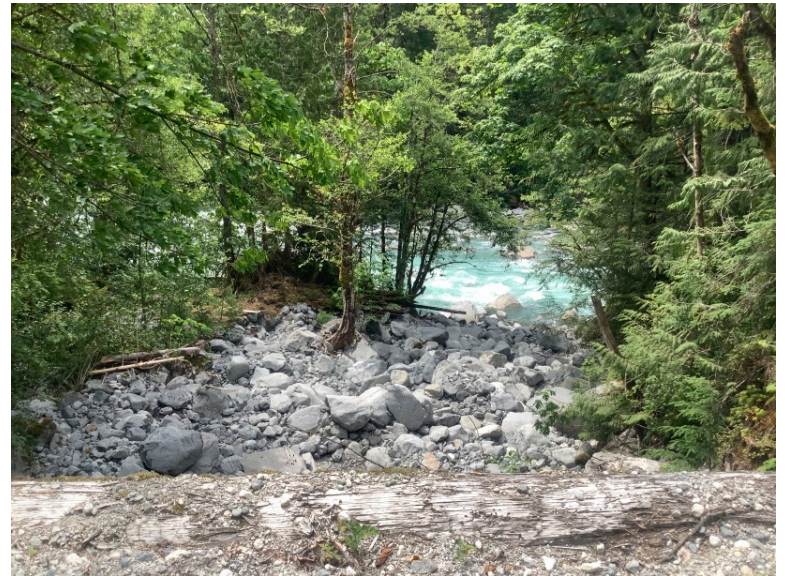
Comments 2 layers of stringers. Half plugged. Since previous inspection (2022) left crib has completely been undermined. Bearing sill crushing. Crib is now completely exposed. Structure requires replacement, it continues to degrade at a rapid pace. Downstream left bank is scouring, poses risk to structure if large boulders shift.

Downstream from Crossing

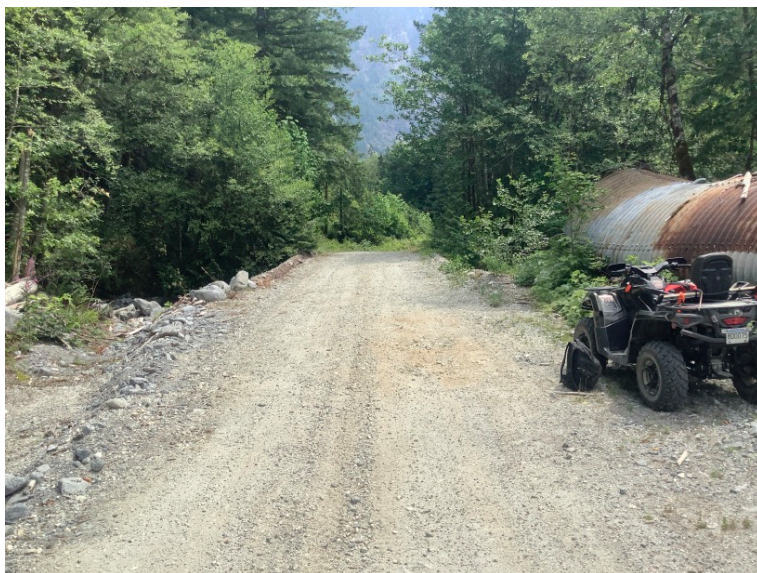
Approach from Right Bank when facing downstream

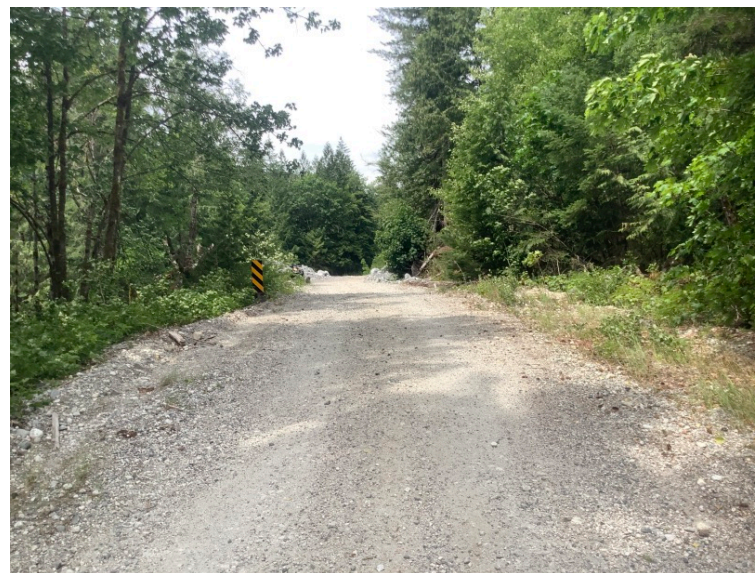
Approach from Left Bank when facing downstream

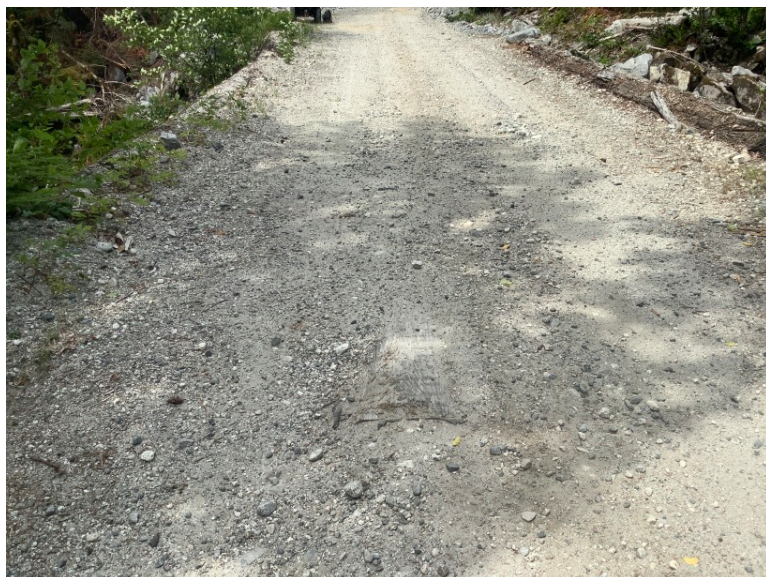
Gravel Surface Poor - thin one stringer end is exposed

Left approach, stringer end visible

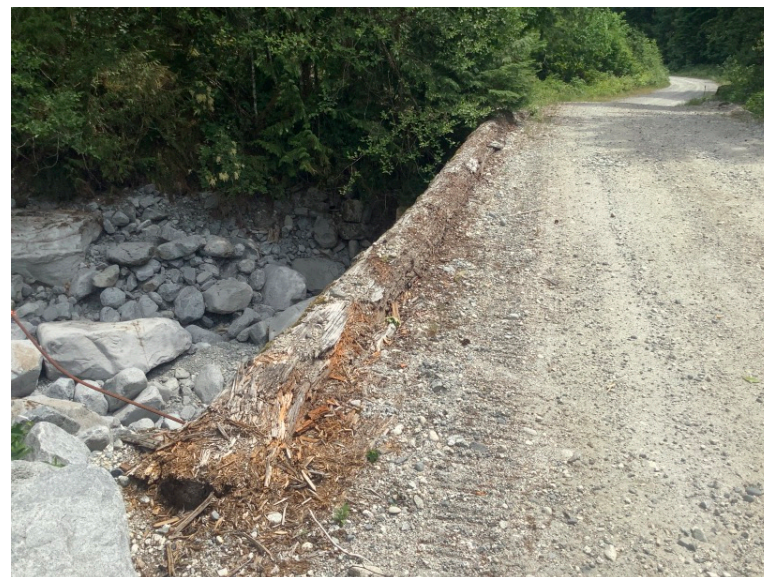
Log Curbs      Poor - rotten and not high enough to be effective

Curb upstream

| Repair Item | Repair Description |
|---|---|
| 2 Structure. Curb Maintenance. # sites. Priority:High | Replace curbs for user safety |

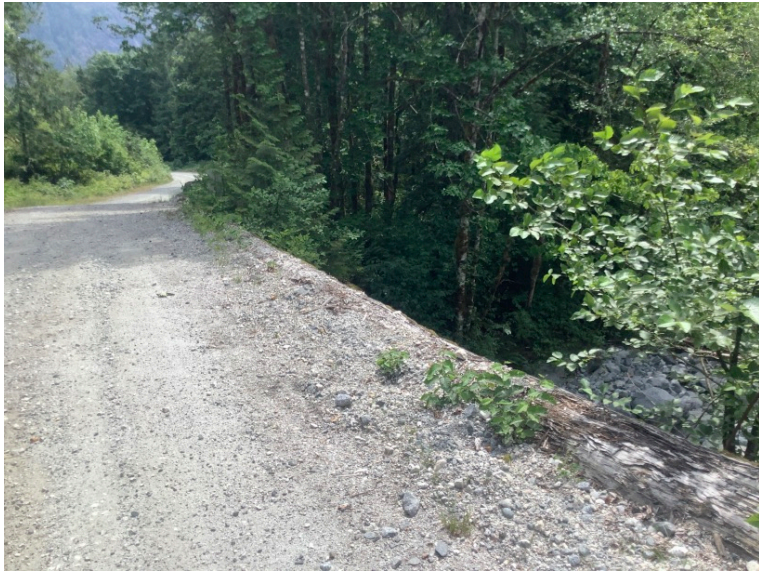
Curb downstream

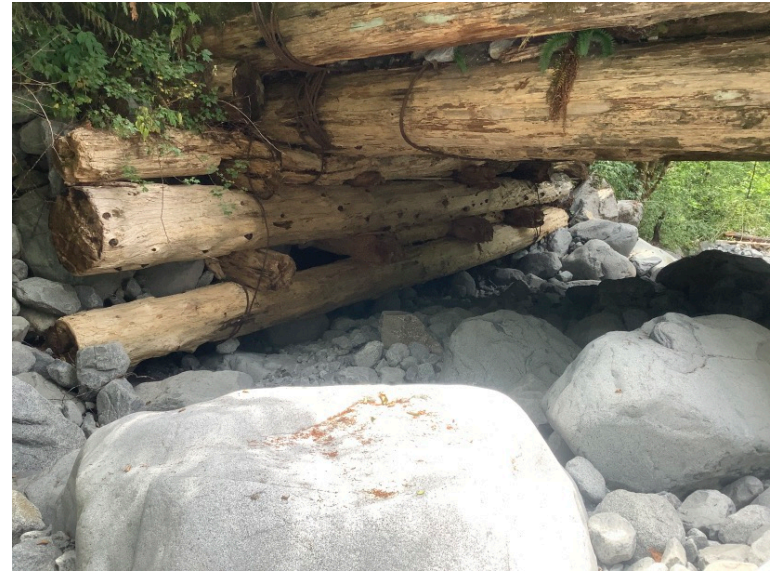
Poor - rotten and crushing. Left crib undermined and entirely exposed

Left Bank Abutment when facing downstream

0 tonnes load limit. Post load rating signs. Replace the entire structure.

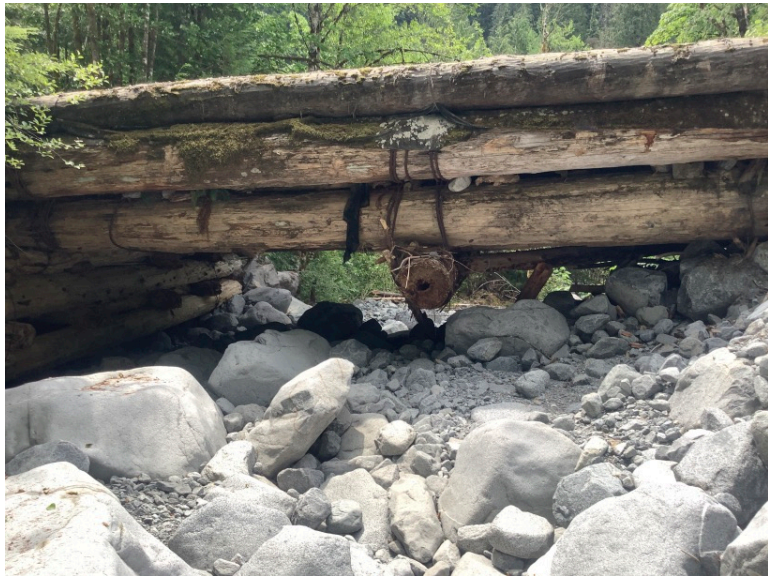
Upstream Profile

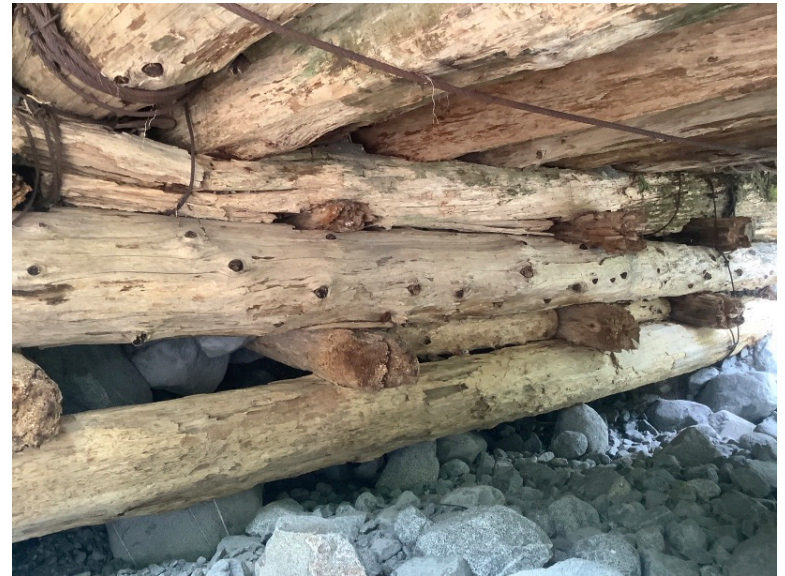
Left Bank Abutment when facing downstream

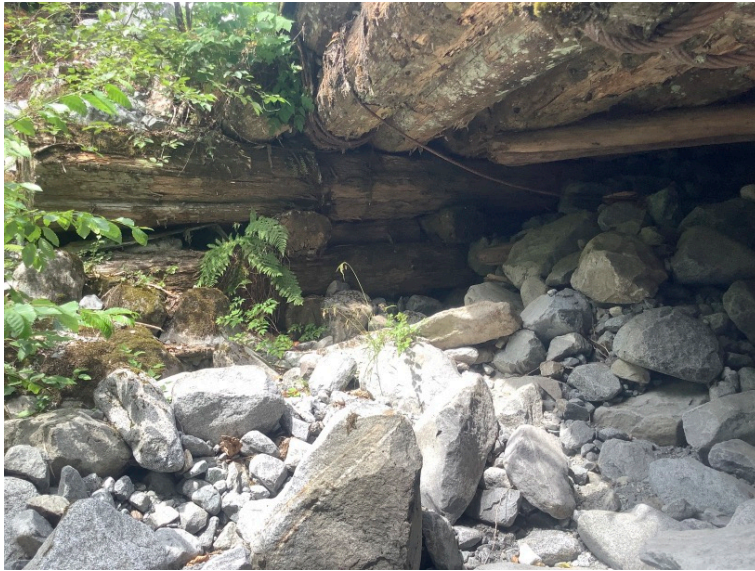
Poor - no riprap. Right crib infilled and left fully undermined

Right Bank Abutment when facing downstream

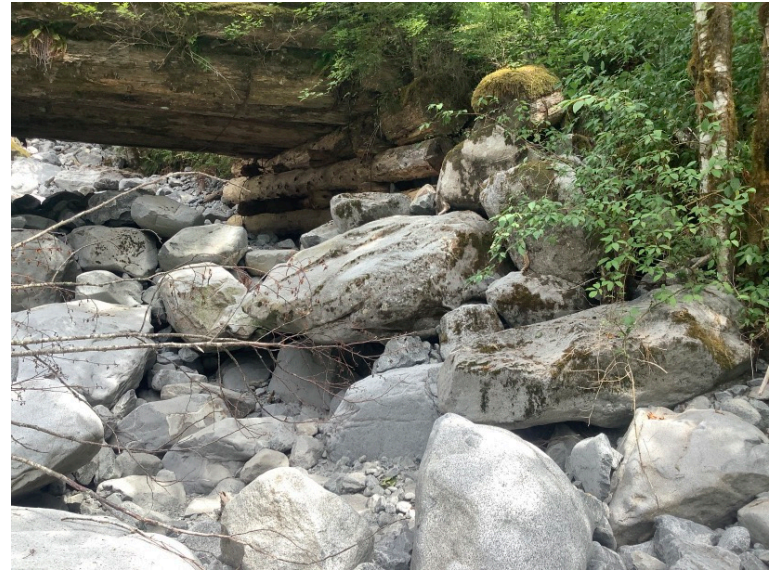
Left Bank Abutment when facing downstream

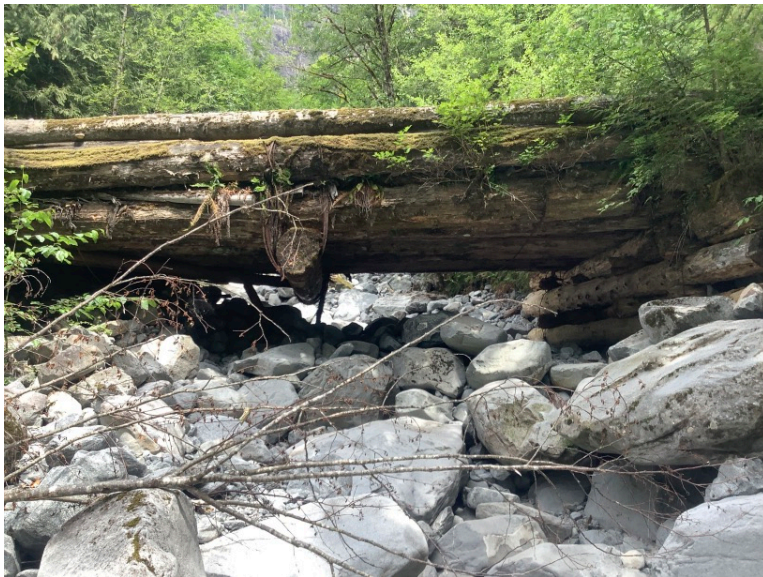
Downstream Profile
