CK-2269

STAVE 20.3km

2021 Inspection

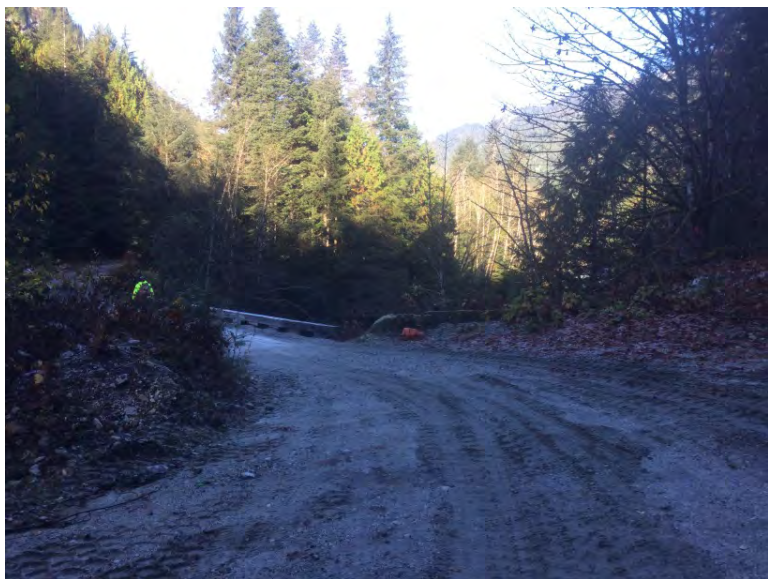
Approach from Left Bank when facing downstream

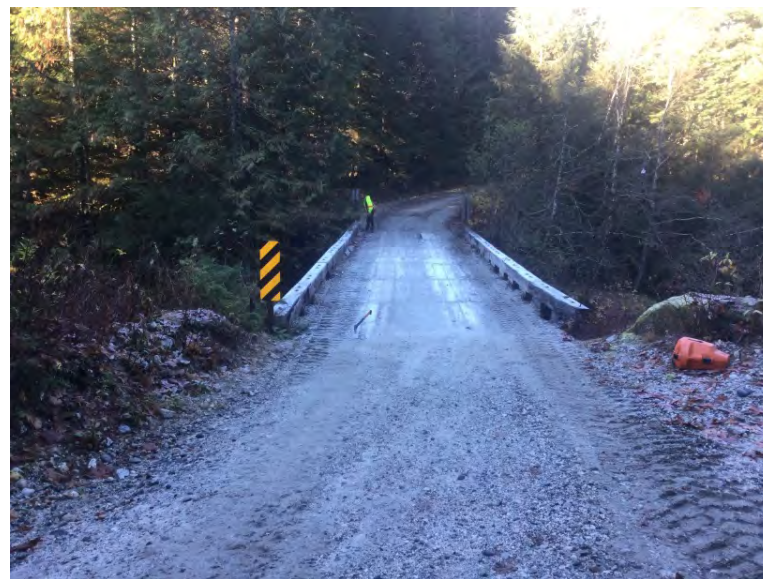
Approach from Left Bank when facing downstream

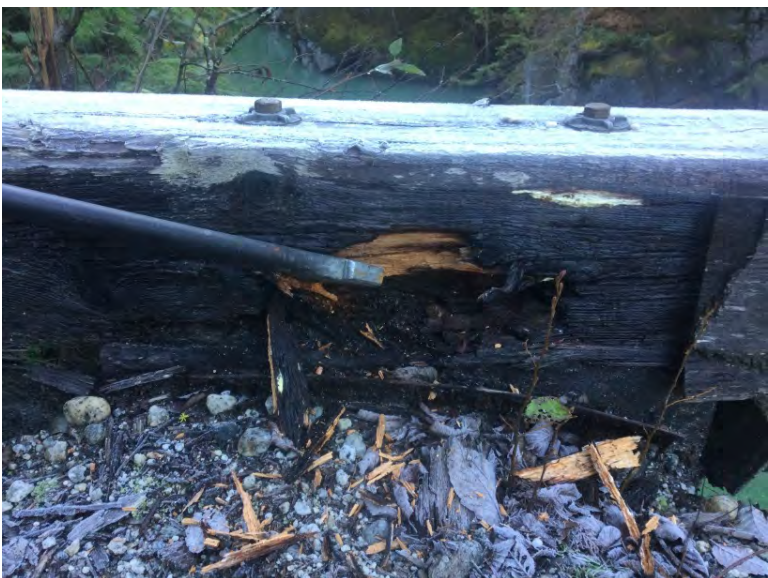
Curb Rail/Blocks/Posts      Poor      Rotten

Hardware      Poor      Loose rail bolts

Guard Rail

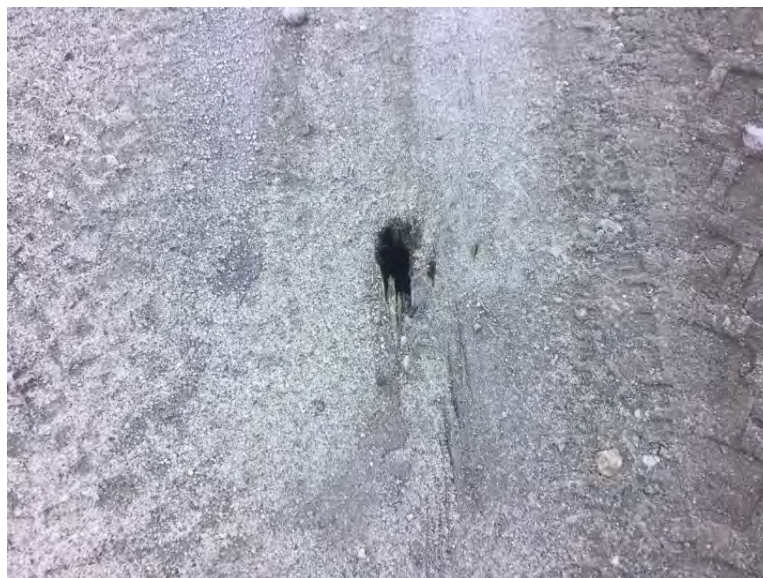
There are now holes in the deck with some planks having been replaced - the timber deck is heavily rotten and in poor condition. The substructure is also in poor condition. Limit loading to L5 or 5 tonnes. Post load rating signs and plan to replace the entire structure.

Holes in deck

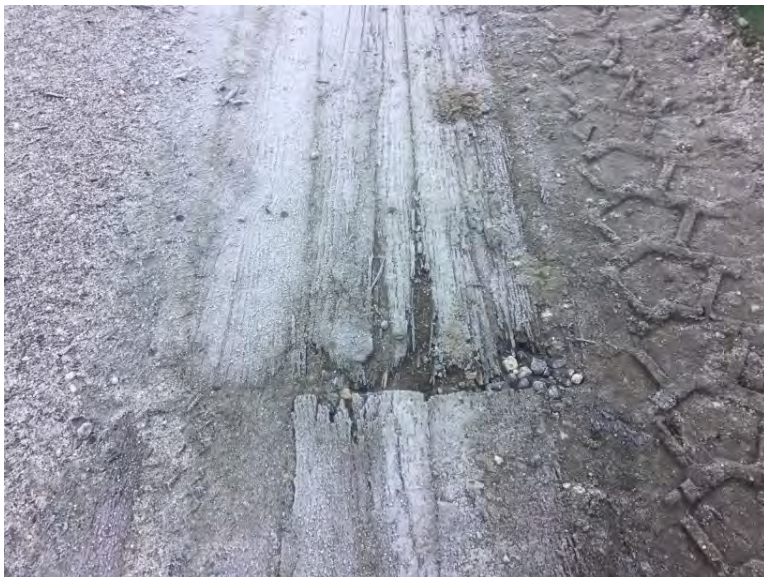
Running Planks      Poor      decay throughout, worn heavily along wheel path, some planks have been replaced at right bank

Deck plank condition

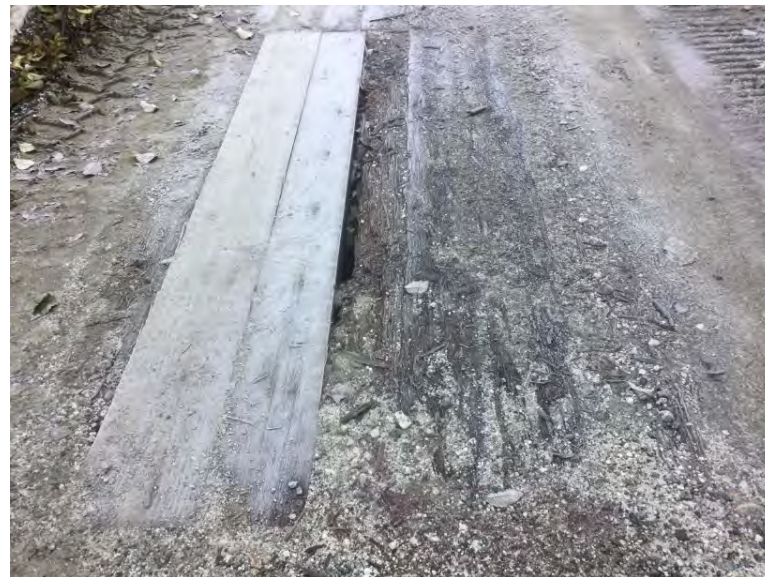
Deck plank condition

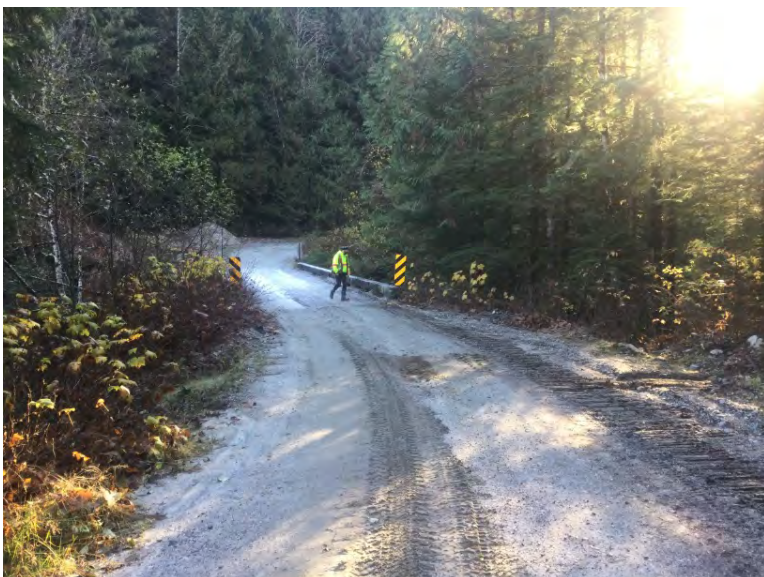
Approach from Right Bank when facing downstream

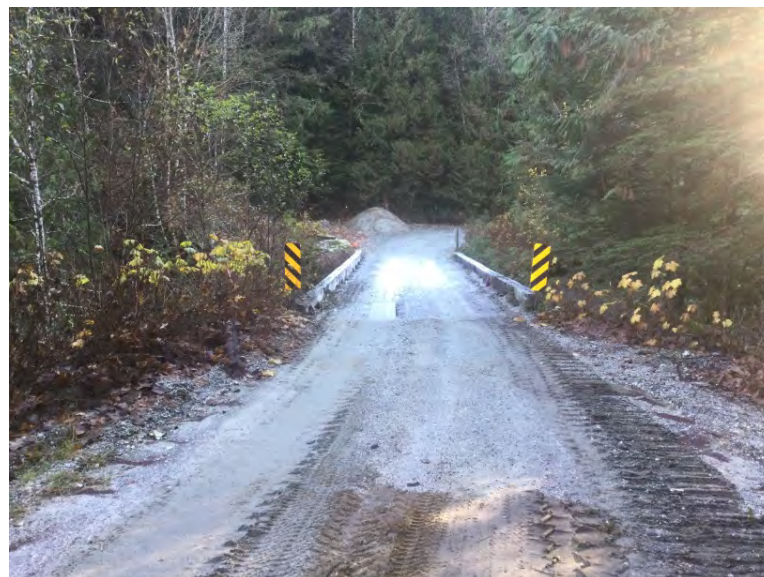
Approach from Right Bank when facing downstream

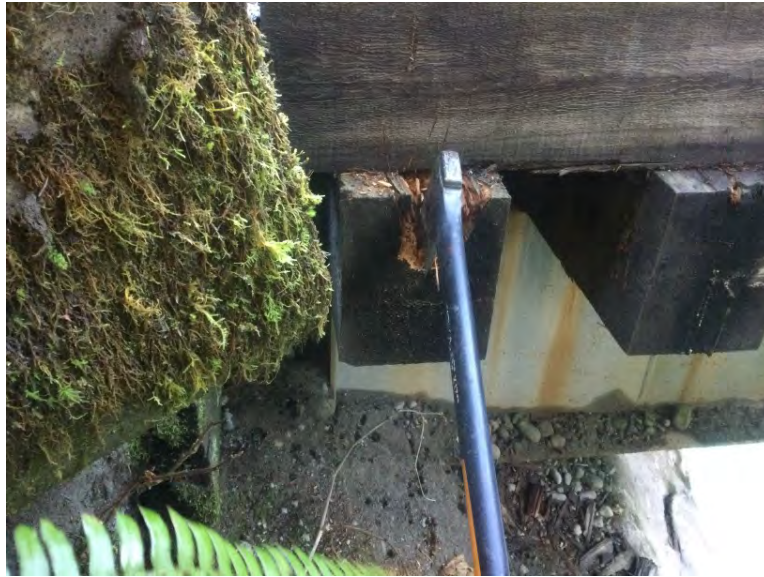
Ties      Poor      extensive rot at ends

Typical cross tie condition at ends

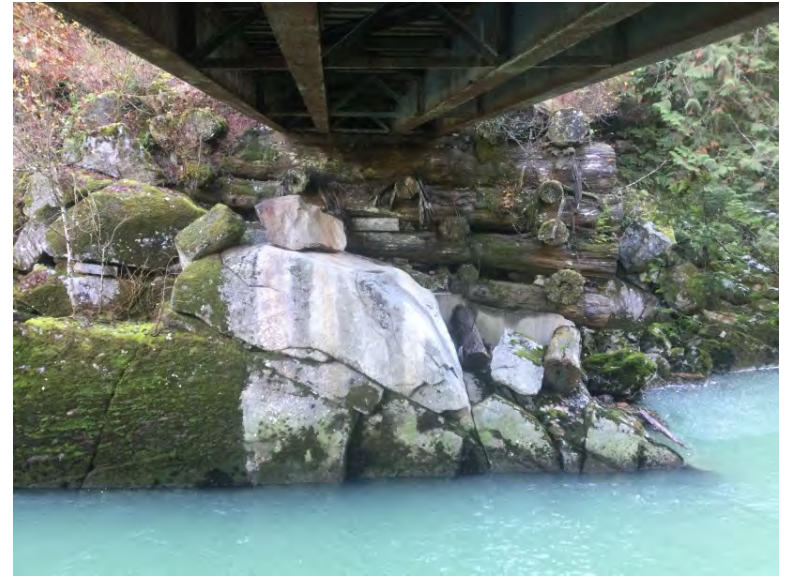
Log/Timber Cribs Poor 4 face logs on left bank - Fair condition, single log sill on mud sills at right bank - poor condition

Left Bank Abutment when facing downstream

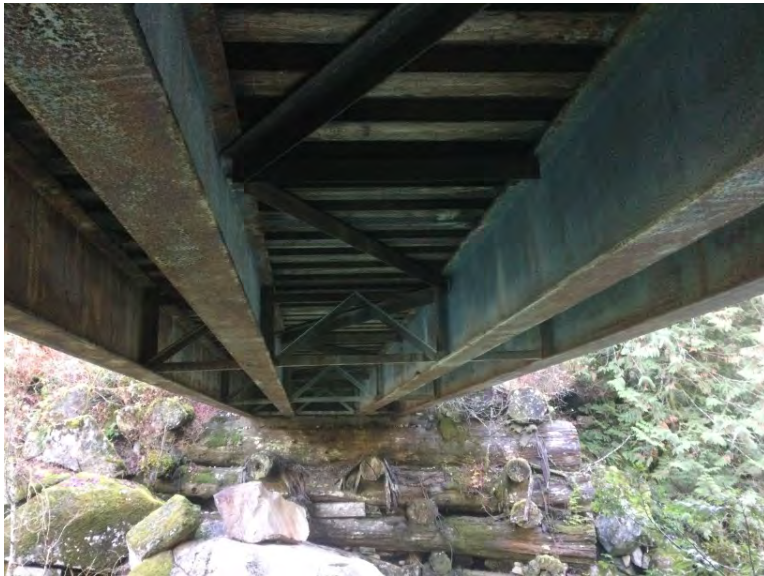
Girders Fair 4 I beams, painted and corroded

Superstructure

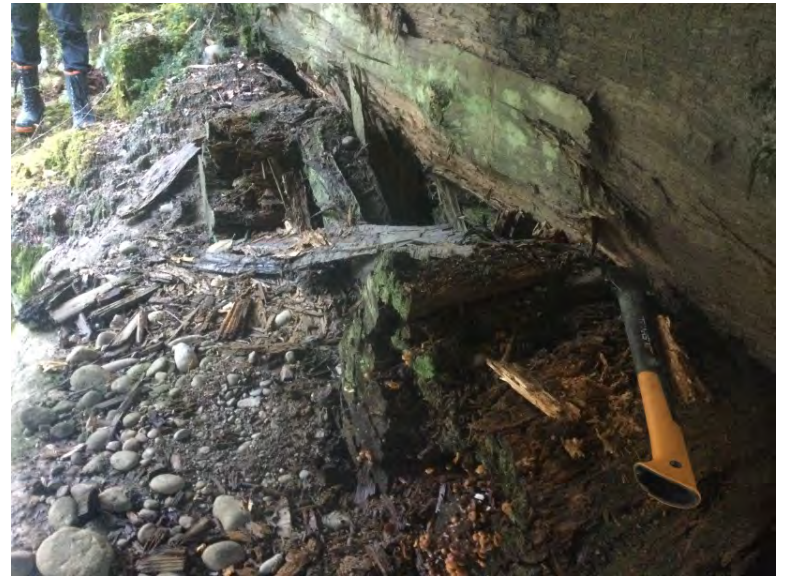
Tie Backs Poor rotting and splitting, includes mud sills

Mudsills at right bank in overall poor condition

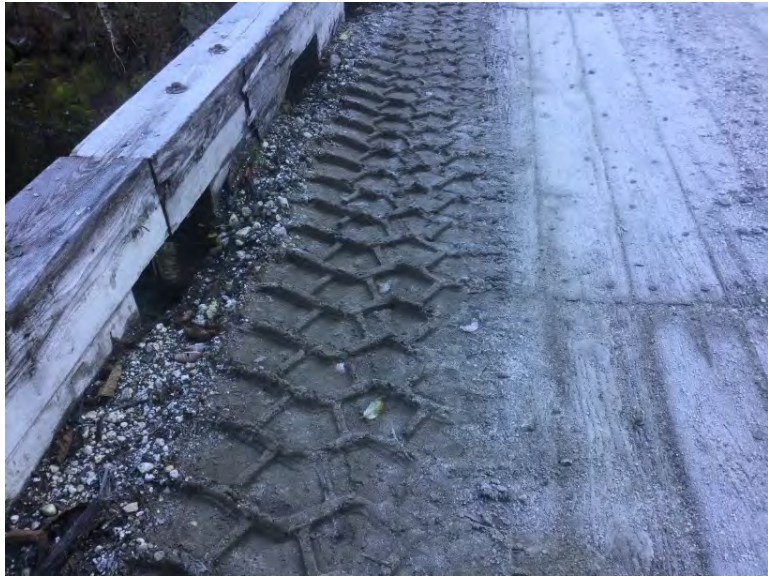
Site has been surveyed  
Bridge was posted at 68 tonnes - sign was removed during inspection  
No apparent change in either abutment; both in poor condition. Timber deck in poor condition.  
Evidence of equipment passing over recently

Recent large wheeled vehicle passing over bridge

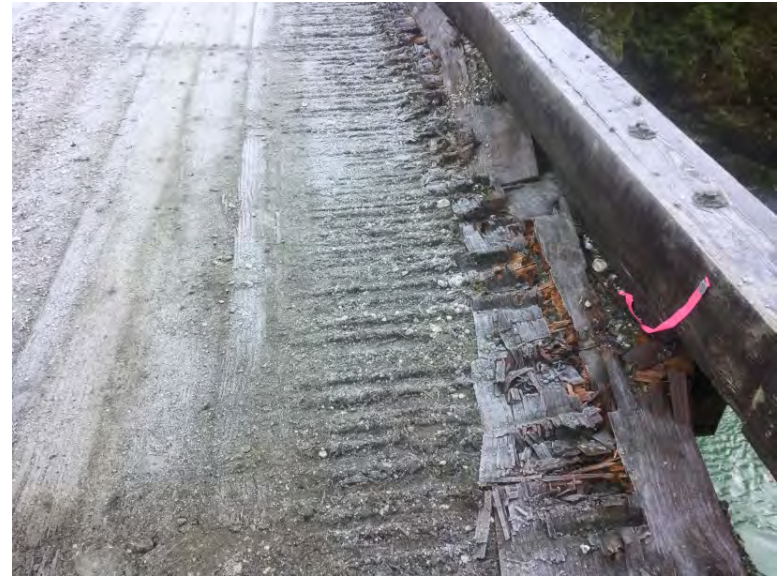
Recent track equipment passing over bridge

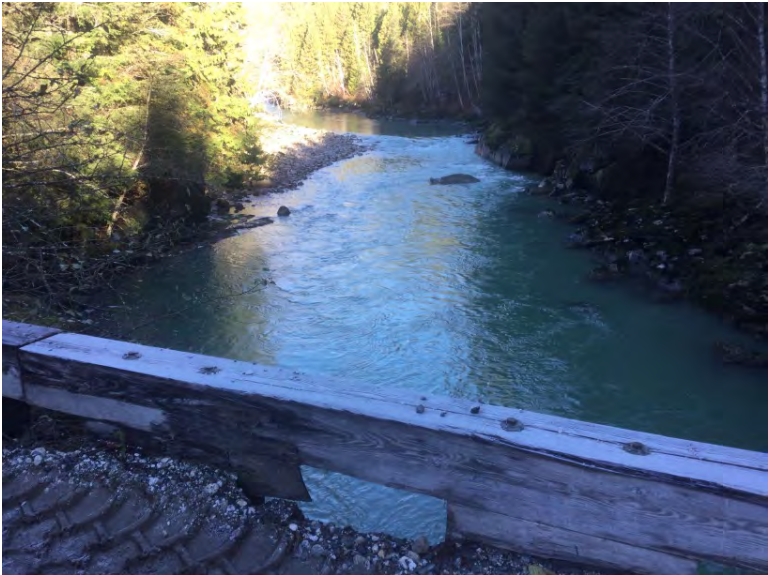
Upstream from Crossing

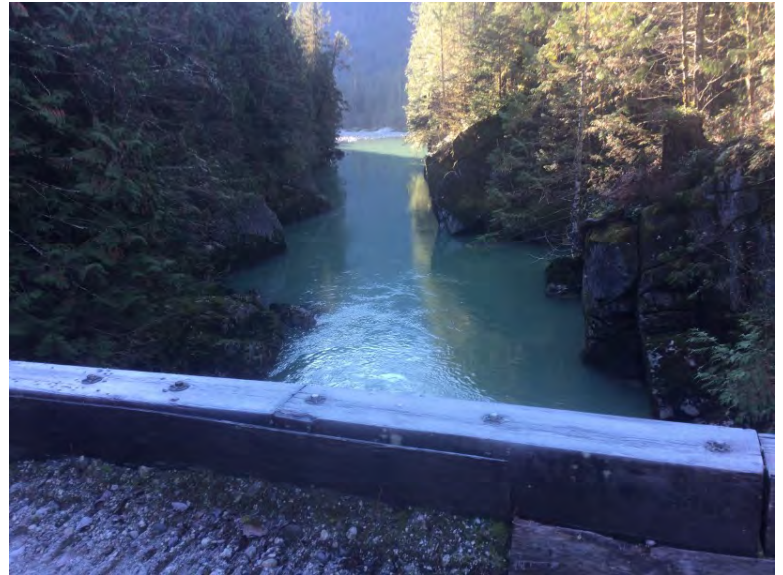
Downstream from Crossing

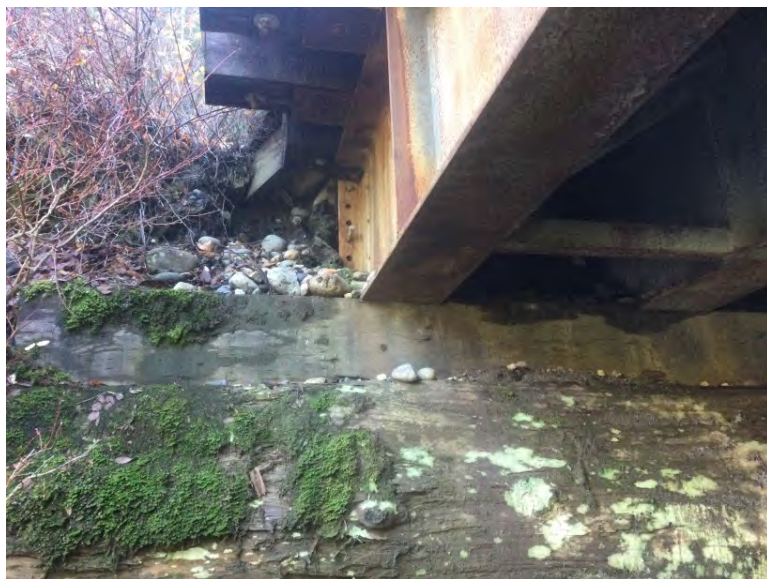
Ballast Wall Poor Failed at upstream left bank

Left bank ballast wall has failed

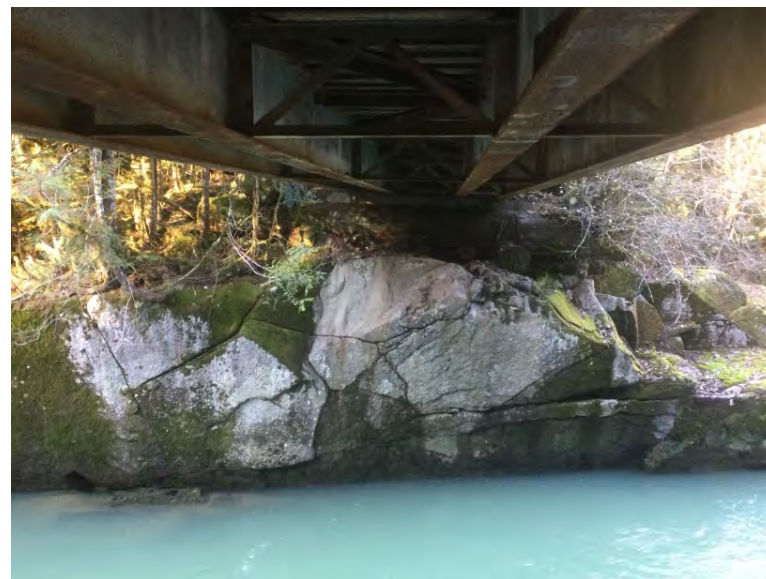
Right Bank Abutment when facing downstream

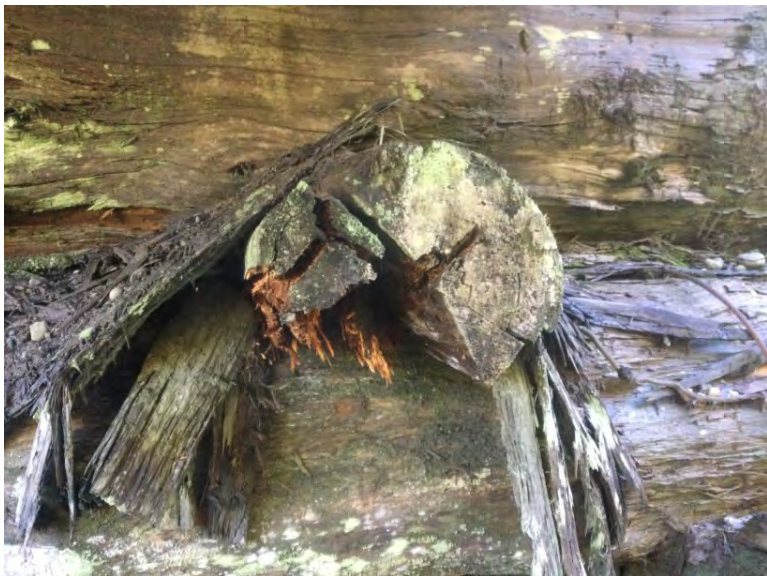
Tieback condition

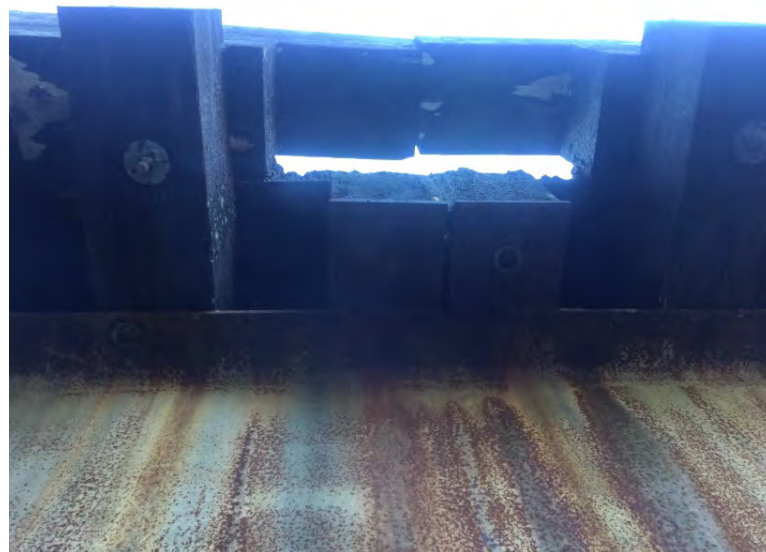
Deck clips

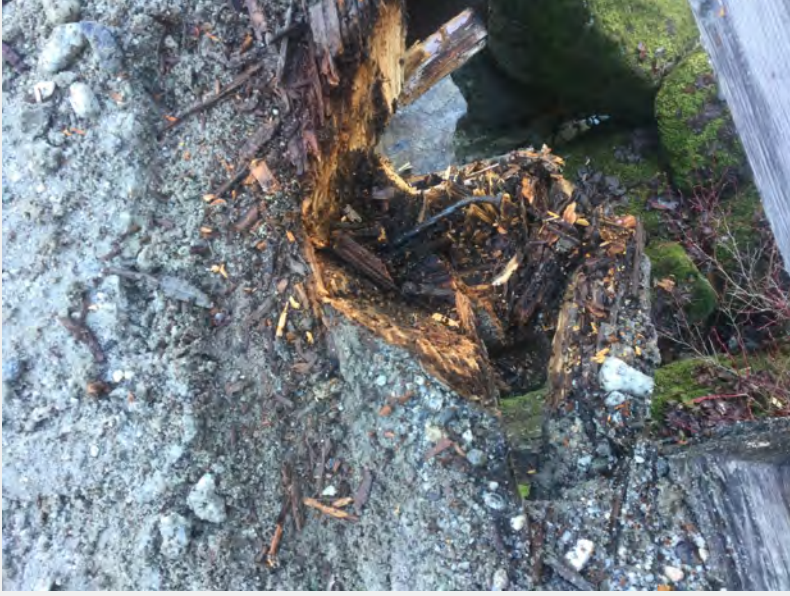
Sub Deck      Poor      upstream deck edges were sampled and extensive rot located

Timber deck condition along deck edge
