CK-2497  
CK-2497

ENGLISH 2.6km

2021 Inspection

| Crossing Name | Side Creek |

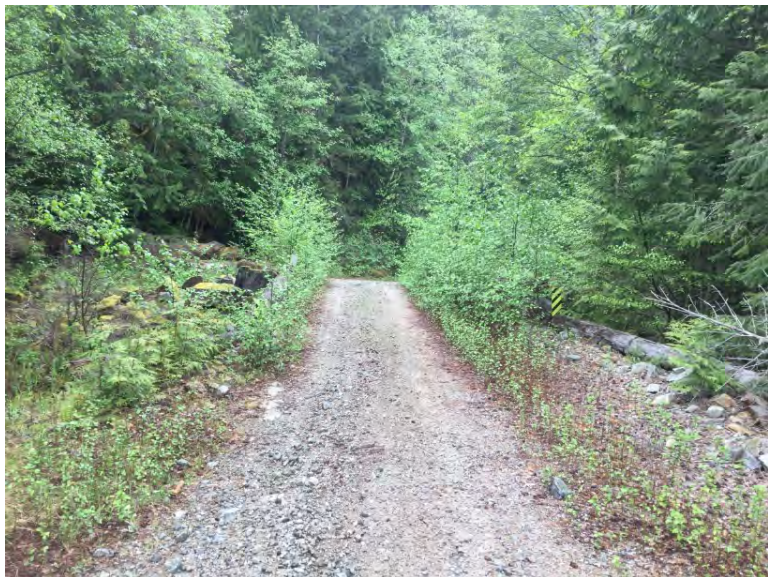
Approach from Right Bank when facing downstream

HC and sharp VC left approach, steep grade through crossing

| Repair Item | Repair Description |
|---|---|
| 1 Approach. Area/sight line brushing. m <sup>2</sup> . Priority: Medium | Brush approaches |
| 2 Approach. Add Warning Signs. # of signs. Priority: Low | Post bridge ahead signs |

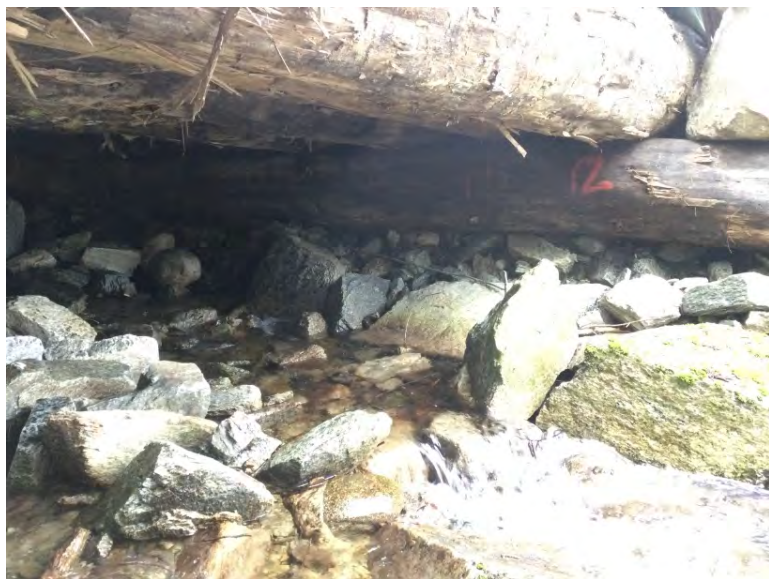
The erosion/scour noted in the 2020 inspection under the log sill at the downstream left bank location continues. Approximately 50% of this material has now been eroded. Recommend repair prior to industrial use.

The erosion/scour noted in the 2020 inspection under the log sill at the downstream left bank continues to persist. Approximately 50% of the foundational material under stringers 7 - 12 has been eroded. Replace the eroded foundational material under the left bank sill, ensure full bearing, and cover with scour protection/riprap. Limit loading to L30 or 27 tonnes until this work has been completed. Brush approaches and post bridge ahead signs. Monitor the scour under the left bank sill. Post load rating sign.

Scoured left bank

Erosion downstream left bank extends to stringer 7

| Repair Item | Repair Description |
|---|---|
| 3 High | Repair scour under left bank log sill and place riprap protection |

| Item | Monitor Description | Frequency |
|---|---|---|
| 1 | Scour under left bank sill | Anually |

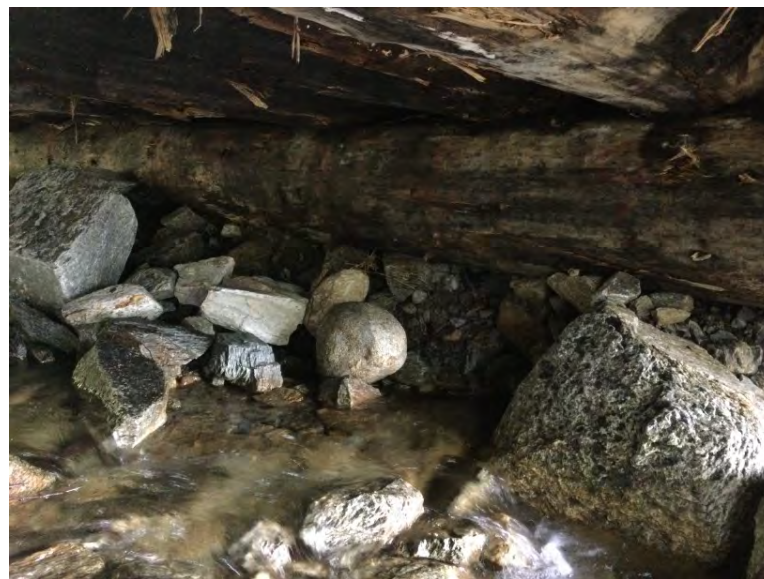
Erosion under stringers 7 and 8
