## TECHNICAL MEMORANDUM

**RE: November 2018, Lost Creek/Lost Murdo FSR Landslide Investigation**

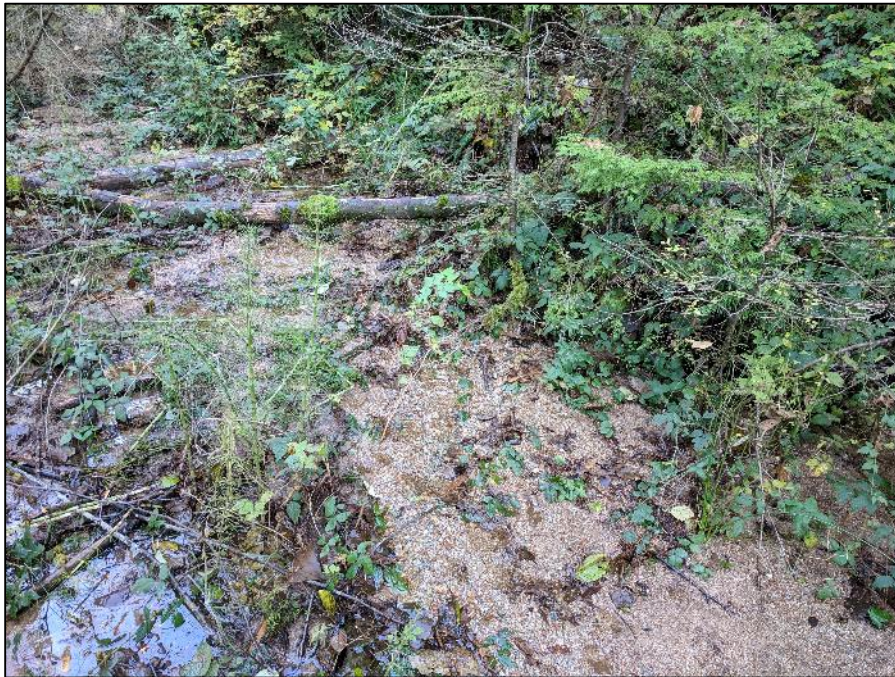
The landslide started from the fillslope of a non-status road where a small stream (S6) crosses the road. There did not appear to be a culvert at the crossing. Water from the stream was flowing down the non-status road instead of across or under it. The small stream built a fan composed of sands that filled the ditch and extended about 1 m onto the road. The road grade is about 5% near the slide initiation zone. Water was pooling on the road surface above the slide scarp (Photo 1).

*Photo 1: NSR above the scarp. The surface has standing water. Coarse sand has deposited on the road surface.*

To reduce the immediate hazard of additional failures from the initiation site, pull back road fill at the scarp. Do not sidecast pulled back fill. Install a cross ditch at the stream crossing to provide a path for the stream to cross the road. Remove decaying timber and/or organic matter from under the fill.

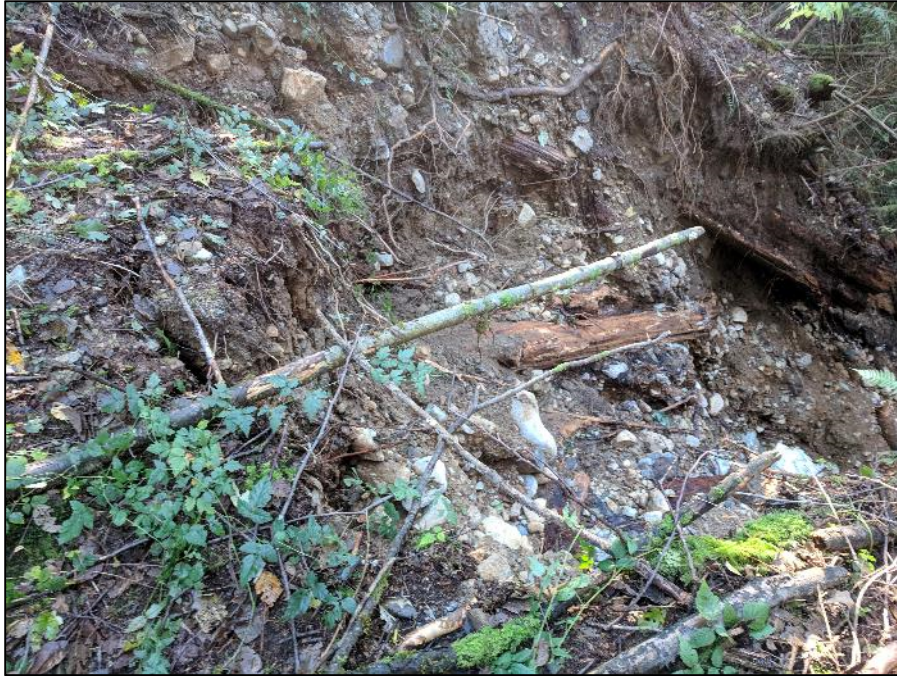
The scarp is about 3 m wide and about 2 m high (Photos 2 and 3). There are tension cracks at the edge of and parallel to the scarp. The cracks are about 20 cm from the edge. They are 30 cm deep, less than 10 cm wide, and about 2 m long.

*Photo 2: Slide scarp from the NSR above. The tension crack on the left side of the photo is about 10 cm wide.*

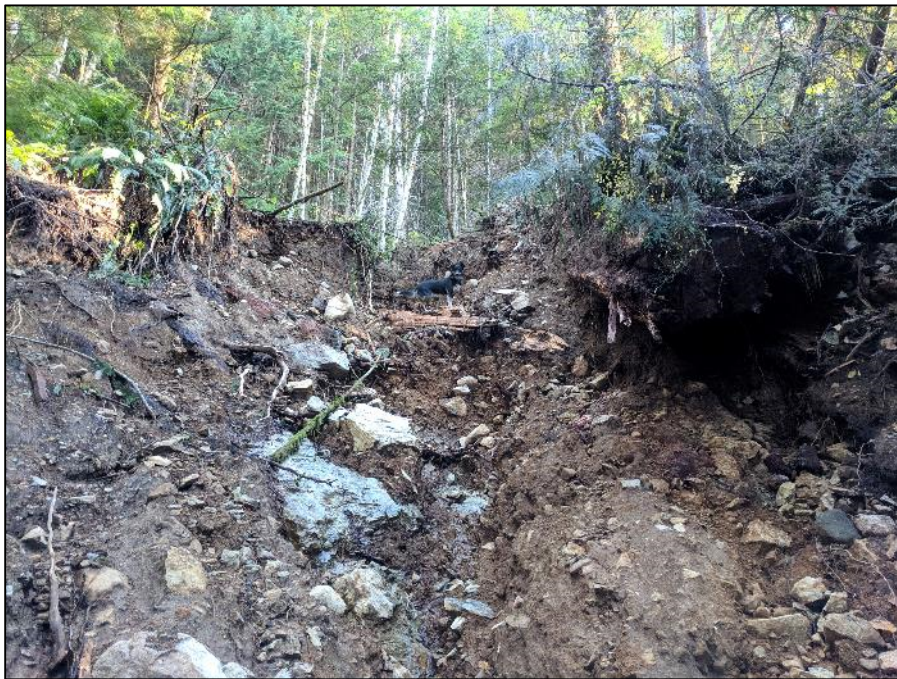
*Photo 3: Looking at the scarp from below. The large log on the right side of the scarp is partially buried under the road surface above. The dog is near where the road fill was before failure.*

In the scarp, there is one large (about 1 m diameter) log. The log is perpendicular to the road and juts out about 2 m from the edge of the scarp. The log may have been puncheon or may have supported road fill. It is starting to decompose and that may indicate that fill near the scarp was at least partially supported on decaying organic matter.

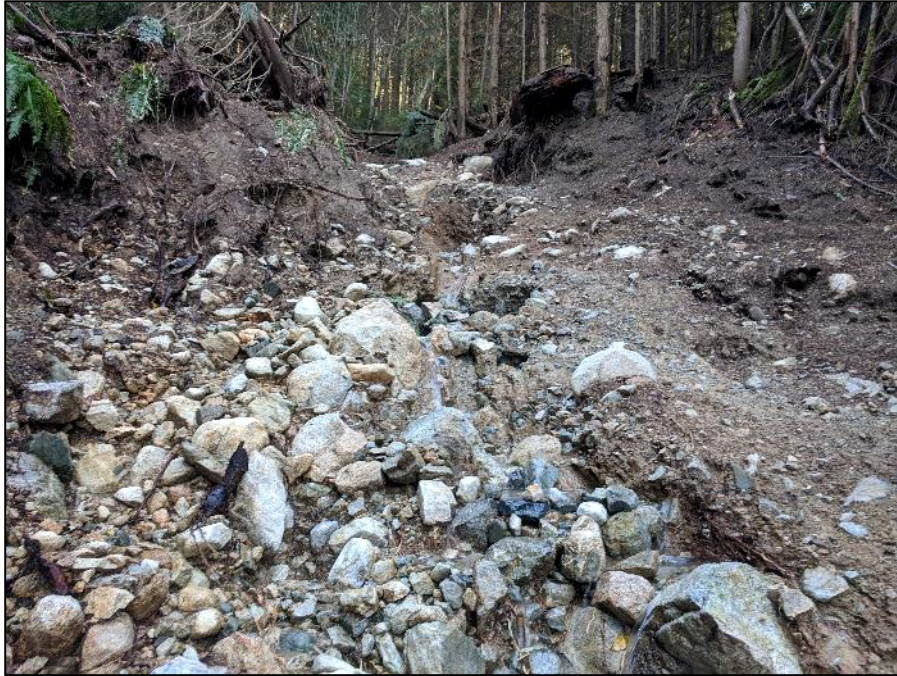
The landslide path gradients range from 40% to 60%, with most reaches closer to 40% interspersed by short (2 m high) pitches with 60% gradients. There is bedrock exposed in the steeper reaches. The landslide scoured to highly compacted or cemented till along most of the track between the initiation site and Lost Murdo FSR (Photo 4).

*Photo 4: Looking up the landslide path. The slide scoured through the compacted or cemented till. The slope gradient is about 50%. The path is about 5 m wide.*

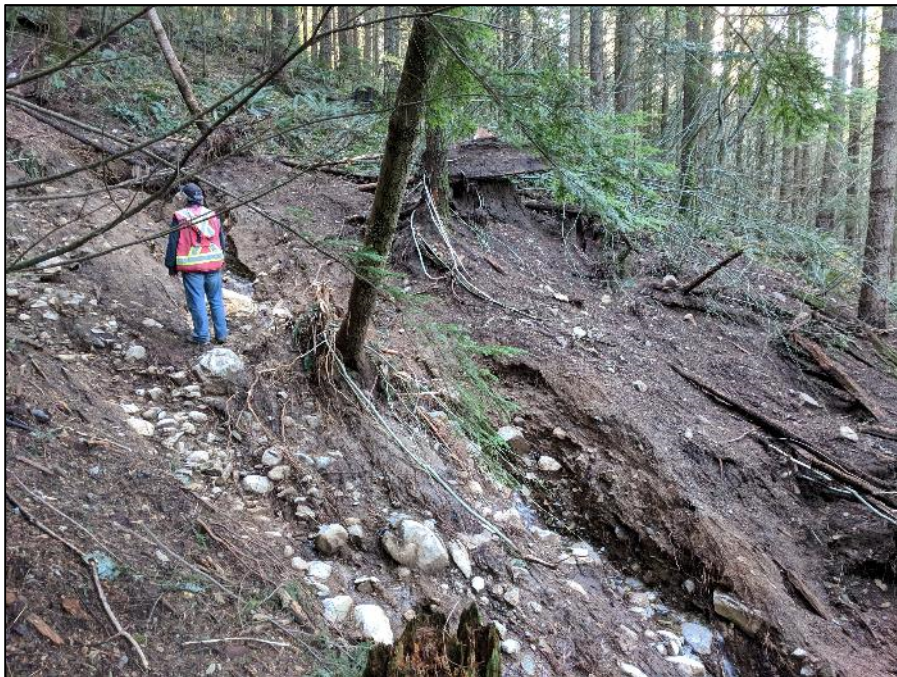
*Photo 5: A wide part of the landslide track, with organic material and fine sediment depositing in the forest at the edge of the main path. The slide incised about 1 m. Slope gradients are about 40%.*

Fine-textured sediments (sands, small organic debris) deposited in the forest outside the main landslide path (Photo 5).

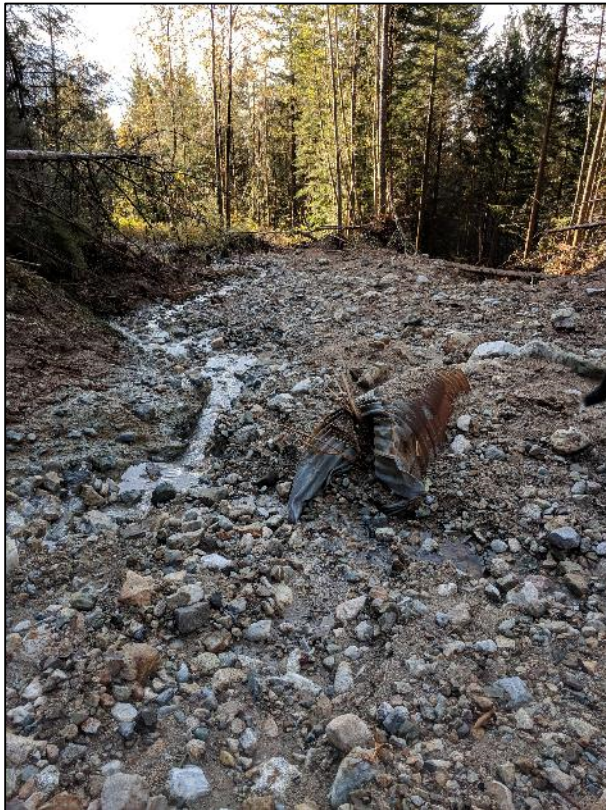
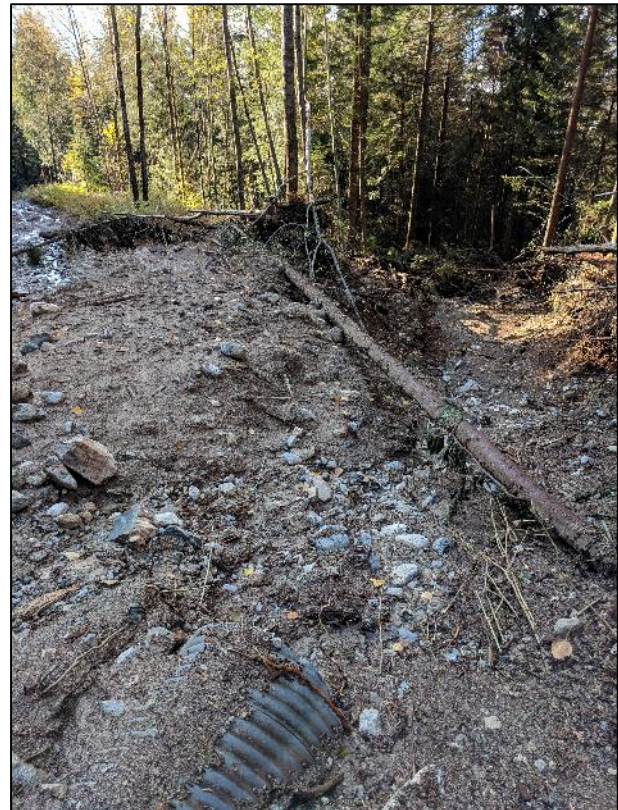
The landslide crossed the Murdo FSR at a stream channel. There is an 800 mm CMP at the crossing. The inlet of the pipe is completely crushed by the slide debris (Photo 6). The sump at the culvert inlet is filled with angular fragments and sand from the landslide. The slide path is 5 m to 7 m wide where it crossed the Lost Murdo FSR (Photo 7). At the crossing, slope gradients are 40% to 50%. There are coarse woody debris, logs, and stumps on Lost Murdo FSR upslope of the crossing.

*Photos 6 and 7: Crushed pipe inlet where at the Lost Murdo FSR. Water is flowing down the road instead of across it. The end of the crushed CMP, where part of the slide continued down the stream channel to The Lost Creek FSR.*

To repair the Lost Murdo FSR where the slide crossed the road, inspect the damaged culvert. If the damaged 800 mm CMP cannot be salvaged, replace the culvert with a larger 1000 mm CMP to accommodate anticipated increased sediment transport in the channel. Add a sump at the culvert inlet and a ditch block to prevent water and debris from flowing down the road.

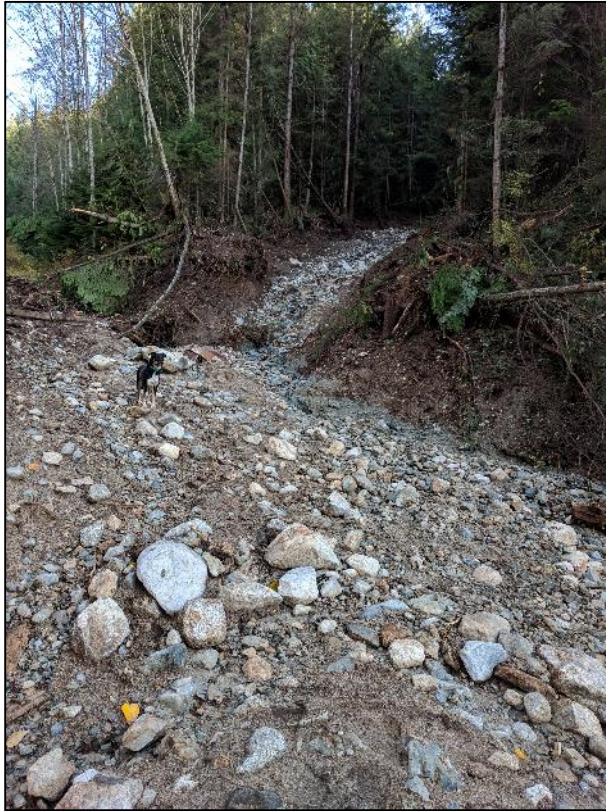
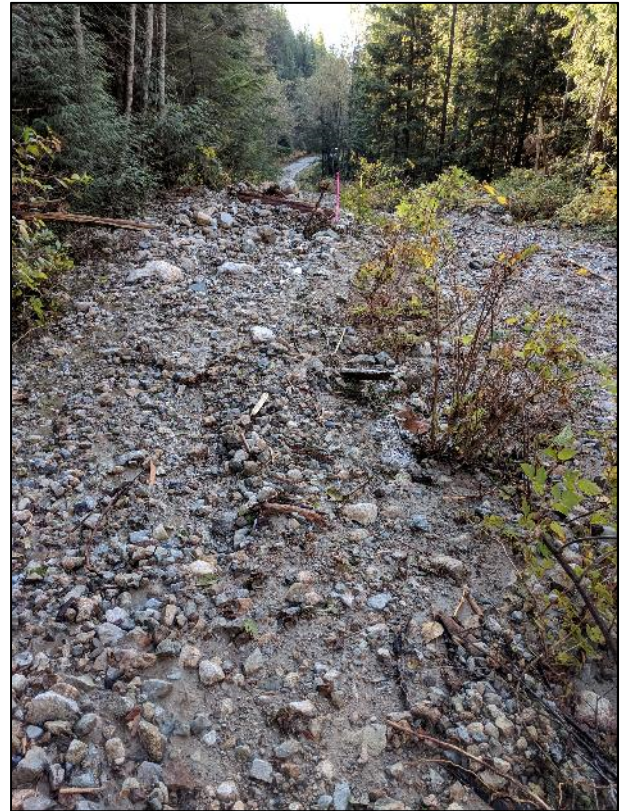
The landslide path split into two paths at the road (Photos 8 and 9). Part of the slide crossed the road and continued down the stream channel and the other part followed the ditch and the Lost Murdo FSR, probably when the culvert at the crossing became plugged. The debris completely blocked the ditch, then deposited on the road. The affected road segment is about 150 m long.

*Photos 8 and 9: The slide path reaching Lost Murdo FSR. Some of the slide debris flowed down the road and some crossed the road.*

Remove slide debris from the road and the ditch. Repair the road where the washout damaged the edge. Inspect the culverts that are about 70 m and 120 m from the landslide crossing. Repair or replace them, as necessary.

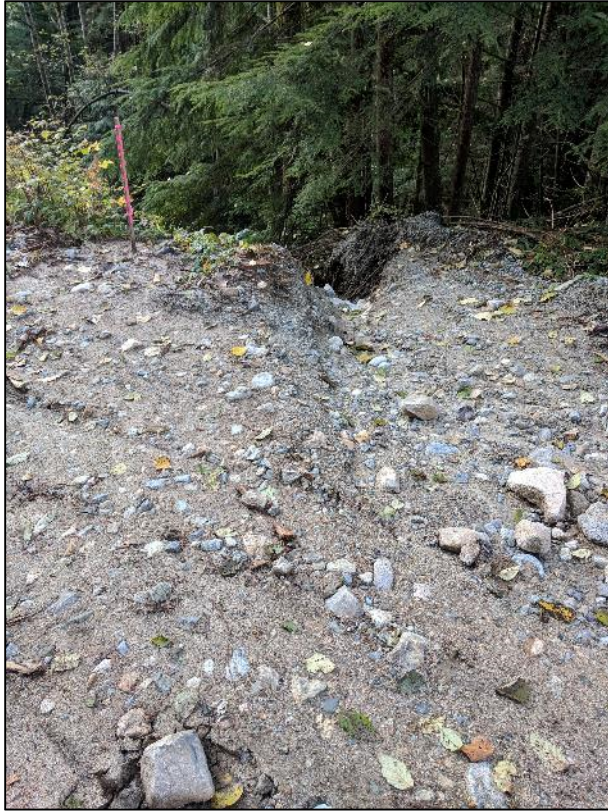
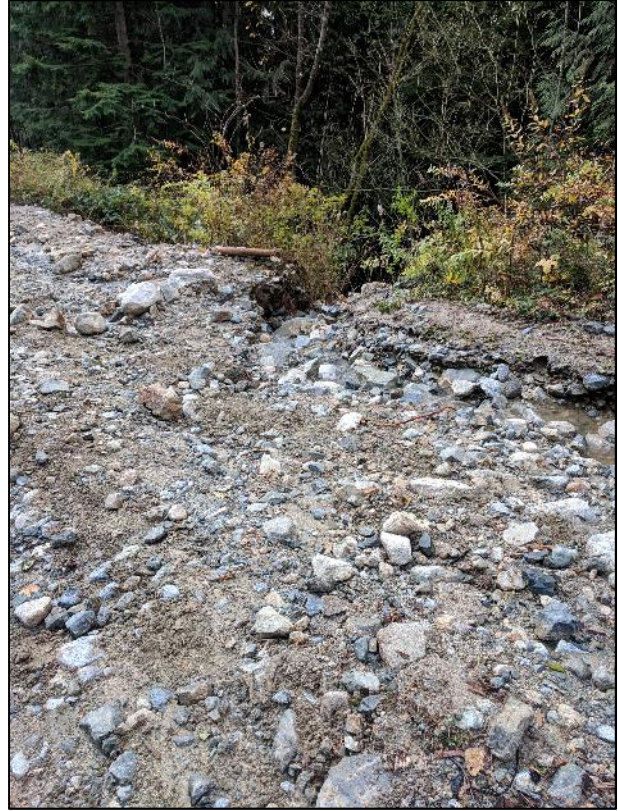
The slide debris left the road in three locations – the first is a CMP about 70 m down the road from the slide path (Photo 10), the second is a washout about 120 m from the slide crossing (Photo 11), and the third is at another CMP (Photo 12). The inlet to the CMP closest to the main slide path is completely blocked with sandy rubbly slide debris and no water is flowing through the pipe. At the washout, the slide eroded about 50 cm into the edge of the road and scoured about 20 cm deep. Water was flowing into the washout. At the CMP furthest down the road from the slide, there is some slide debris (rubble and sand) in the sump at the inlet but it is not completely blocking water flow through the culvert.

*Photos 10 and 11: The culvert outlet, about 70 m from the slide crossing and the washout.*

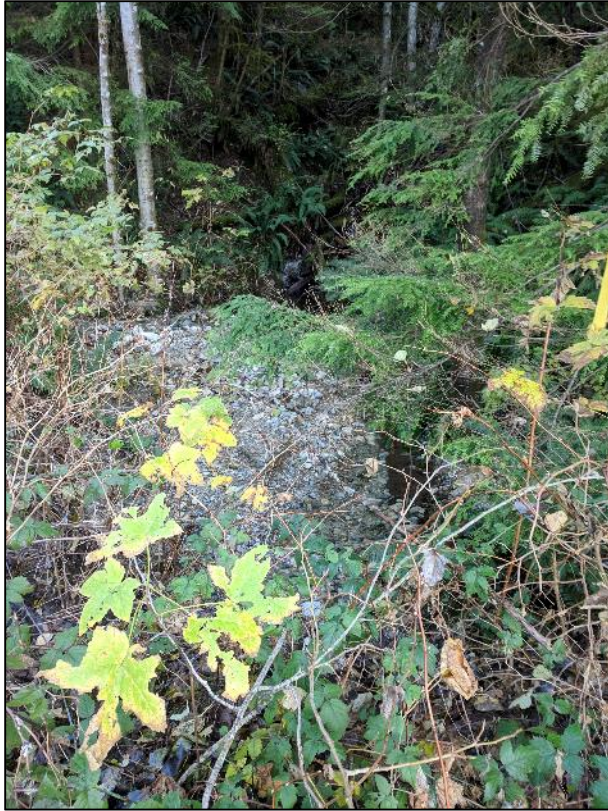
*Photo 12: The CMP outlet at the bottom of the segment of the Lost Murdo FSR where the landslide sediment deposited. Some landslide sediment deposited in the forest at that outlet, but water is flowing through the culvert.*

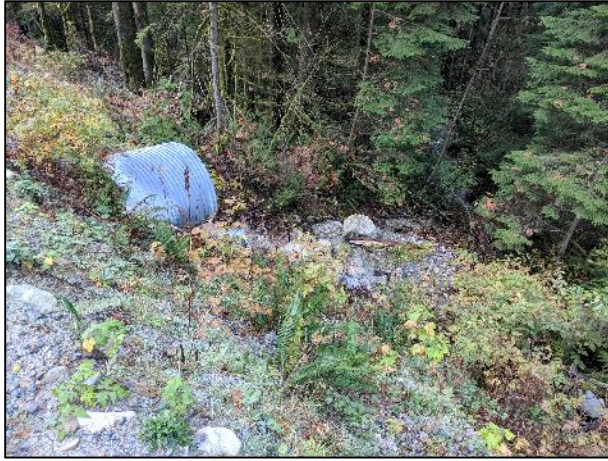
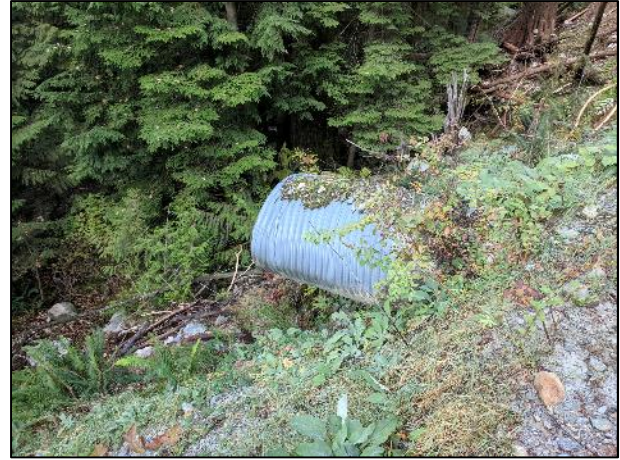
When the landslide reached the Lost Creek FSR, most of the sediment deposited in the ditch for about 100 m past a culvert to another, lower culvert. Debris flowed across the road over the lower culvert. The lower culvert inlet is not blocked and it has water flowing through it (Photo 13). The inlet to the upper culvert is blocked by slide debris, mainly sand and rubble (Photo 14). The sediment that did not flow down the ditch crossed Lost FSR, where it deposited on a bench about 20 m downslope of the road. Most of the sediment that crossed the road was coarse woody debris, organic debris, and large woody debris.

*Photos 13 and 14: The culvert near where the slide crossed Lost Creek FSR. Photo 13 shows the lower culvert, with water flowing in the pipe. Photo 14 shows the upper culvert that has a blocked inlet, with no water flowing through the pipe.*

Inspect the culverts at the two crossings near the slide. Repair or replace damaged culverts with appropriately-sized CMPs. Clean the sumps at the culvert inlets.

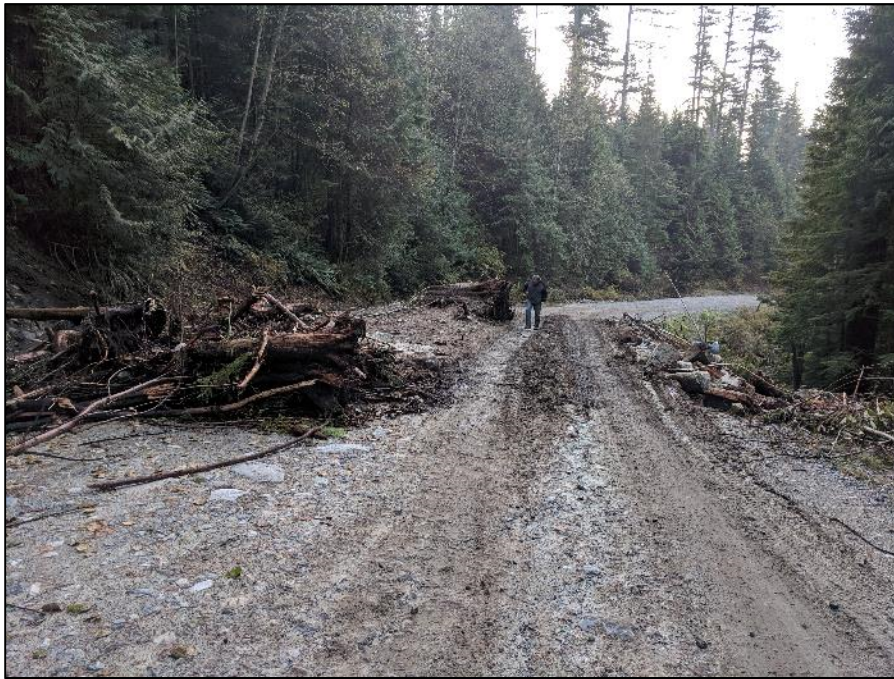
The slide deposited fine sediment and organic debris (stumps and logs) on Lost Creek FSR (Photo 15). The road does not appear to be damaged by the slide and vehicles can drive past the deposit.

*Photo 15: Looking down the Lost Creek FSR near where the landslide crossed the road. The slide entered the road on the left and deposited large woody debris and fine textured sediment on the road, but did not completely block the road.*

Remove the landslide debris from the Lost Creek FSR and the roadside ditch. Pull back as much of the debris from below the road that can be safely reached. Do not sidecast excavated debris.

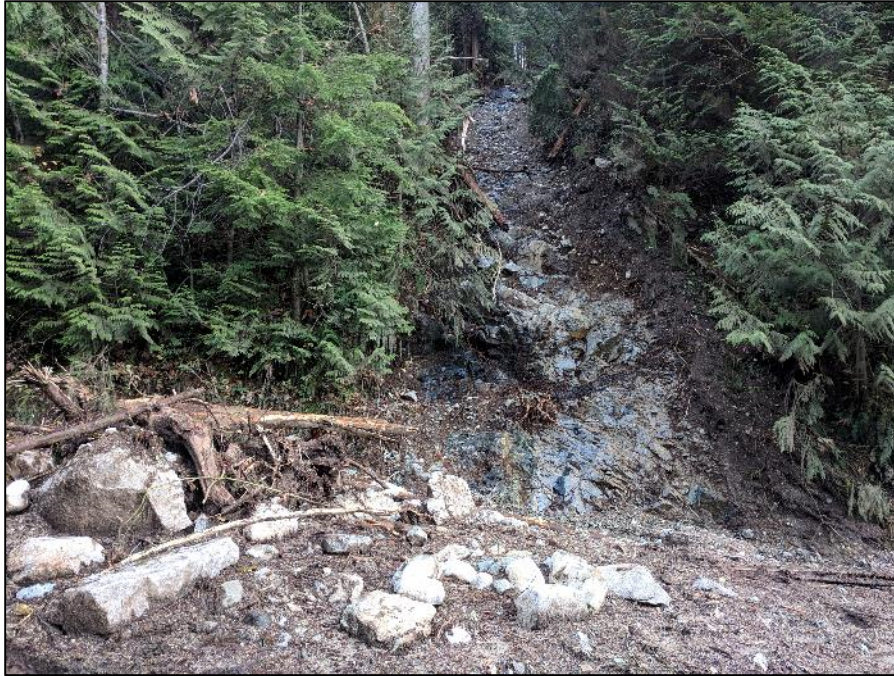
There is no culvert at the landslide location because the road was constructed on bedrock. There is bedrock in the road cut and the scar above the road is scoured to bedrock (Photo 16).

*Photo 16: The landslide reached Lost Creek FSR where the road was constructed on bedrock. Note the bedrock exposed in the slide track.*

Additional failures at the landslide initiation site are possible until the non-status road is deactivated. To prevent future landslides from crossing the road, construct a berm with large boulders, lock blocks, or logs at the edge of the road. The upslope side of the berm should be slightly higher in elevation than where the landslide hit the road and it should continue downslope for about 10 m. The berm will direct flow into the ditch rather than across the road. It should remain in place until the upslope, non-status roads are deactivated.

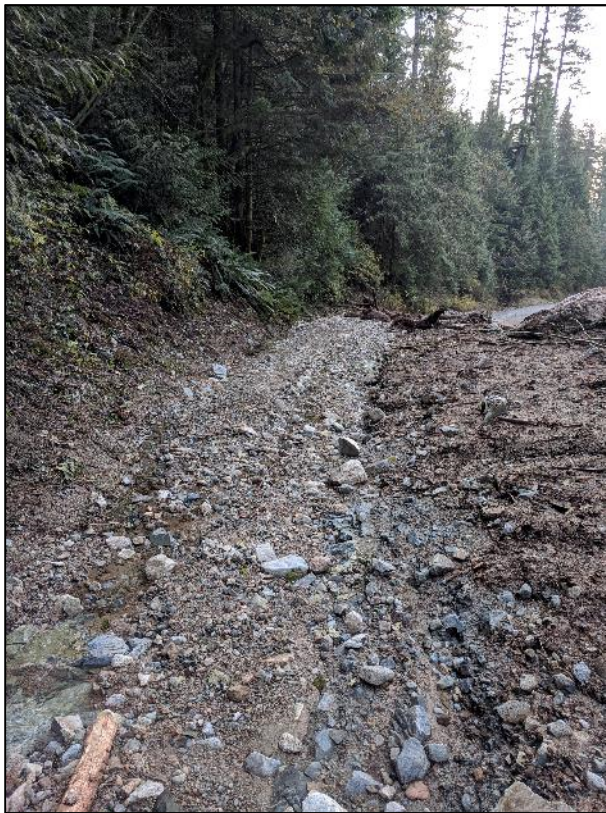
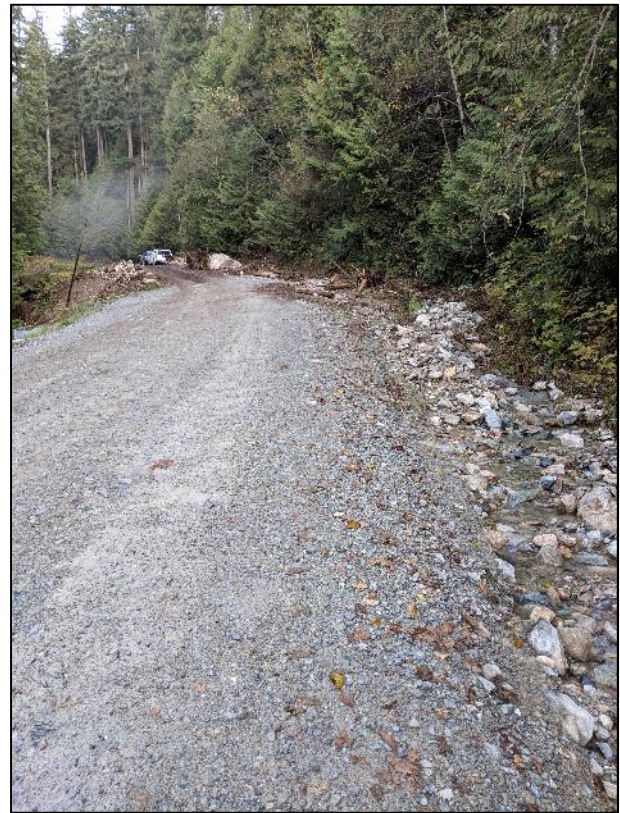
*Photos 17 and 18: Landslide debris filled in the ditch between where the slide hit the road and the upper culvert. Between the upper and lower culverts, there was less sediment in the ditch.*
