**Landslide Report Form****General Information**

Landslide Report#: \_\_\_\_\_ Date of Occurrence: 2017  
 (Number according to: operation-year- investigation # e.g., HBO-06-01) FVO-18-02  
 Operation: Fraser Valley Tenure: F.L. A19201  
 General Location: East Anderson F.S.R. 22.5 km.  
 Latitude: 49° 44' 40" Longitude: 121° 19' 53"  
 Road: East Anderson F.S.R. Cutblock: -

**RE: Reconstruction of road across from rockslide, East  
Anderson Mainline**

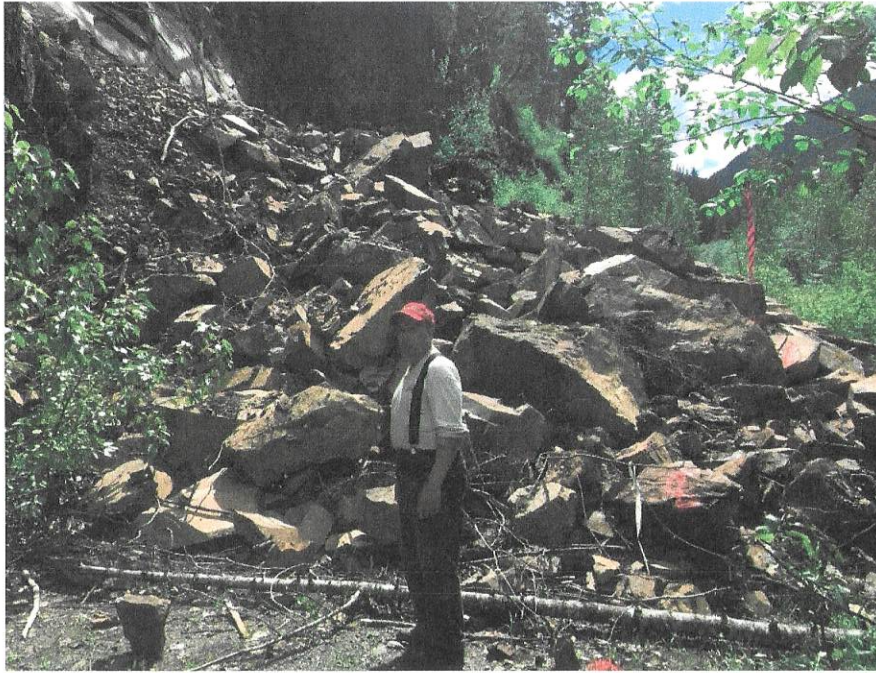
A section of road estimated at 30 m long, has been buried under a rockslide on East Anderson Mainline;  
The rock face above (east of) the road stands at 70-75° for an estimated height of about 30 m;  
The rock consists of hard, fine-grained sandstones and argillites of the Pasayten Group;  
The rock strata dips at 55° towards 260°. This dip is coincident with the slope;  
There are numerous wedges of various sizes that appear to be partly or mostly detached;  
The road is buried under an estimated 2 to 5 m of coarse rock fragments, some exceed 5 m in median diameter.  
Anderson Creek is located to the west of the road here. I did not measure the distance from the road to the stream;  
The terrain between the slide deposit and Anderson Creek appears to consist of fluvial or alluvial deposits sitting at a low gradient.

Photo 1. Rock slide deposit has buried the road for an estimated 30 m section

I suggest rebuilding the road but shifting the alignment to the right (west) to gain further distance from the rock slope. I understand that the extent of the alignment may be dictated by the need to maintain a riparian buffer on Anderson Creek.  
Due to the on-going hazard I recommend using the angular rock fragments to construct a protective berm on the inside (east side) of the road;  
Ideally the berm should be 2 to 2.5 m high and at least 10 m from the crest of the berm to the base of the steep rock face. The objective here is to protect road users from on-going rock fragment dislocation, and also to maintain sufficient capacity to contain these fragments.  
The berm should be built from existing rockslide deposits, and ideally placed to ensure high internal friction (eg: interlocking angular fragments), ie not just piled randomly.  
Given the high angularity of the fragments this should not be challenging.

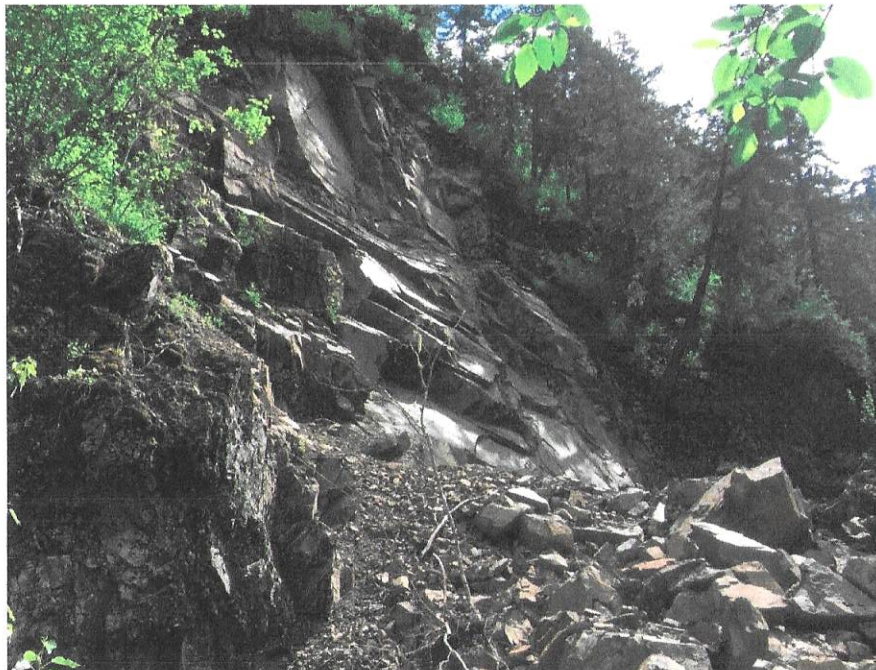
I estimated that roughly 4000 to 5000 m<sup>3</sup> of rock failed;  
The rock face is unstable and will likely be subject to further detachment of wedges, resulting in an on-going rockfall hazard consisting mainly of individual or a small number of rock fragments;  
The potential for a rockslide of similar magnitude cannot be discounted.

Photo 2. Exposed rock face, standing at 70-75°. The dip of the rock strata is coincident with the slope, rendering it unstable, particularly for individual rock fragments. The hazard warrants construction of a protective berm.

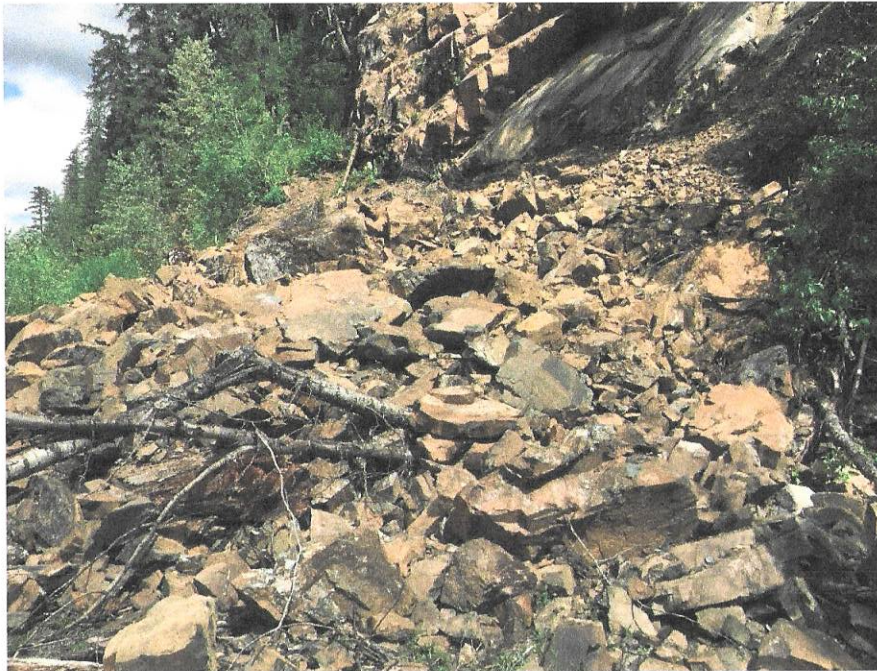
Photo 3. Rubbly, Blocky rockslide deposit from the far (south) side

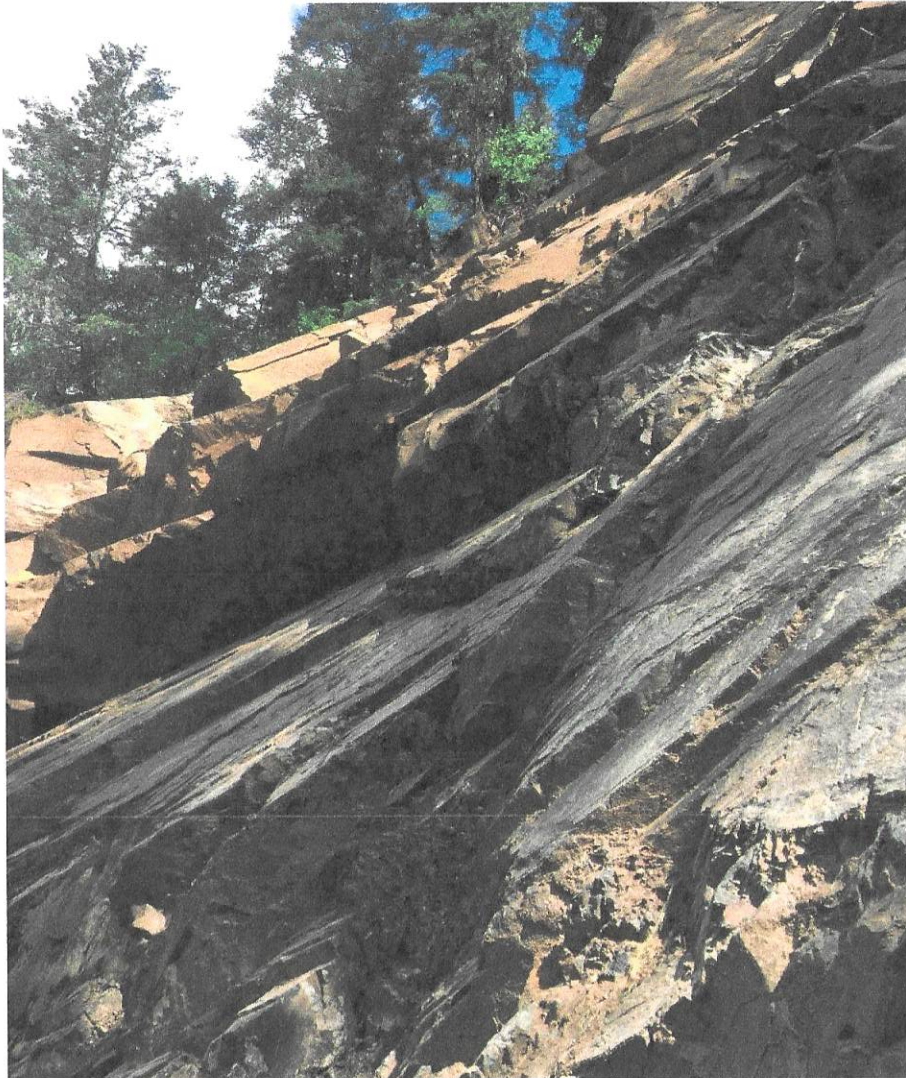
Photo 4. Close up of rock slope, showing dip coincident with the slope.
