# **An Overview Assessment of Forest Development- Related Issues in the Deroche Creek Area, Forest License A74688**

October 2, 2006

**Prepared by:** Brian Roberts, M.Sc., P.Ag., P.Geo.  
Research Geomorphologist/Hydrologist  
Coast Forest Region  
2100 Labieux Road, Nanaimo, BC  
ph (250) 751-3132; fax (250) 751-7101  
<http://www.for.gov.bc.ca/rco/research/>

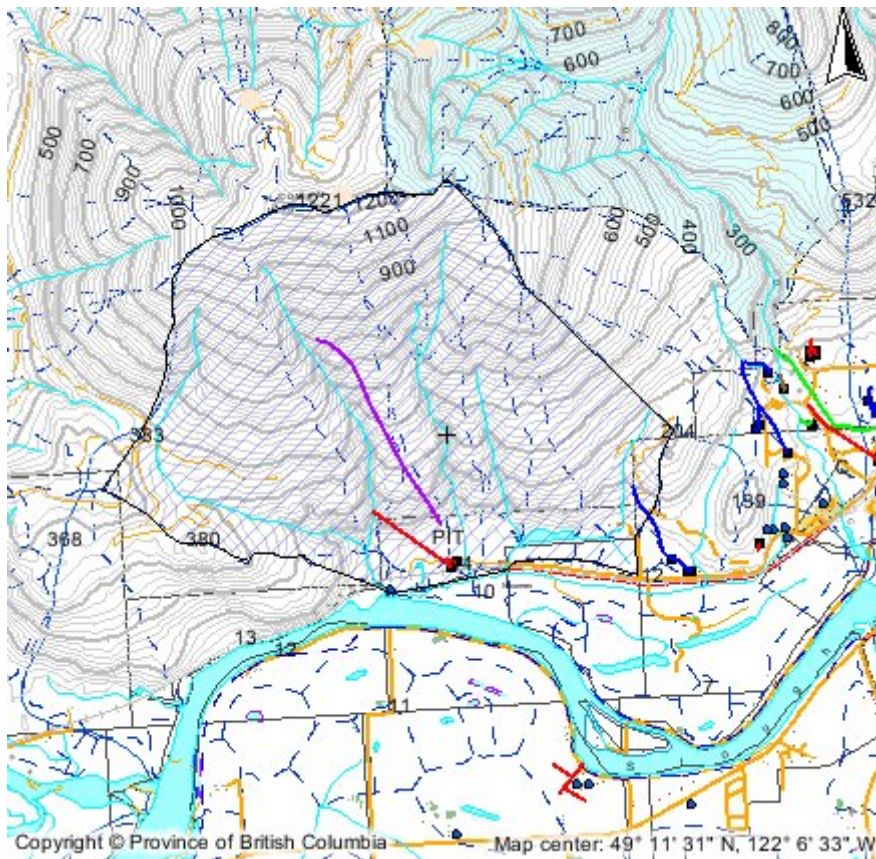
Figure 1: Residual Area 1 showing residential development and water intakes

Outside of the Deroche Creek community watershed, water users draw water from dispersed point sources, likely from a combination of wells and direct intakes (Figures 1 and 2). It is my understanding that there are no large, shared community water sources. Licensed water users in the area are identified on the Hatzic/Deroche Productive Crown Forest Land Watershed Overview Map (MOF, July 2006) and on the iMap (Figures 1<sup>2</sup> and 2<sup>3</sup>) and BC Water Resources Atlas webpage<sup>4</sup>. In RA1, there are three active water licenses identified on the Watershed overview map to be drawing water from the catchment area (Figure 1). In RA2 there are 15 water licenses visible on the map (Figure 2). Several water users may draw from each active water license (Figures 1, 2 and 3) and unlicensed water users are also likely dispersed throughout the area.

- The numerous water supply intakes identified using iMap (Figures 1 and 2) should be clearly identified prior to the commencement of logging operations in order to avoid impacts to water quality or damage to infrastructure.
- Although not a community watershed, it is recommended that land managers seek guidance from the Community Watershed Guidebook in order to better protect water users in the area.
- Ensuring water quality will require that all related recommendations provided above are followed.
