## **BGC Project Memorandum**

| <b>Subject:</b> | Hatzik Valley Preliminary Debris Flow Hazard Assessments | | |
| <b>No. of Pages (including this page):</b> | 17 | <b>Project No:</b> | 0378.001 |

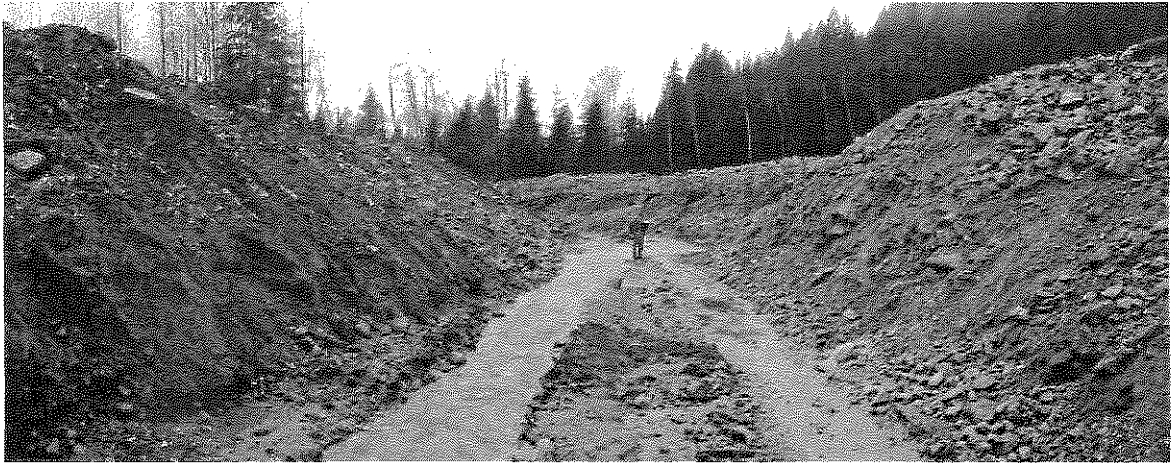
Photo 2 shows an example of channel works carried out on MacNab and Eng Creeks. Excavators have used the creeks' talwegs to access the channels. Accumulated channel material is excavated and placed on the channel sidewalls at slope angles between 20° and 40°. The side-casted material is neither consolidated nor armoured by riprap.

- decrease in debris flow hazard on the fan from existing (post event) condition due to higher channel conveyance;
- exposure of fine-grained material at the channel bottom and channel sidewalls;
- decrease in channel roughness due to removal of coarse clasts from the channel bottom and, therefore, an increase in water flow velocities which is likely partially offset by selfarmouring of coarser clasts;
- undercutting of the channel sidewalls by fluvial erosion and steepening of the banks;
- retrogressive collapse of channel sidewalls where undercut;
- a sharp increase in sediment delivery to the creek channel;
- rapid aggradation in the affected lower gradient channel sections with an associated decrease in conveyance;
- infilling of culverts and bridge crossings; and
- increase in hazard to areas adjacent to the channel by a decrease in conveyance.

**Photo 2.** MacNab Ck approx. 100 m upstream of the Sylvester Road crossing. Dec. 8, 2003.

The rate of the processes listed above will depend on the number and magnitude of floods in the next few months. For these reason, the channel works presently carried out at the affected creeks cannot provide sustainable protection to human development on the creek fans.

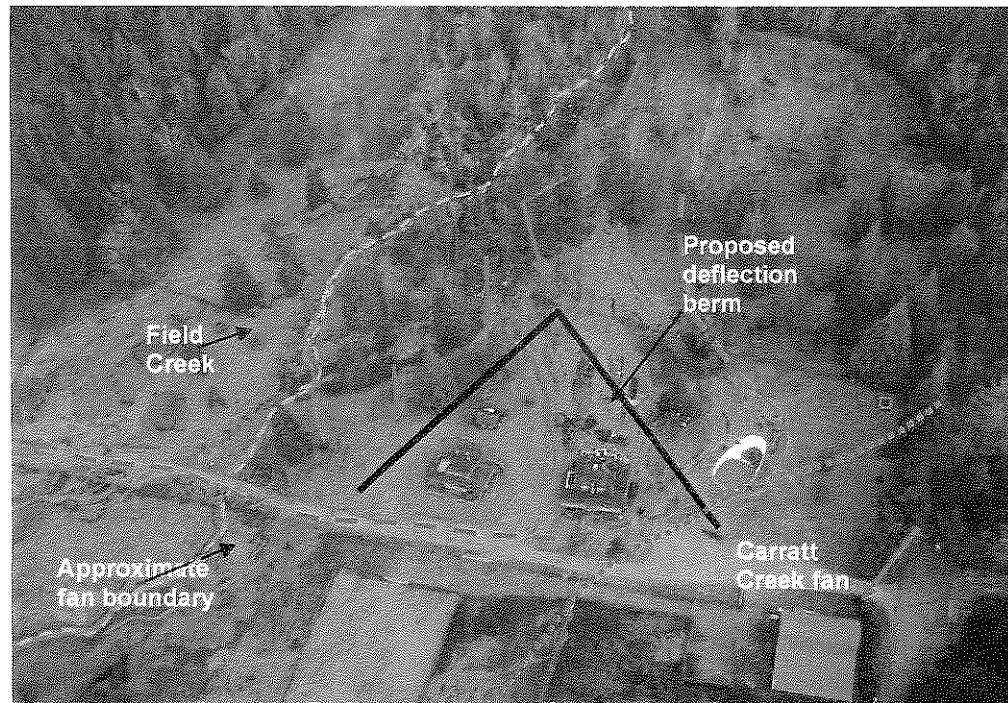
In summary, the Virtue property is located at the fringe of an active debris flow fan. Future debris flows could transport boulders of up to 1-m diameter against the house with estimated velocities of 3 m/s to 5 m/s. An event of this magnitude would likely cause severe structural damage. Deepening of the existing channel may temporarily lower the potential of avulsions on the fan; however, avulsions upstream of the modern fan apex could bypass the excavated channel section and impact the Virtue residence. A deflection berm could be constructed with a minimum height of 2.5 m and grouted riprap on the outside of the berm.

Photo 2. The Field Creek Fan and Virtue property. The blue arrows are possible avulsion routes of floodwaters and debris flows. Future debris flows from Carratt Creek may also affect the Virtue property. December 3, 2003.

| Objectives and Questions | Answers and Mitigation Options |
|---|---|
| <ul style="list-style-type: none"> <li>What, if any, cost-effective mitigation measure could be implemented at Field Creek to prevent structural damage?</li> </ul> | <ul style="list-style-type: none"> <li>A A-shaped engineered deflection berm could surround the buildings. Costs for such berm would likely be near or exceed the costs of the building (Fig. 2). Channel excavation will cause a temporary lowering of the existing hazard but not provide a long-term solution.</li> </ul> |

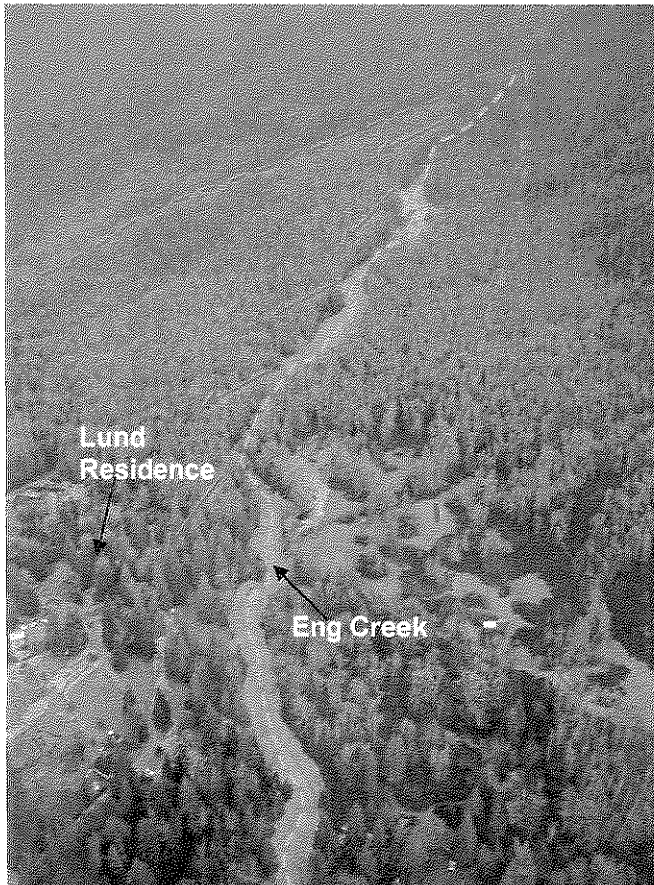
**Photo 3.**

In summary, Eng Creek is an active debris-flow prone creek. Properties on the fringes of the fan are subject to debris flow impact. Low return period debris flows could transport boulders of up to 0.5 m diameter with estimated velocities of 1 to 3 m/s into the developed area. An event of this magnitude could cause structural damage. Deepening of the existing channel may temporarily lower the potential of avulsions on the fan; however, avulsions upstream of the modern fan apex could bypass the existing channel section and impact existing homes.

Eng Creek fan. Note that the fan boundary is approximate. Blue arrows indicate possible avulsion routes. December 3, 2003.

| Objectives and Questions | Answers and Mitigation Options |
|---|---|
| <ul style="list-style-type: none"> <li>What, if any, cost-effective mitigation measure could be implemented at Eng Creek to prevent structural damage?</li> </ul> | <ul style="list-style-type: none"> <li>Houses on the lower fan could be raised by at least 2 m and their upstream and lateral mound slopes should be armoured by large (&gt; 1m diameter) angular riprap. Alternatively, A-shaped engineered deflection berms could surround the buildings as shown on Photo. Debris basins or debris barriers do not appear to be cost effective.</li> </ul> |

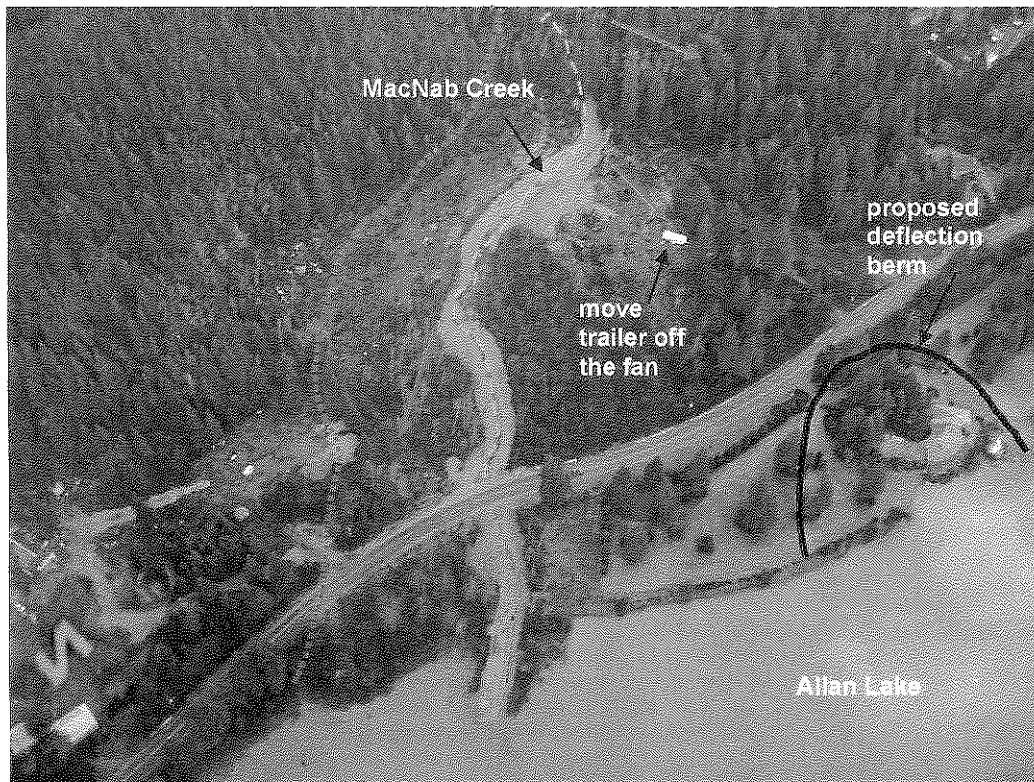
| Objectives and Questions | Answers and Mitigation Options |
|---|---|
| <ul style="list-style-type: none"> <li>Has the hazard to the residences increased due to the recent debris flow?</li> </ul> | <ul style="list-style-type: none"> <li>Slightly. The recent event can be classified as flood flow rather than debris flow and deposited material on the lower part of the fan, thus decreasing the conveyance on the fan.</li> </ul> |

**Photo 4.** MacNab Creek with approximate southern fan boundary. Blue arrows indicate possible avulsion routes. December 3, 2003.

| Objectives and Questions | Answers and Mitigation Options |
|---|---|
| <ul style="list-style-type: none"> <li>What, if any, cost-effective mitigation measure could be implemented at MacNab Creek to prevent structural damage?</li> </ul> | <ul style="list-style-type: none"> <li>Houses on the lower fan could be raised by at least 2 m and their upstream and lateral mound slopes should be armoured by large (&gt; 1m diameter) angular riprap. Alternatively, Λ or ∩-shaped engineered deflection berms could surround the buildings as shown on Photo 3. Debris basins or debris barriers do not appear to be cost effective.</li> </ul> |
