**Re: 2005 As-Built Flood Damage Recovery Works, Lagace Creek, Hatzic Valley  
Final Report**

## 2005 AS-BUILT FLOOD DAMAGE RECOVERY WORKS LAGACE CREEK, HATZIC VALLEY FINAL REPORT

OCTOBER 2005

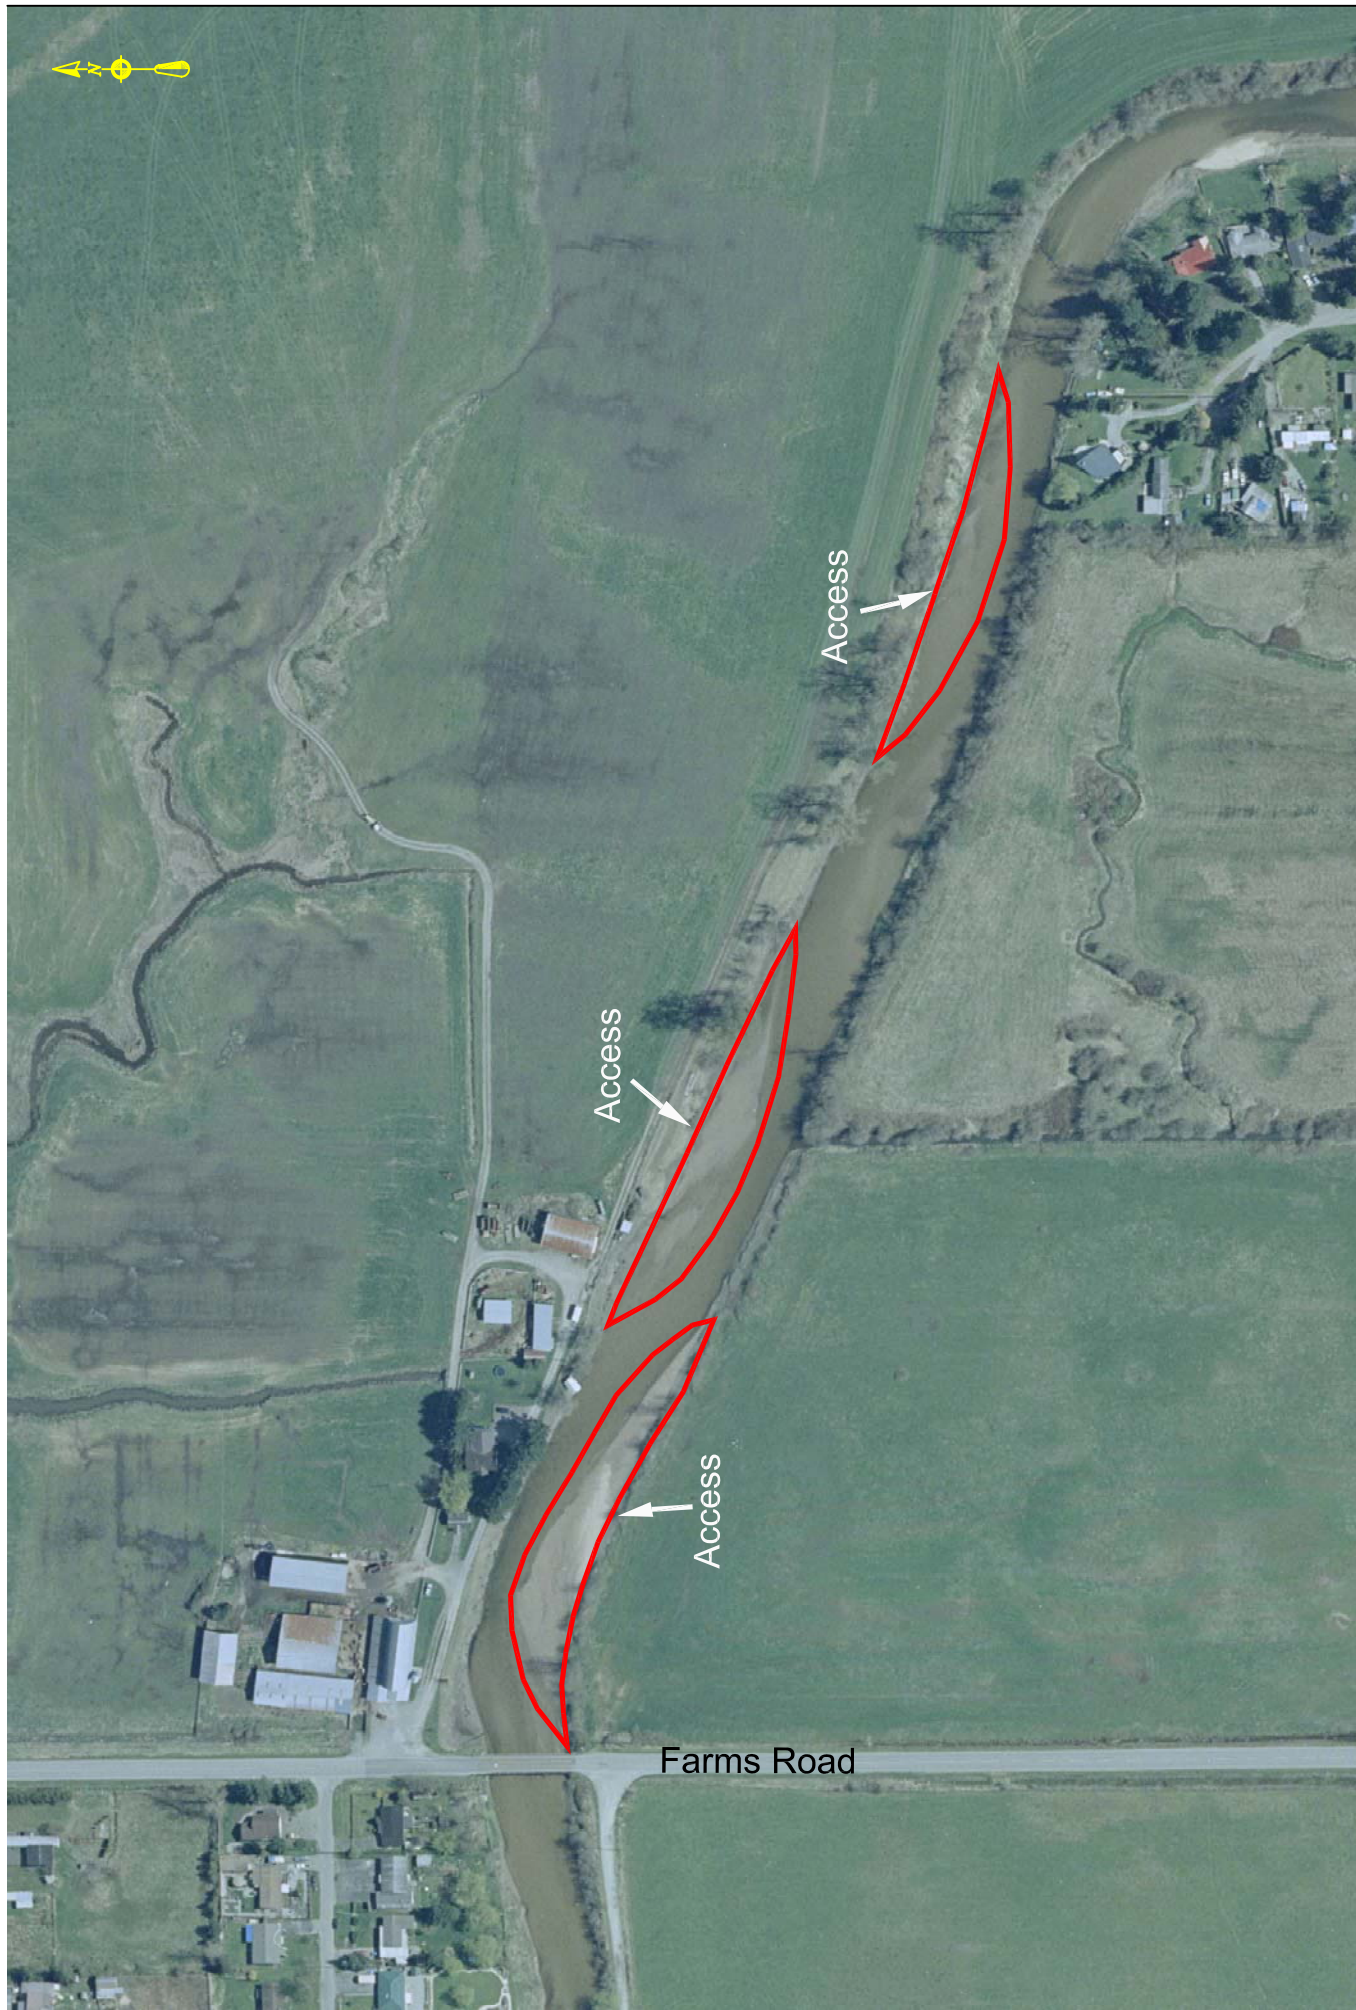
Figure 1. Location of excavated bars in Lower Reach 1.

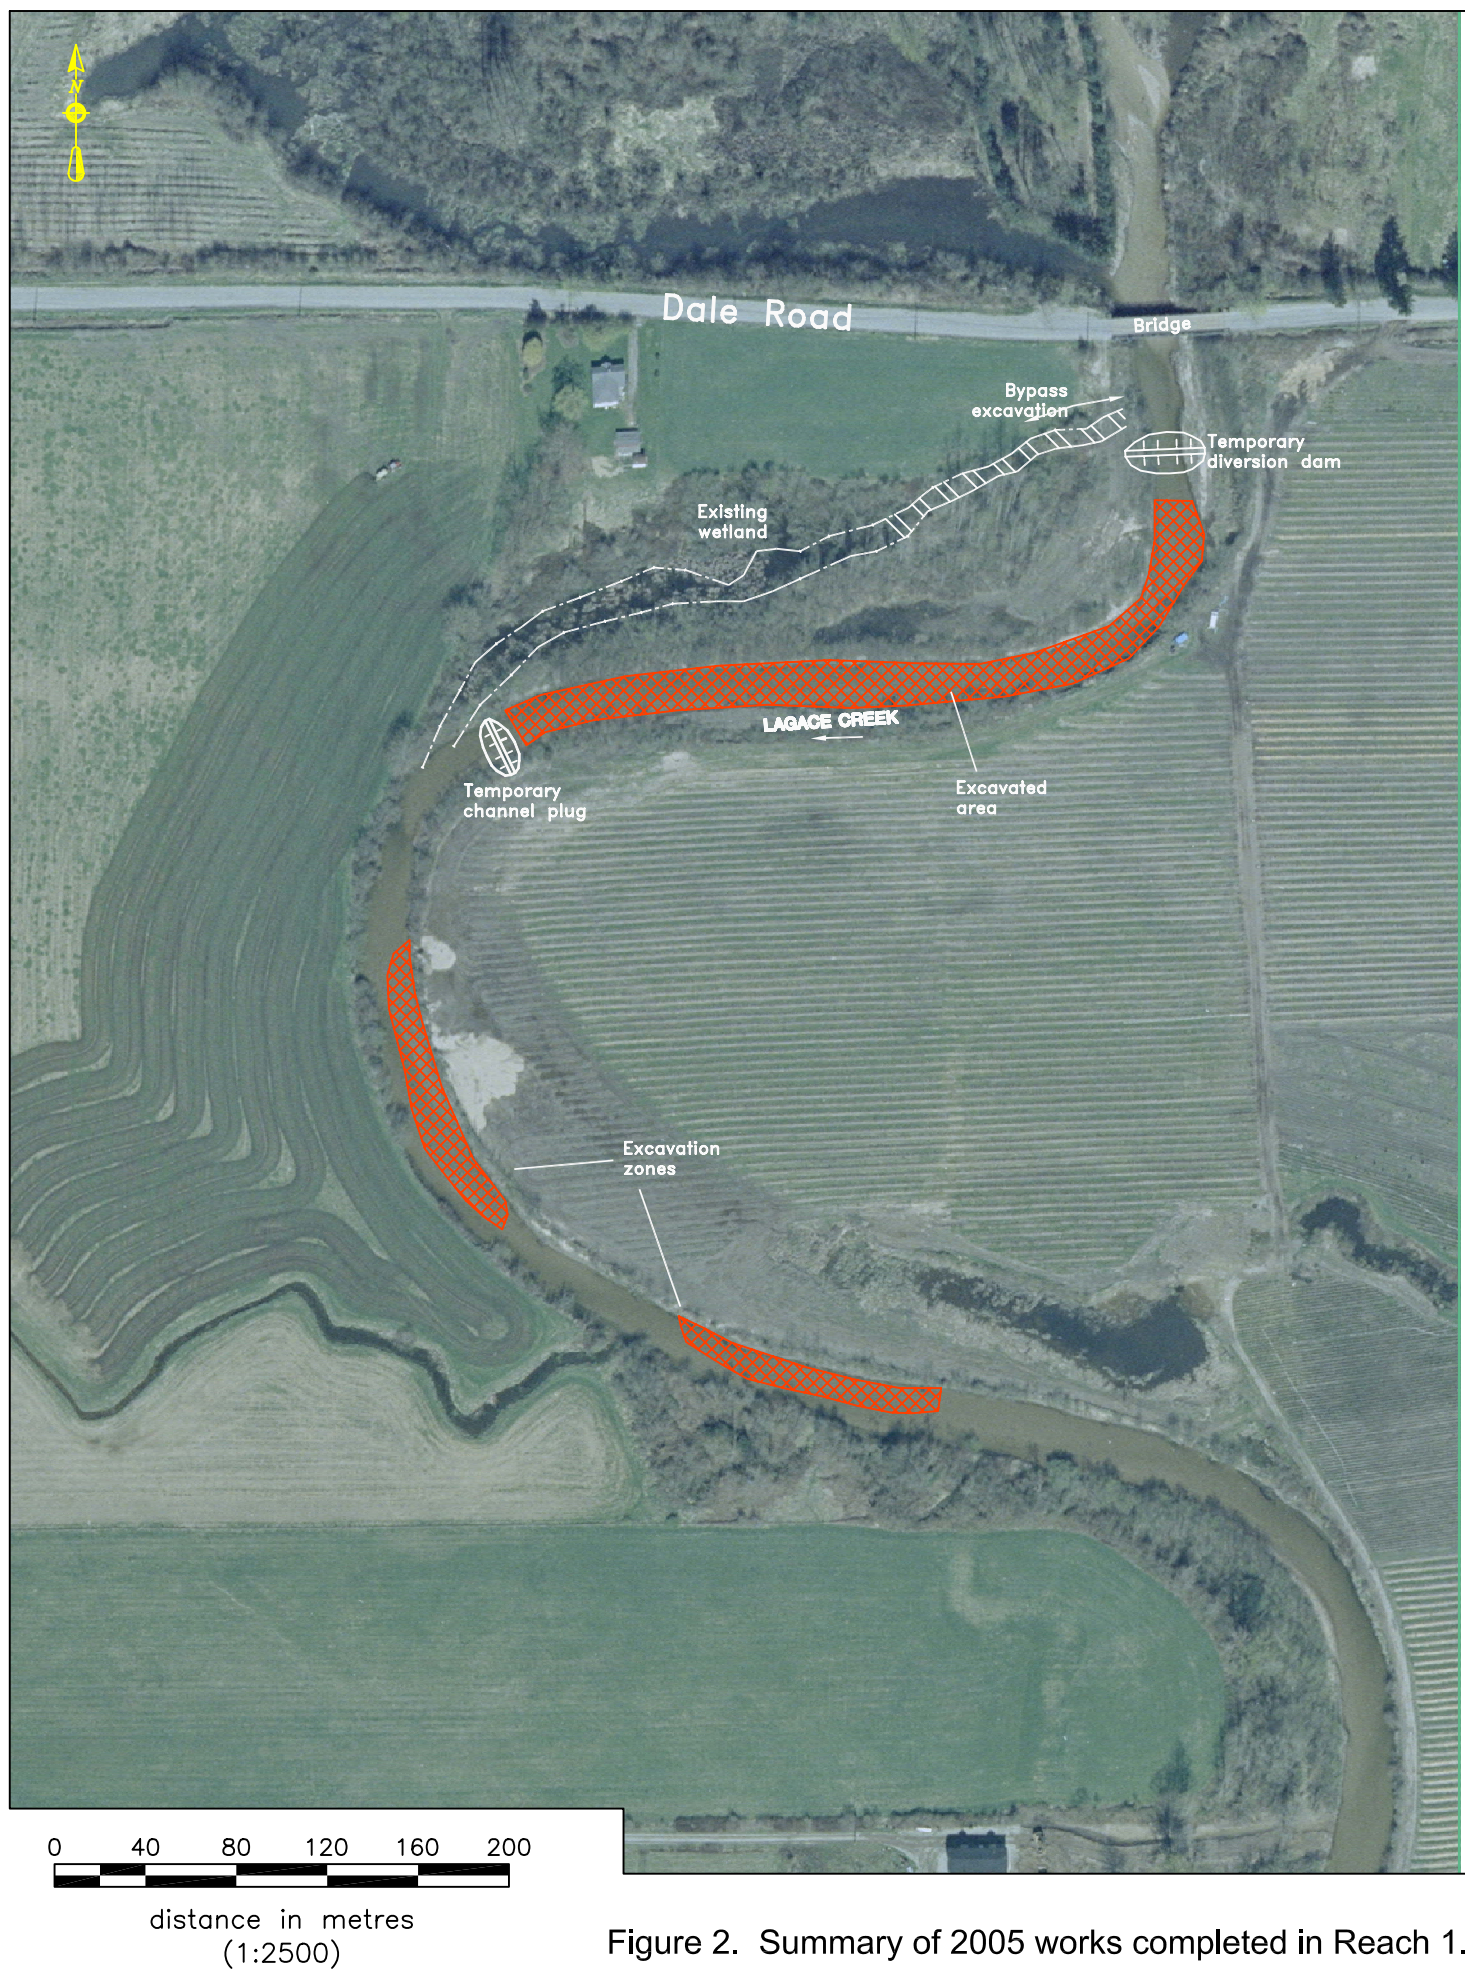
Figure 2. Summary of 2005 works completed in Reach 1.

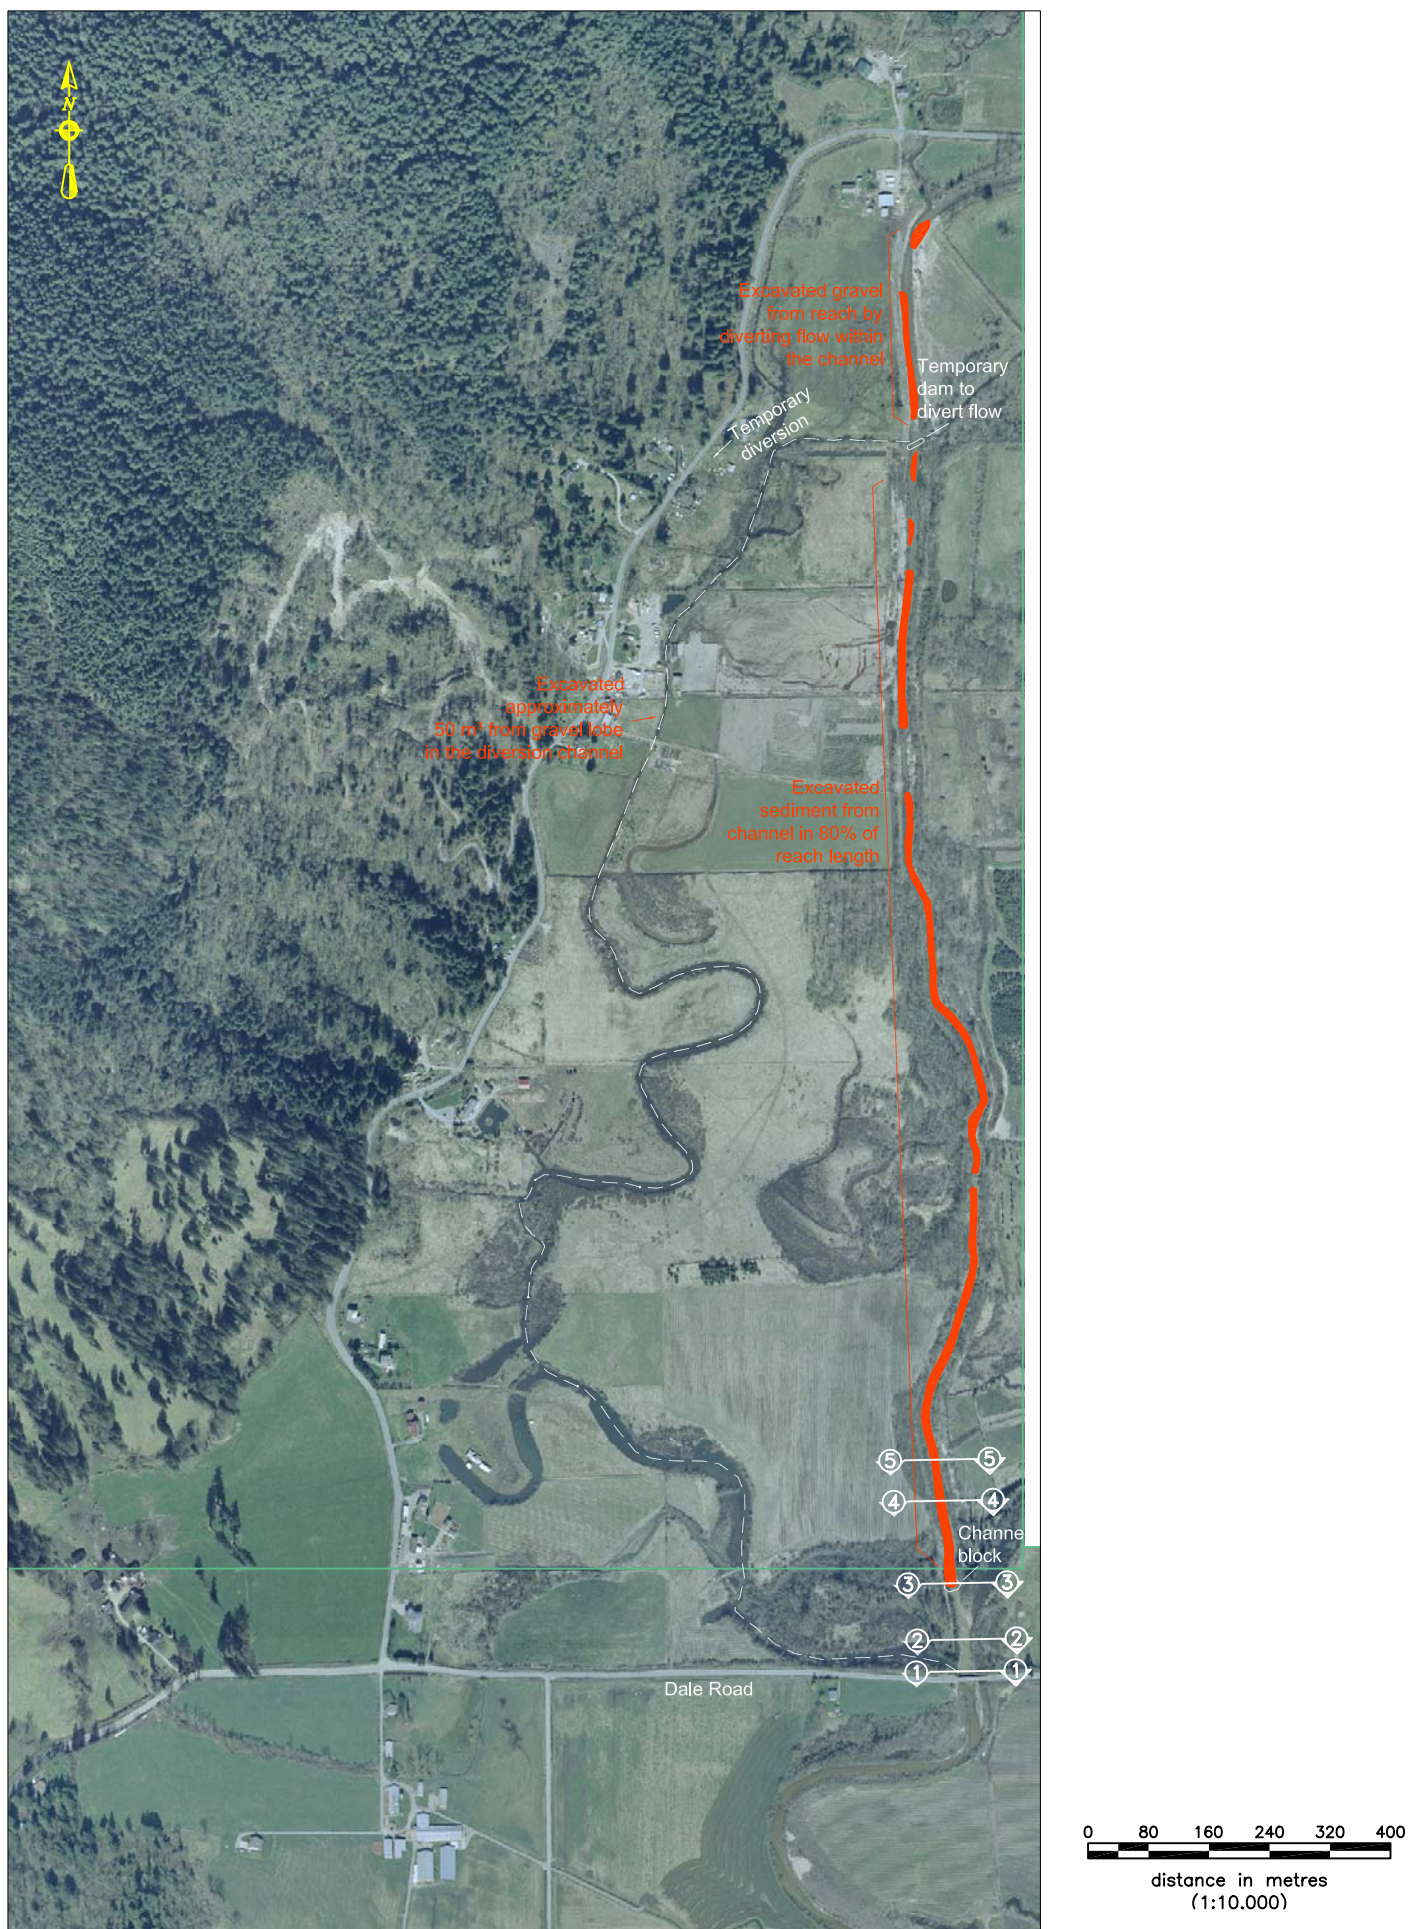
Figure 3. Summary of 2005 works completed in Reach 2.

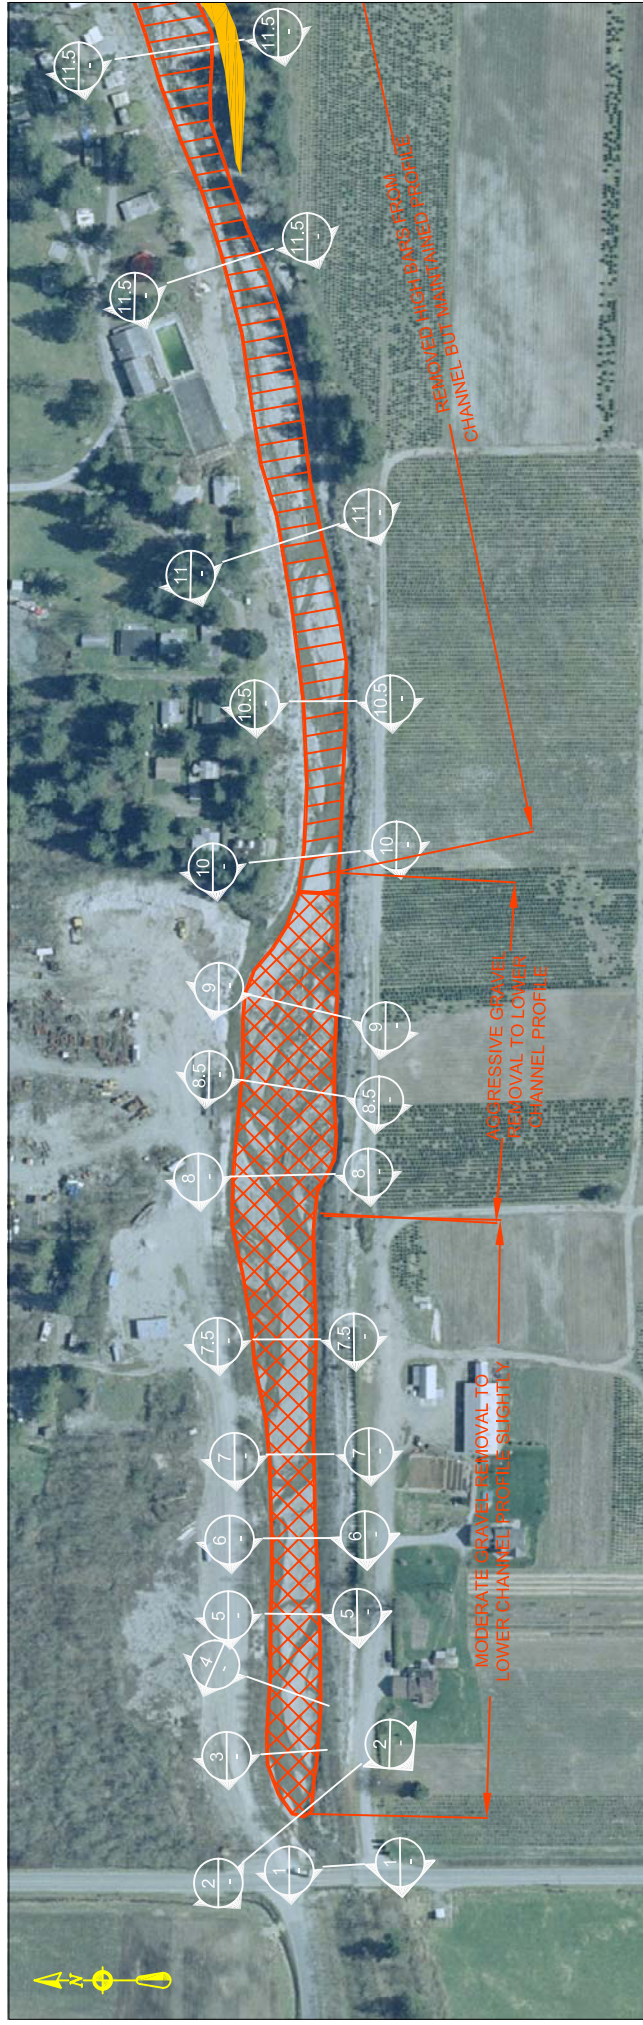
Figure 4. Summary of 2005 works completed in Reach 3.

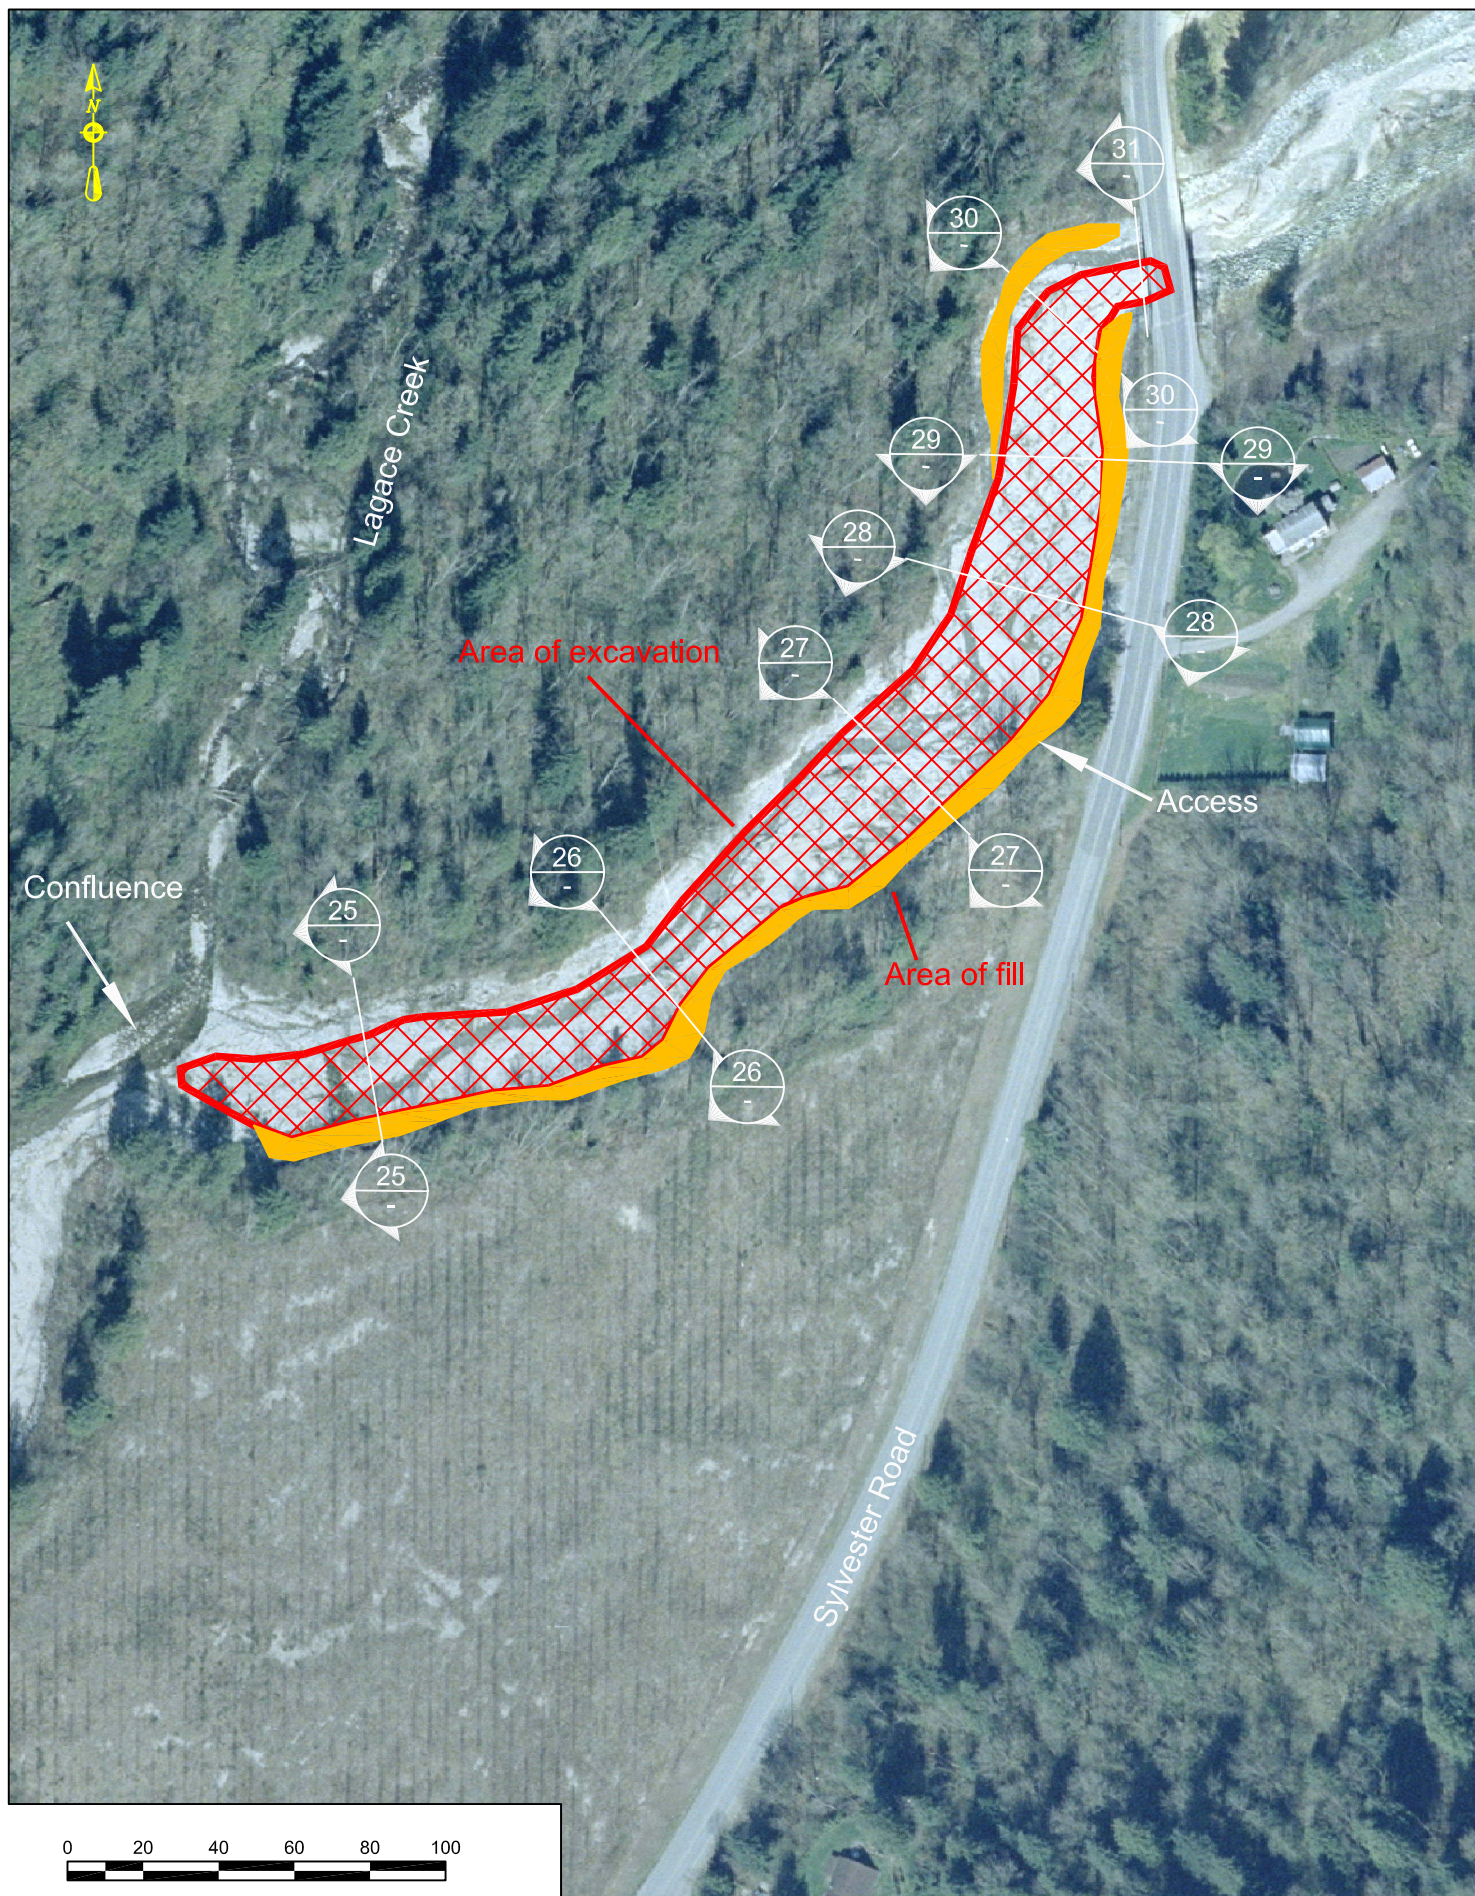
Figure 6. Summary of 2005 works completed in Reach 5.

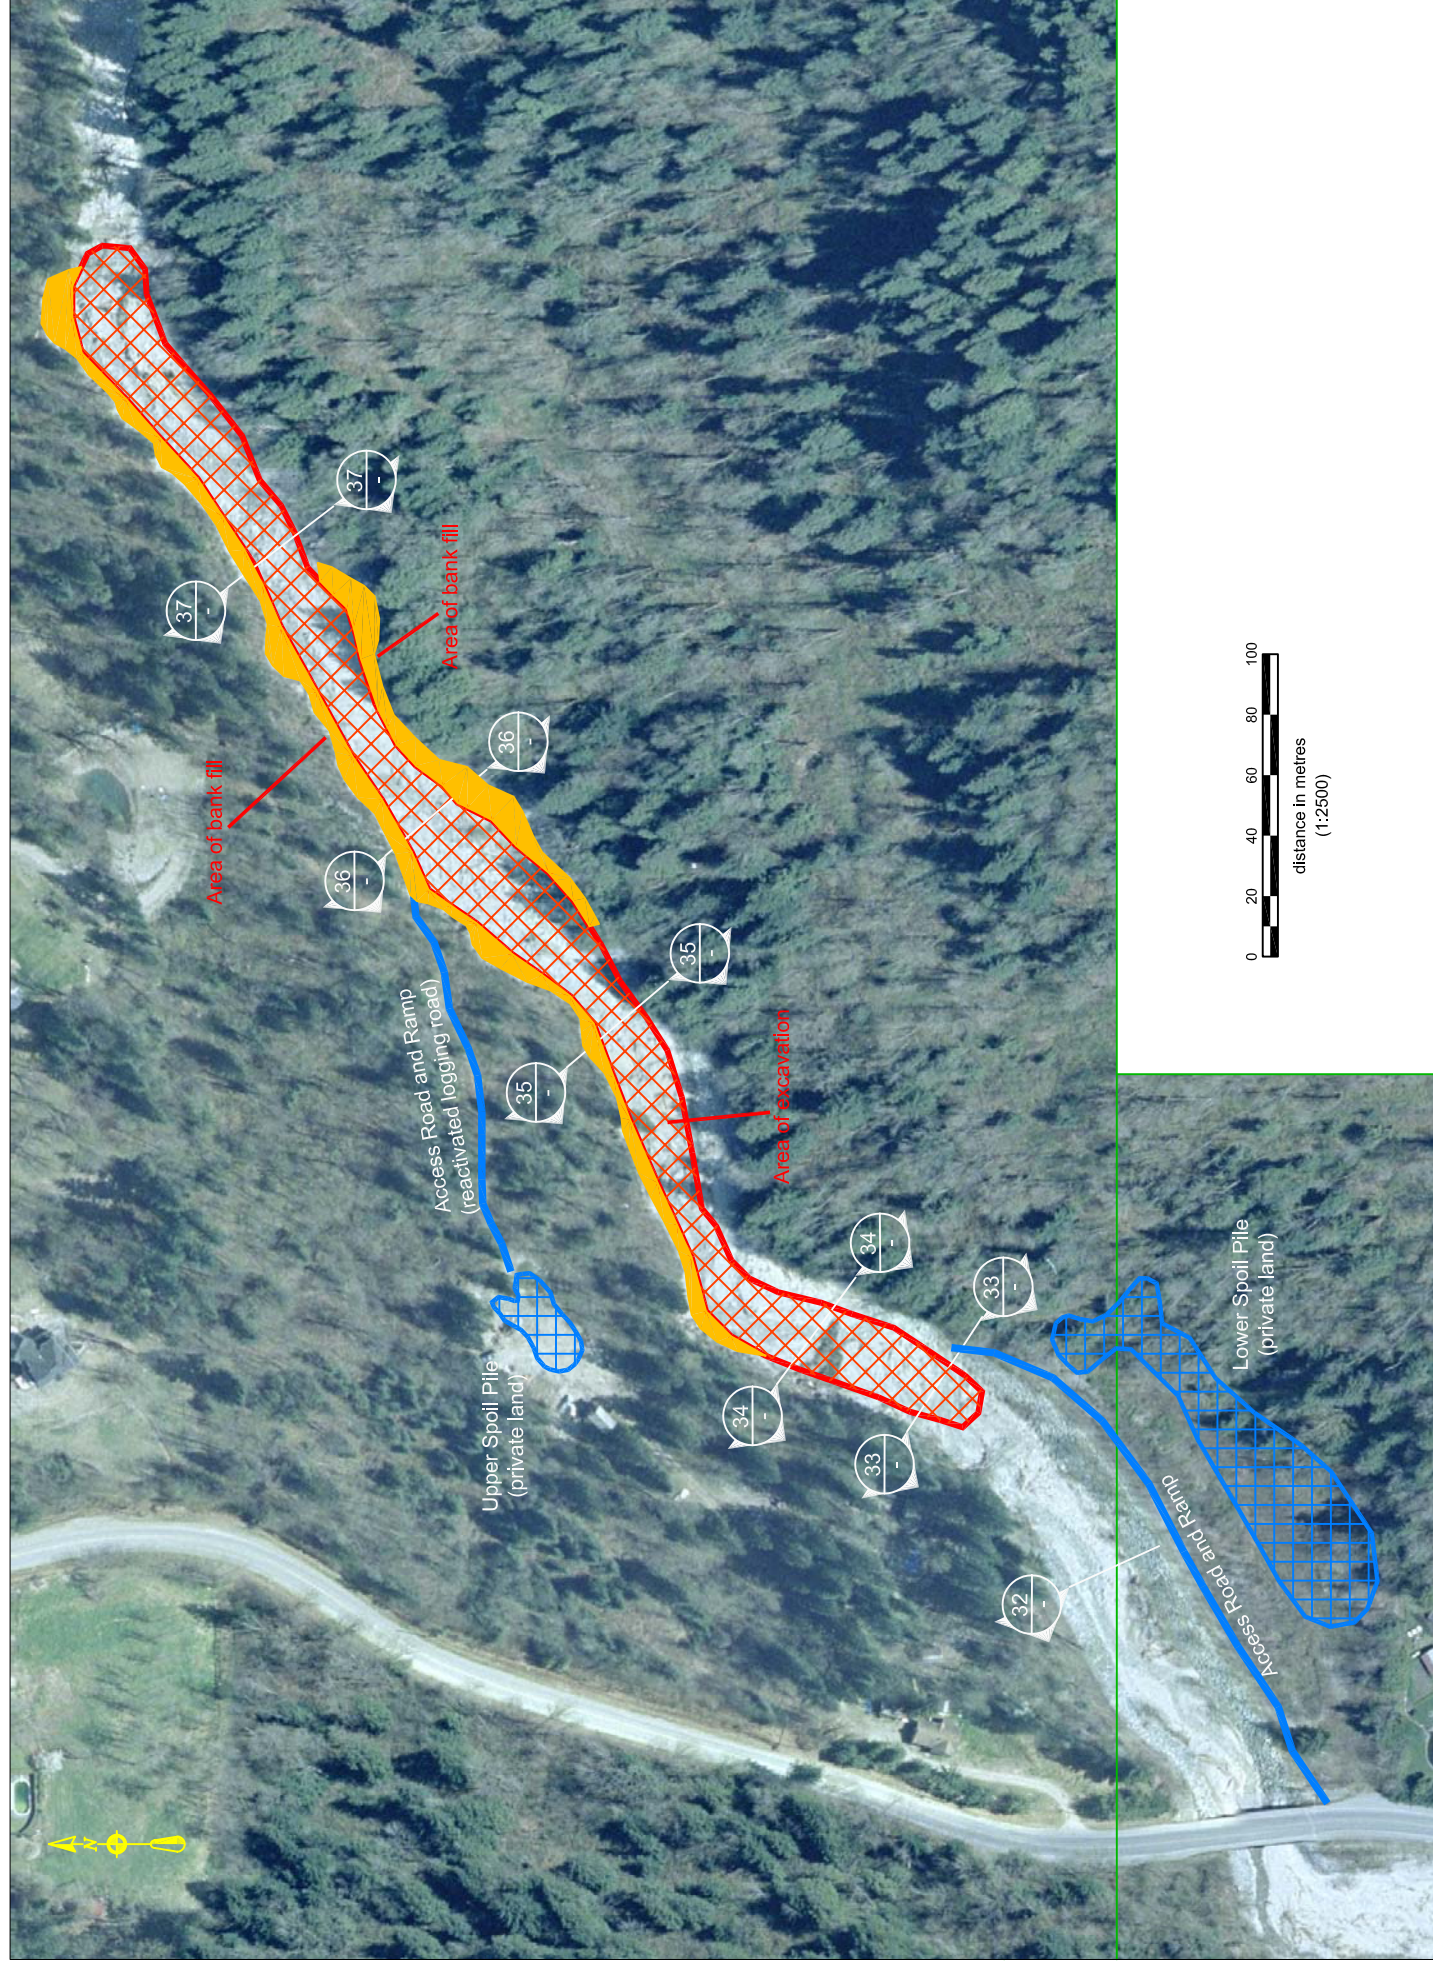
Figure 7. Summary of 2005 works completed at Reach 6.

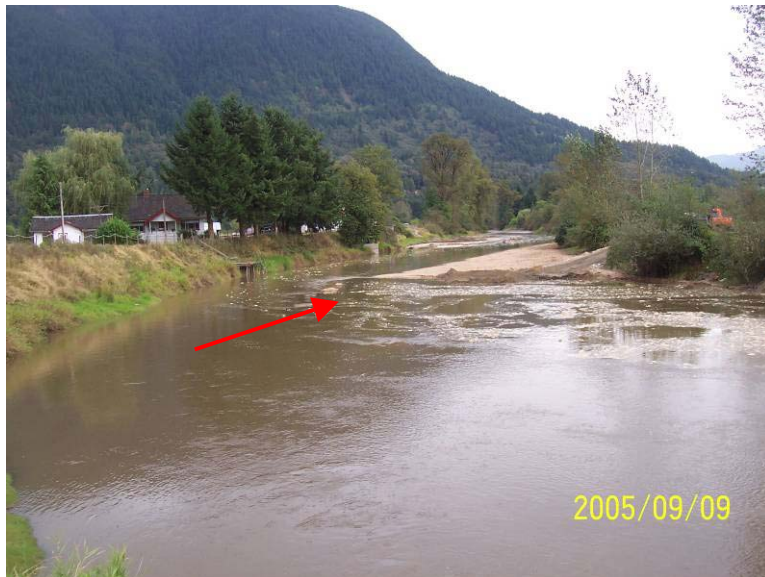
**Photograph 5.** Water level when the diversion berm in Reach 1 at Dale Road was pulled. Raised water inundated the isolation berms (red arrow). Excavators halted work until levels dropped.

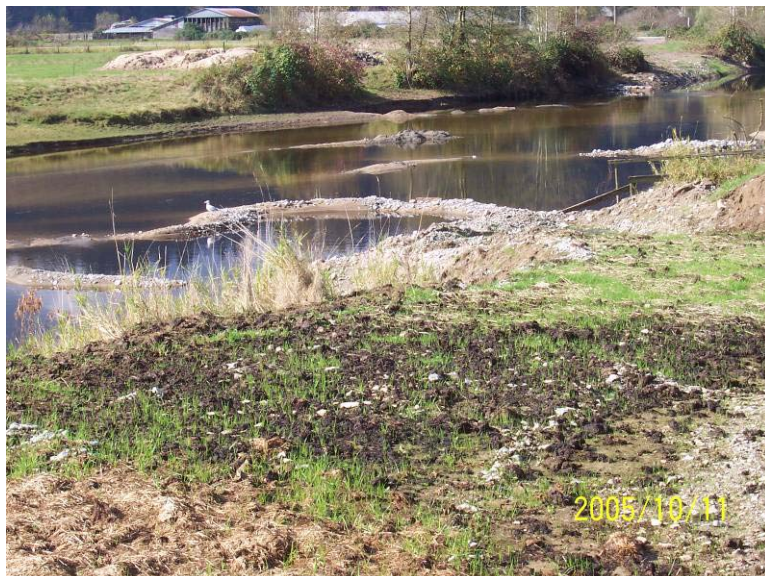
**Photograph 6.** Looking upstream at the excavated sandbar and access along the left bank (see Photograph 1). Grass is growing, berms are breached and the site is stable.

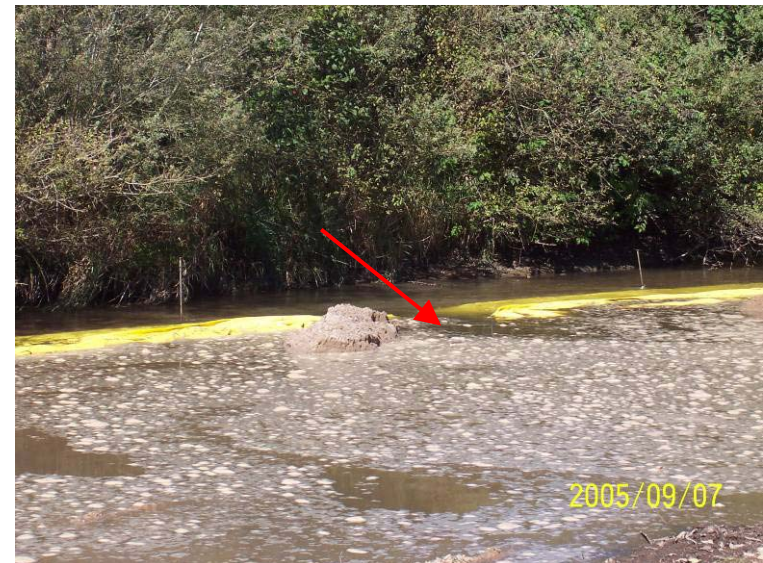
**Photograph 7.** The Megasecure failed to isolate flow at the first location (water undermined substrate under the Megasecure). Excavation was almost complete when the failure occurred.

The WaterGate product used to isolate the excavation areas in Reach 1 cannot maintain a stable diversion for long periods of time in soft substrate such as sand. Small leaks in the system caused slow undermining and eventual failure of the structure. The product was used at two separate sites within Reach 1 and both times the diversion failed. The timing of failure was roughly coincident with the end of excavation and eventual flooding of excavated area was part of the plan but nonetheless the product was unsuccessful at controlling the flows for any great length of time. We recommend that an alternative flow diversion method be investigated.

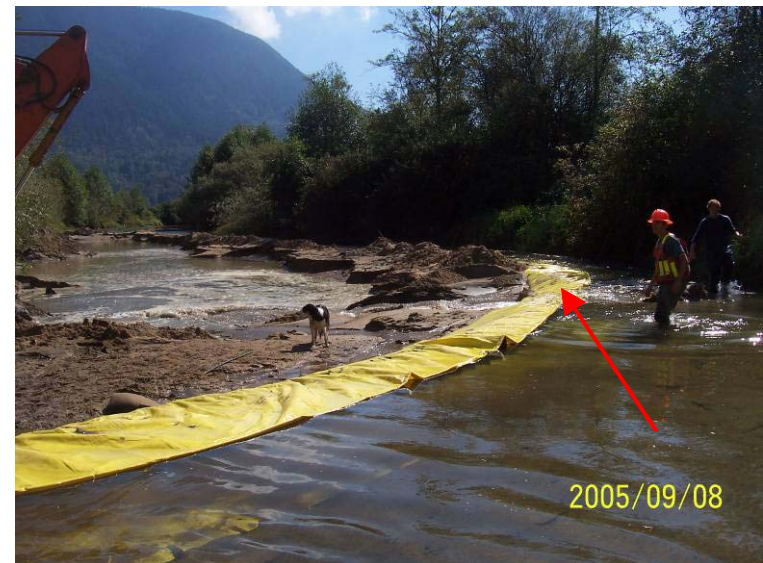
**Photograph 8.** The Megasecure also failed to isolate flow at the second location. Again, the excavation was almost complete when the failure occurred.

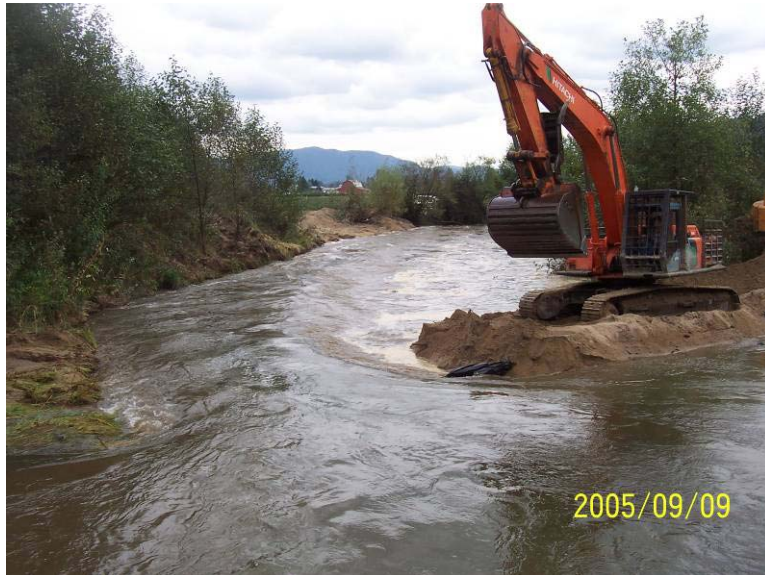
**Photograph 9.** Once excavation works were completed, the dam was breached and the diversion channel filled in. The dam breach caused isolation areas in Reach 1 at Farms Road to fail.

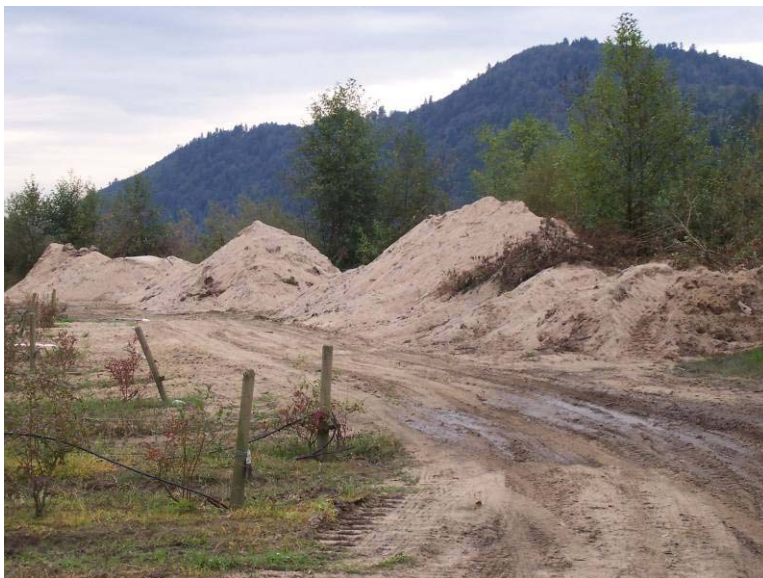
**Photograph 14.** View of temporary spoil piles on the east side of Lagace Creek. The piles are located behind a small riparian buffer (3 to 5m). Spoil should be removed as soon as possible.

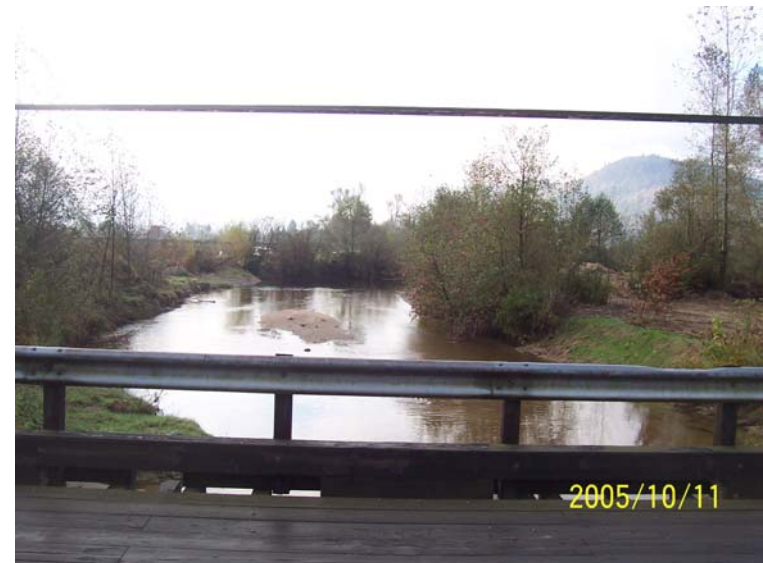
**Photograph 16.** View downstream of Dale Road bridge. An elevated mid channel bar is forming.

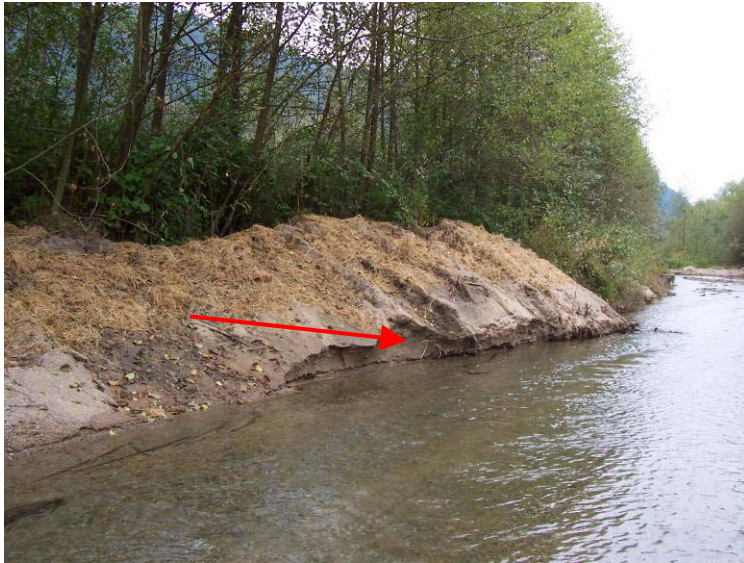
**Photograph 13.** In a few places, excavator operators placed spoil against newly excavated over steepened banks as they thought it would reduce the grade. During high flow events, this spoil will likely erode.

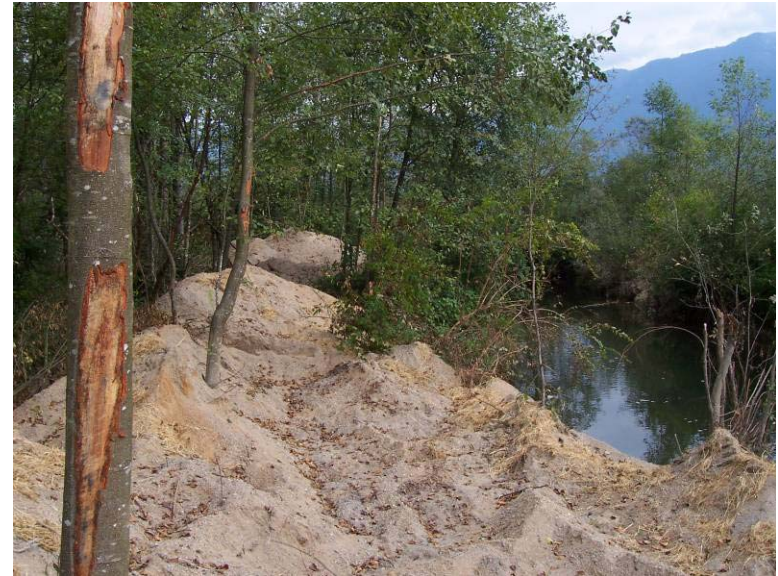
**Photograph 15.** Looking at spoil piles along the right bank that are inaccessible. Spoil was placed in open spaces, but girdled alder trees. The trees should survive as they will grow advantageous roots.

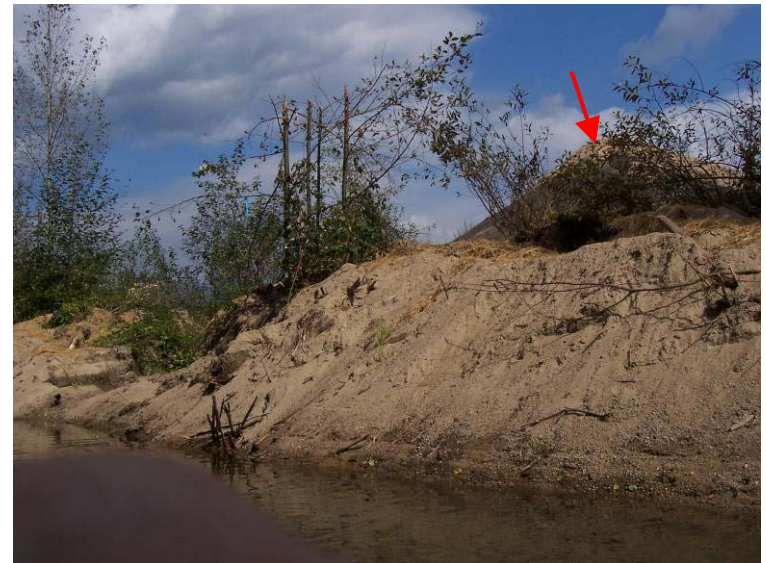
**Photograph 16.** Temporary spoil piles have been placed above the top of bank (red arrow) and some vegetation replaced, however, sloughing may occur on this site due to exposed steep banks.

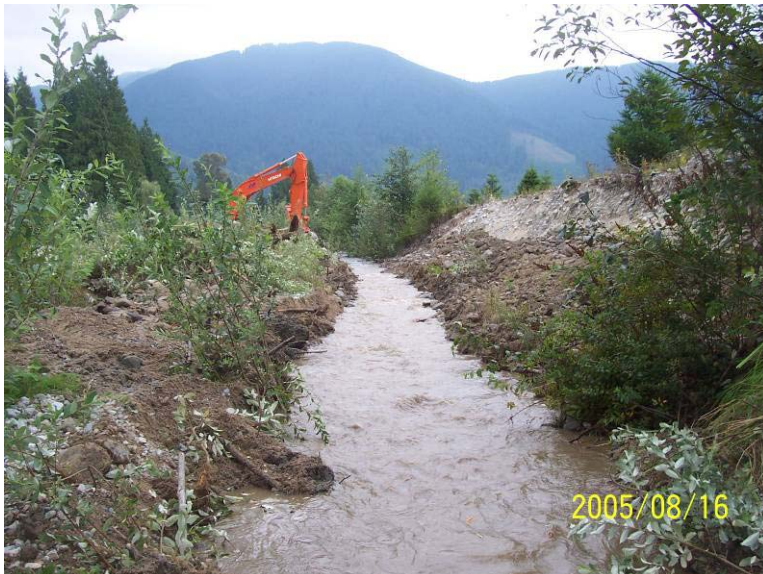
**Photograph 6.** The left bank channel was deepened in spots to direct water away from the right bank. This caused sediment plumes for up to 45 minutes in duration.

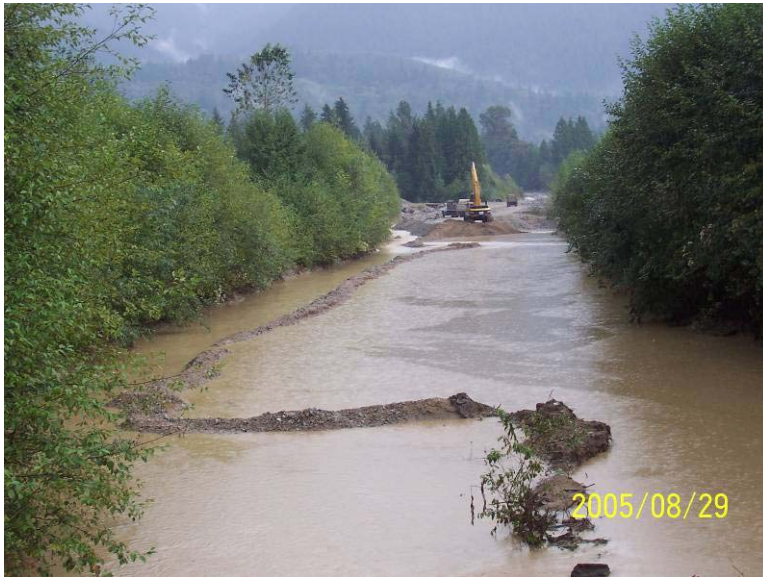
**Photograph 13.** Rain event on August 29.

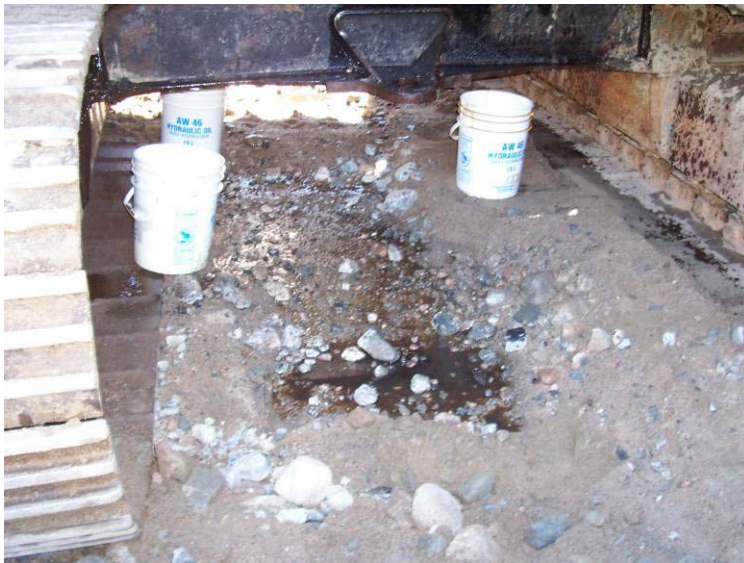
**Photograph 14.** Hydraulic leak on gravel bar at the Anderson site on August 25, 2005.

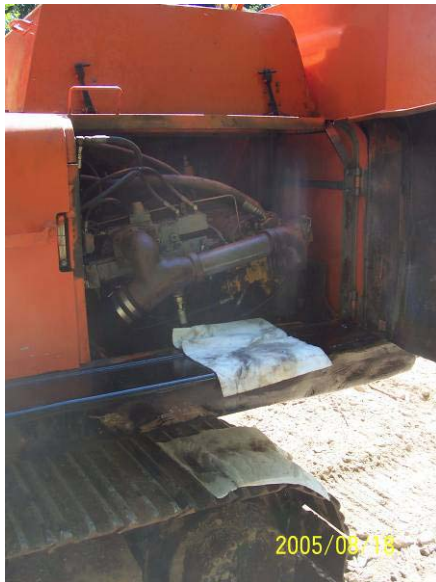
**Photograph 6.** A small hydraulic leak occurred when preparing the left bank haul road. All oil was contained.
