**FRASER VALLEY REGIONAL DISTRICT**

# **ENGINEERING STUDY OF THE CASCADE/CARRATT CREEK FLOOD PROTECTION WORKS**

## **FINAL REPORT**

**MARCH 1999**

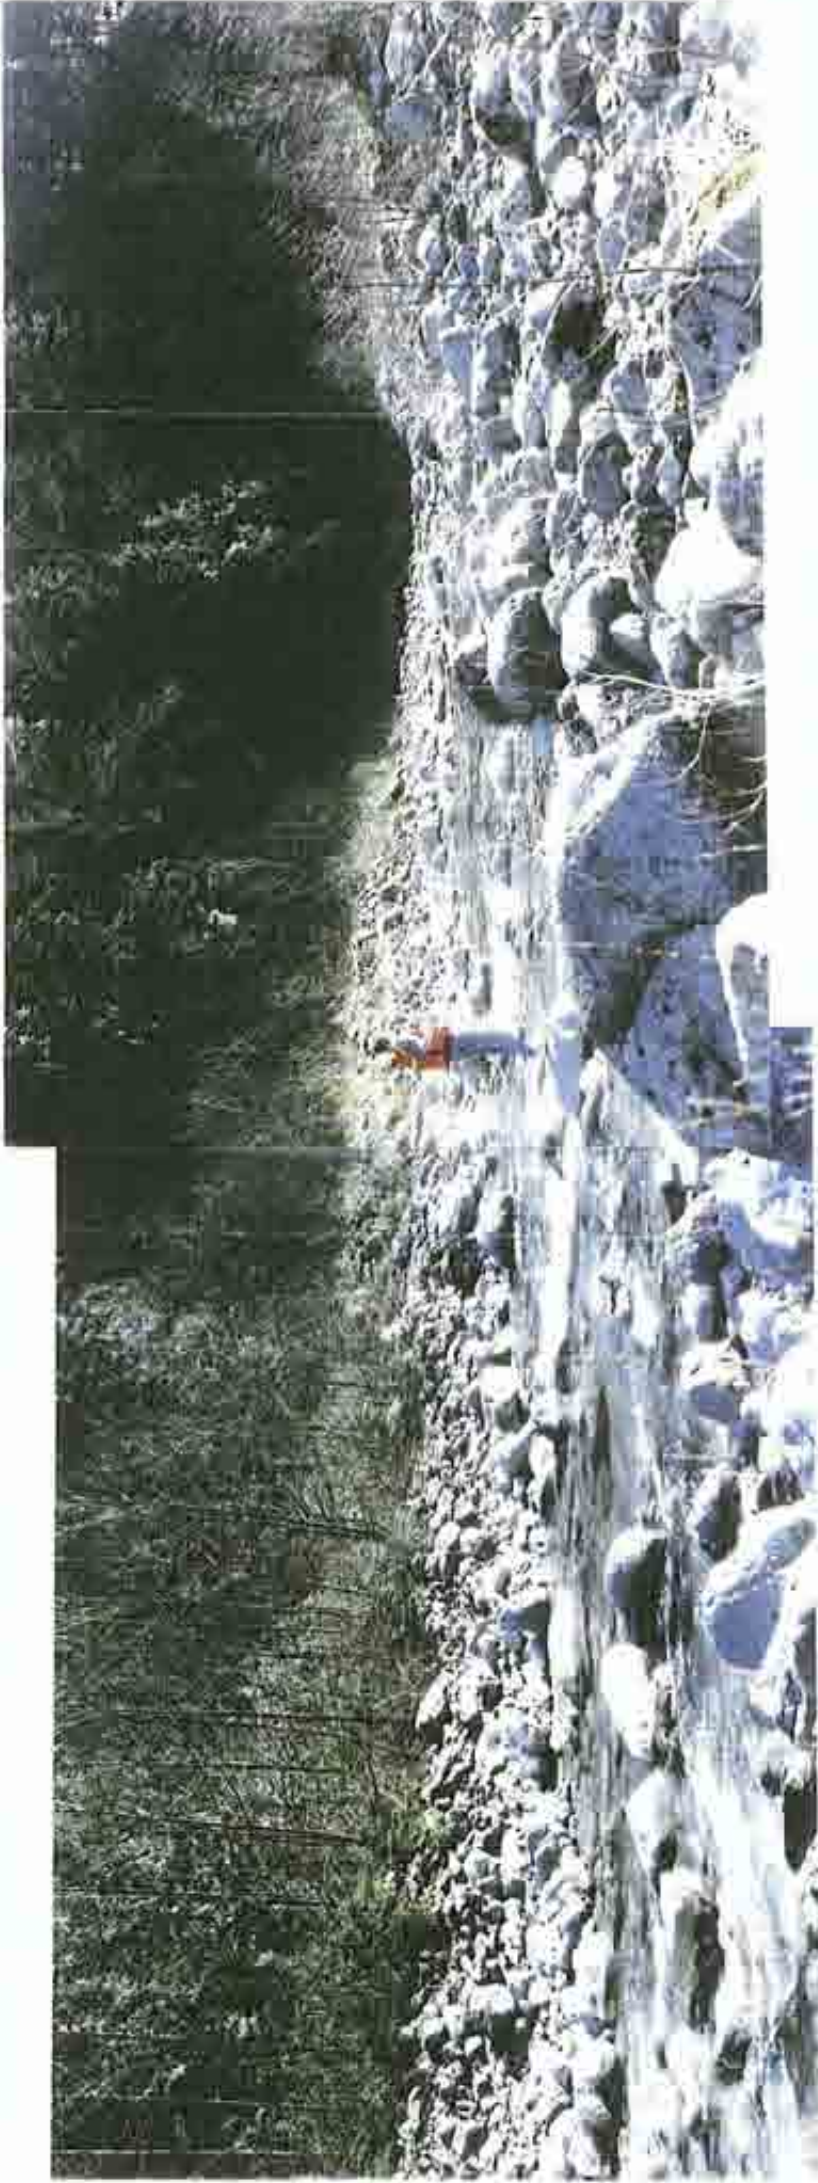
Photo 1 - Cascade Creek Monitoring Section - XS-1

For cross section XS-1, the target bed level was selected to be somewhat higher than the 1999 level, because the bed has degraded naturally at this location, and it is not necessary for flood protection to maintain the bed at such a low level.

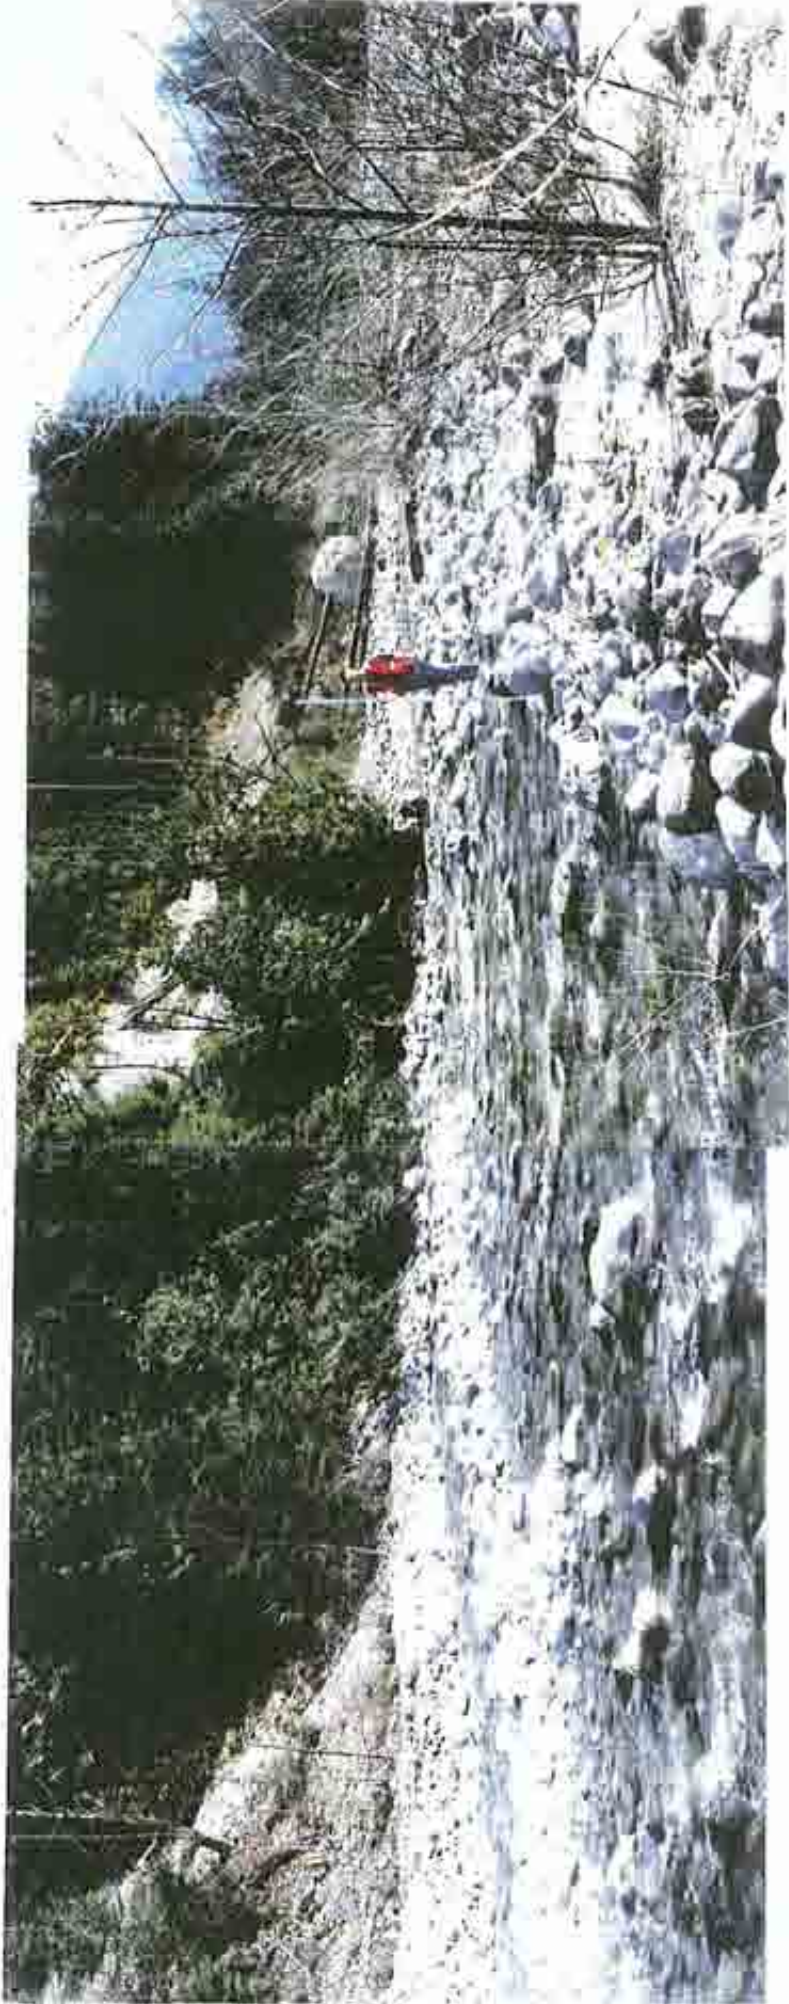
Photo 2 - Cascade Creek Monitoring Section - XS-3 (left channel)

For cross section XS-3, the target bed level was selected to be approximately one metre lower than the 1999 bed level. No gravel removal was done here in 1998 and the current bed level is relatively high. The right bank just upstream of XS-3 is relatively low, and this appears to be a likely place for an avulsion to occur. A right bank avulsion at this location could be dangerous because a new channel could form along the dyke and cause undermining and erosion of the dyke fill.

Monitoring and maintaining stream bed levels is most important toward the lower end of Cascade Creek (XS-11), because this is where the dyke freeboard is the smallest. Cross sections XS-5 and XS-7 are also important because sediment build-up here will increase the flood risk to property east of the creek, which is relatively unprotected. Sediment build-up along the upstream portion of Cascade Creek is less critical because of the generous amount of freeboard provided by the dyke. Channel maintenance upstream of approximately XS-4 (particularly between XS-2 and XS-3) is recommended primarily to reduce the chance of an avulsion that could undermine or erode the dyke. Sediment deposition near XS-3 is also contributing to erosion of the left bank, which is a significant source of sediment due to its height and steepness (Photo 2; note unstable slope and fallen trees in background).

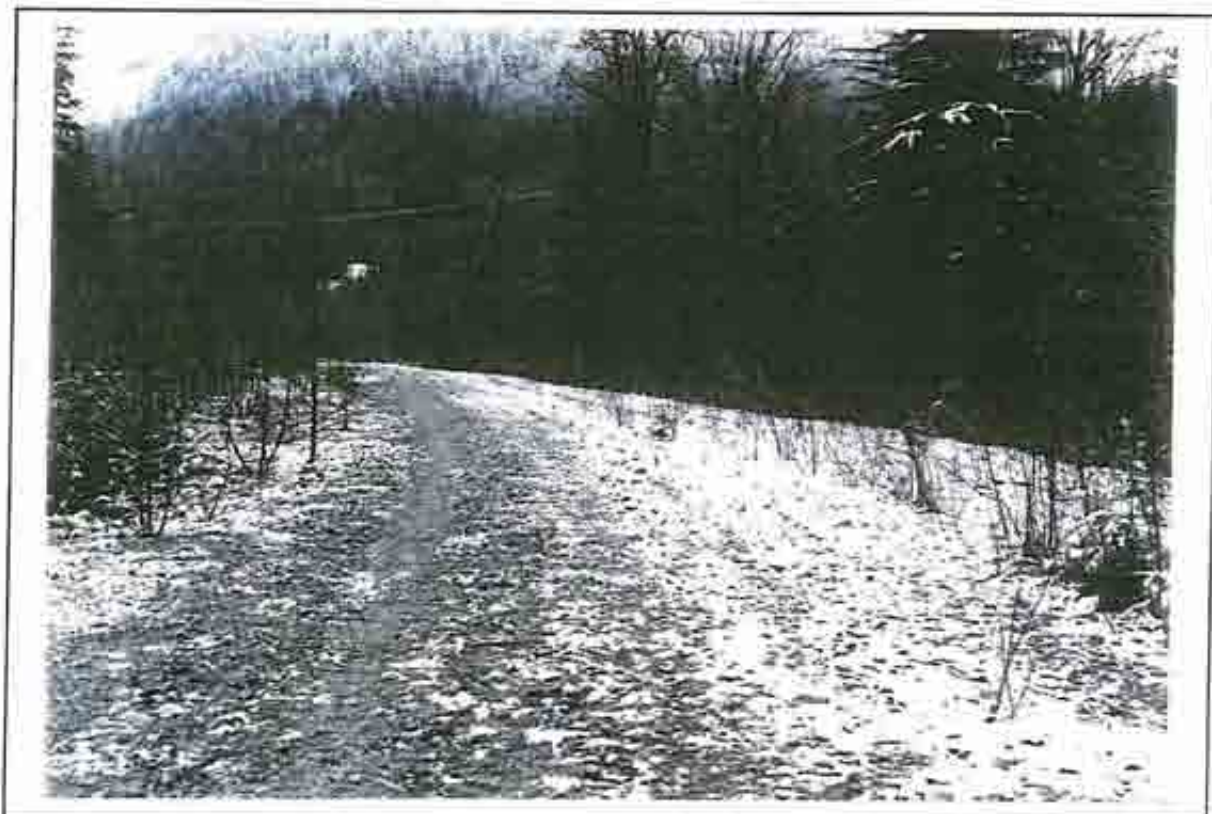
Photo 11 - Cascade Creek Dyke looking upstream near XS-5.

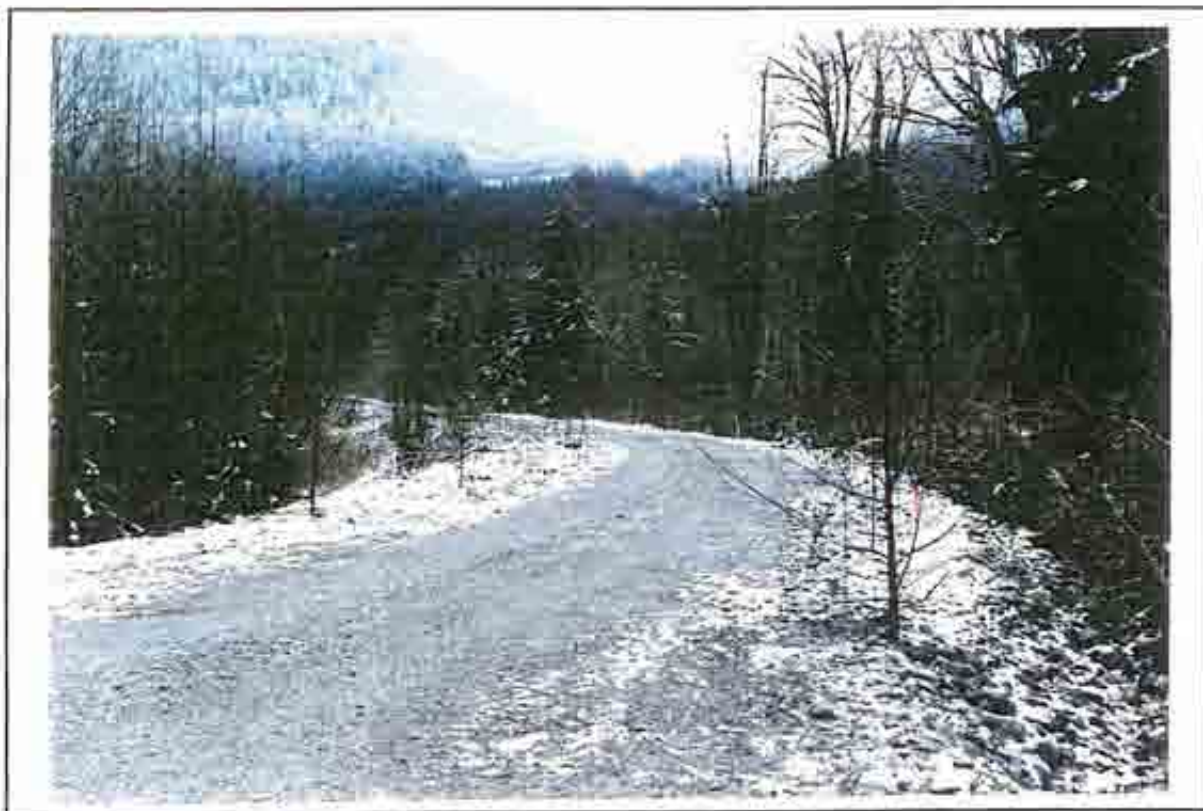
Photo 12 - Cascade Creek Dyke looking upstream at XS-7.

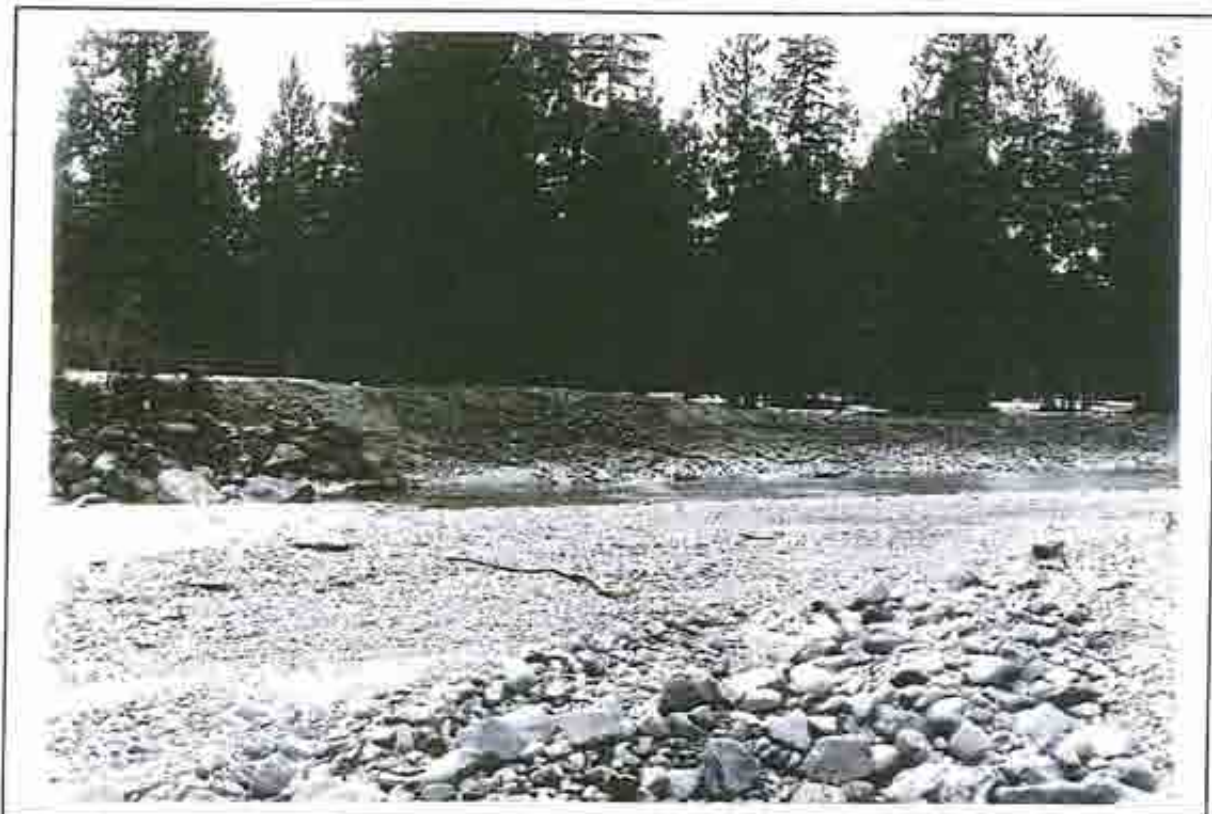
Photo 14 - Cascade Creek looking at the left bank downstream of XS-6. Riprap is required here.

It is recommended that the failed riprap downstream of XS-6 be replaced (Drawing 101). The bank where the riprap has failed is a relatively likely place for an avulsion<sup>2</sup> to occur, and further erosion of this bank will increase this likelihood. Recommended specifications for materials are provided in Appendix B. The riprap should be placed at a side slope of 1.5:1 or flatter (2:1 is preferred), and extend a metre below the minimum bed level to prevent undermining.

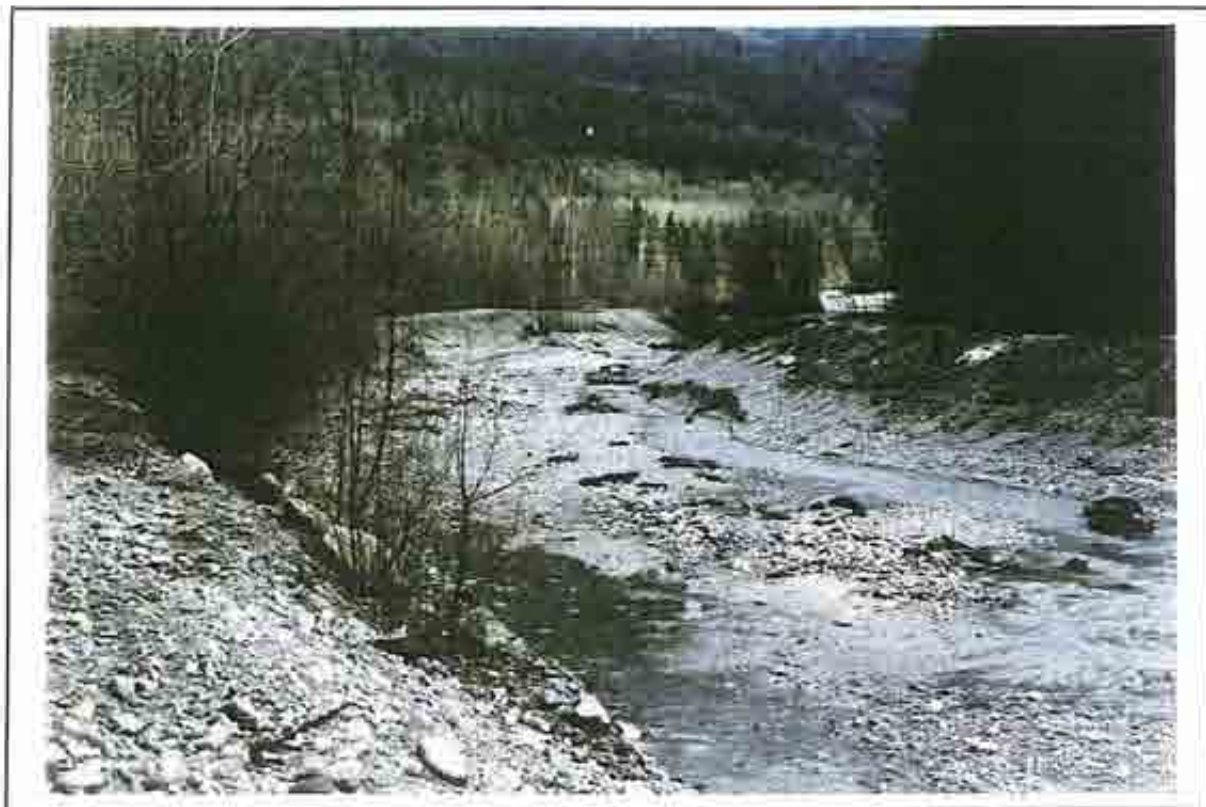
The Carratt Creek berms are generally located with no setback from the creek bank (Photo 15). The crest width typically varies between 4 and 8 metres. Side slopes are typically 1.5:1, but are as steep as 1:1 in places (Photo 16). The berms appear to be generally in as-constructed condition, with the exception of vegetation growing on the side slopes and crest in some places (mostly alders up to 10 cm, Photo 17). The crest of the left berm in the vicinity of XS-20 appears to be about 0.8 metres lower than in 1985.

Photo 15 - Carratt Creek looking upstream from XS-15.

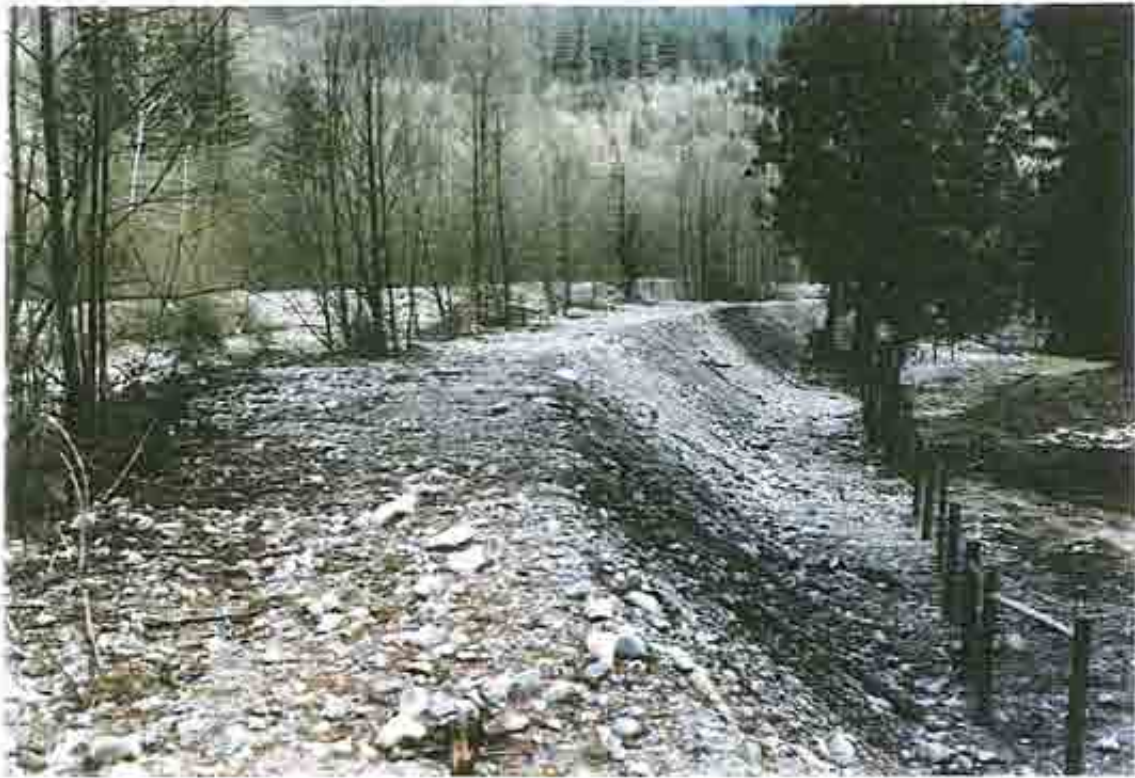
Photo 16 - Left Carratt Creek Berm looking upstream between XS-15 and XS-16.

To reduce the likelihood of a berm failure, the berms should be widened where necessary to a minimum crest width of 6 metres and maximum side slopes of 1.5:1 (2:1 is preferred). Most of the existing berms meet these requirements, with the exception of the left berm downstream of the Carratt Road bridge (Photo 16). Recommended specifications for materials are provided in Appendix B.

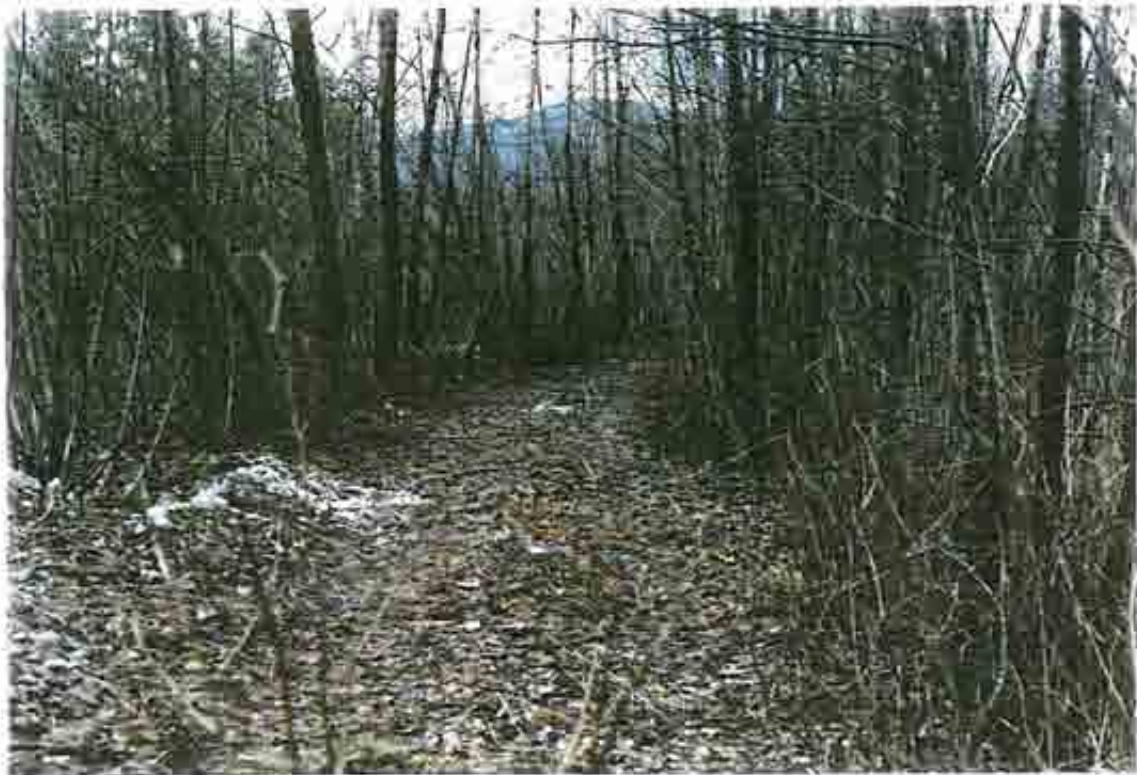
Photo 17 - Right Carratt Creek Berm looking downstream near XS-15.

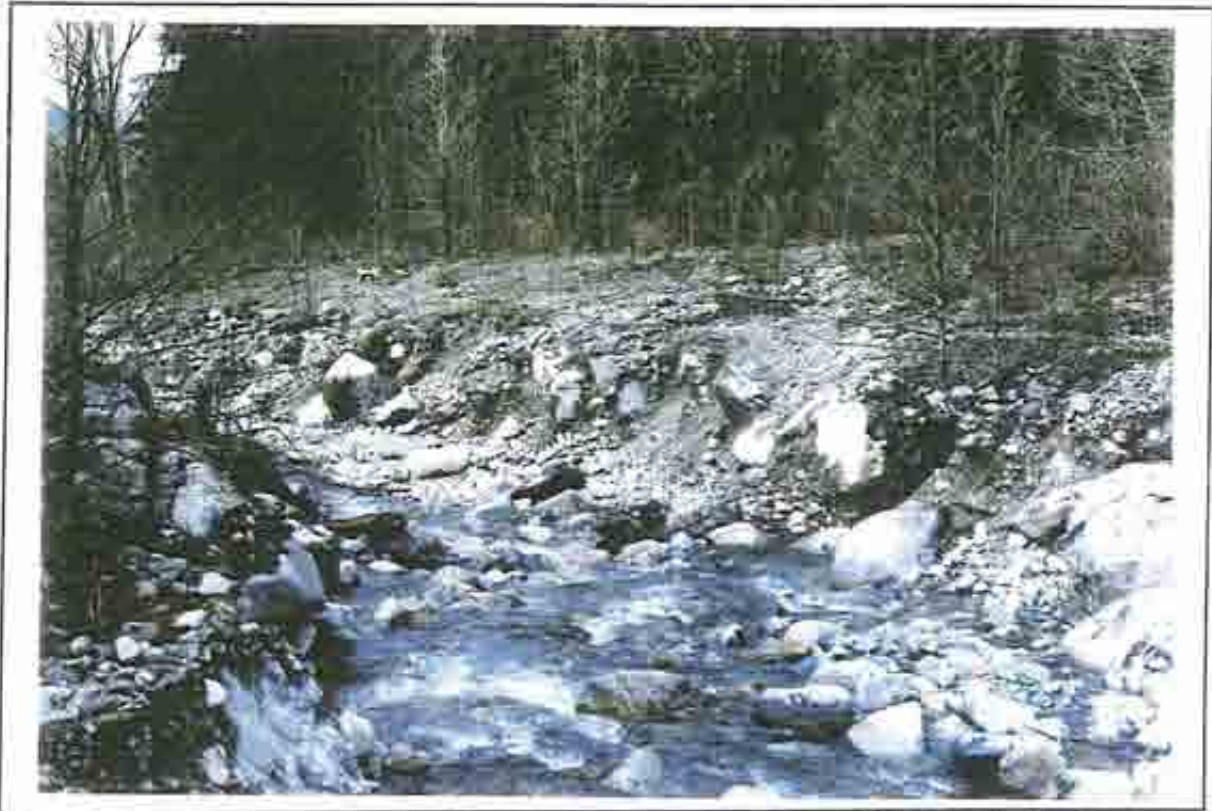
Photo 18 - Carratt Creek looking downstream from about XS-21. This bank was previously riprapped.
