**THURBER ENGINEERING LTD.**

November 7, 2003

**EMERGENCY RESPONSE TO OCTOBER 16-18 DEBRIS FLOOD  
AT 35900 DALE ROAD, HATZIC VALLEY**

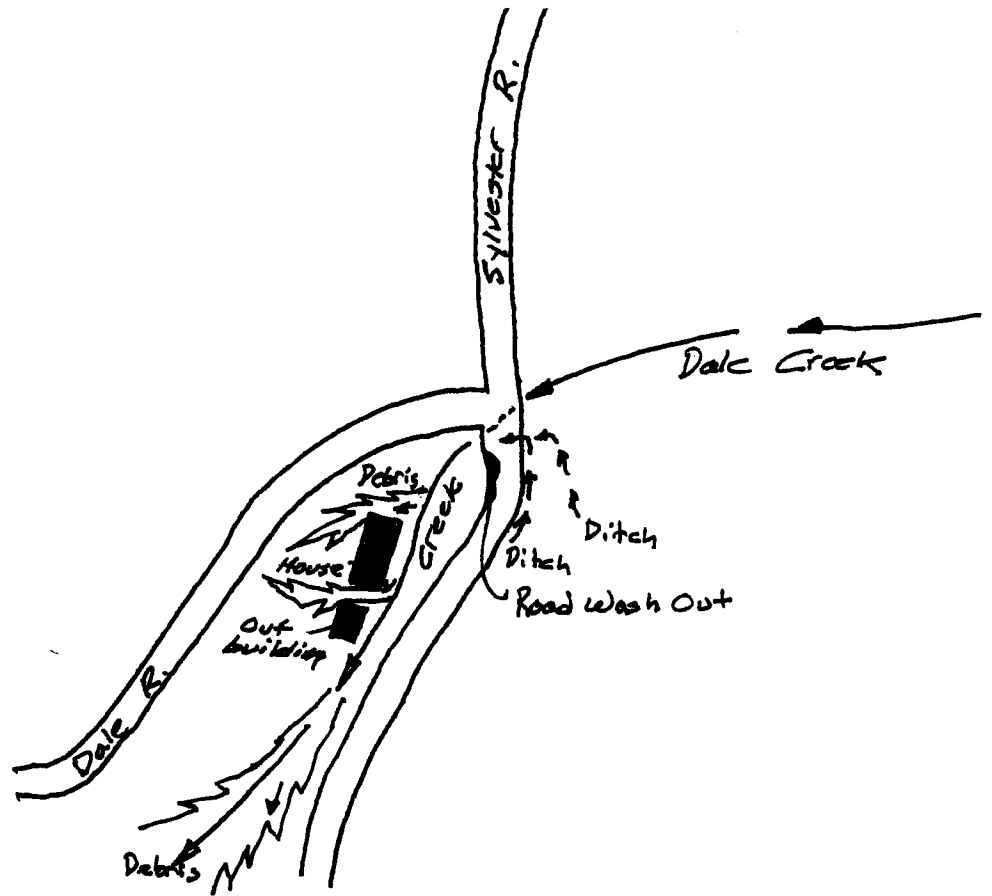
Figure 2

Creek and roadway debris descended the channel located immediately behind the subject residence (Figure 2). The creek flows along the base of Sylvester Road fill and is confined on its right (west) side by a low gravel dyke that protects the adjacent house from low magnitude creek floods. The subject house is constructed of cinder block. There is a wood frame outbuilding (a garage) just south of the house. The creek also flows along the side of the outbuilding. Most of the family (including 2 children) occupy the house; one child occupies the outbuilding.

The October 17 event filled the creek channel, breached the low dyke and allowed water, mud and debris to break out on each side of the house. Water and debris alarmed the residents. Up to about 0.6 m of sand, gravel and cobble debris was deposited on each side of the

Sketch showing Dale Road, Dale Creek and Sylvester Road Area with road ditches, Sylvester Road washout, and debris tracks below the road and adjacent to subject house and out building. There is a low gravel dyke between the buildings and the lower creek. The dyke was breached by water and debris in the October 17 flood.
