Attached plans of Chelastie River  
Bridge, Bridge Inspection Reports and  
photos.

# Chelastie Bridge

### Chelaslie River and Michelle Creek Bridge Inspections

### Re: Bridge Inspections

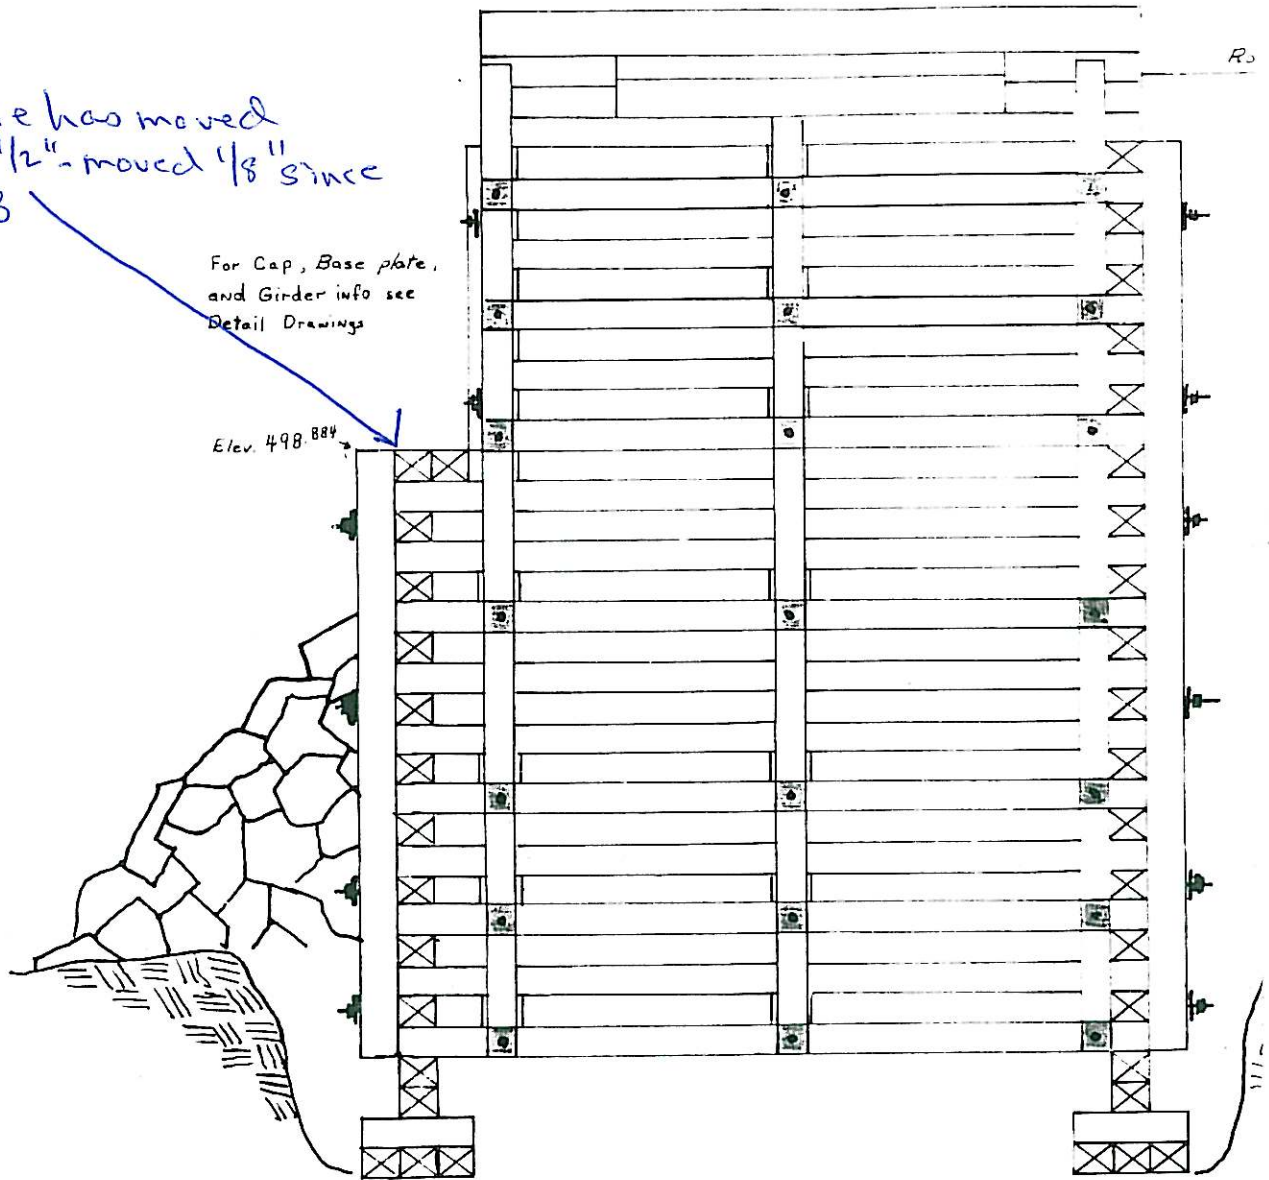
— SIDE WALL —

vertical tie has moved  
out by  $2\frac{1}{2}$ " - moved  $\frac{1}{8}$ " since  
May, 2003

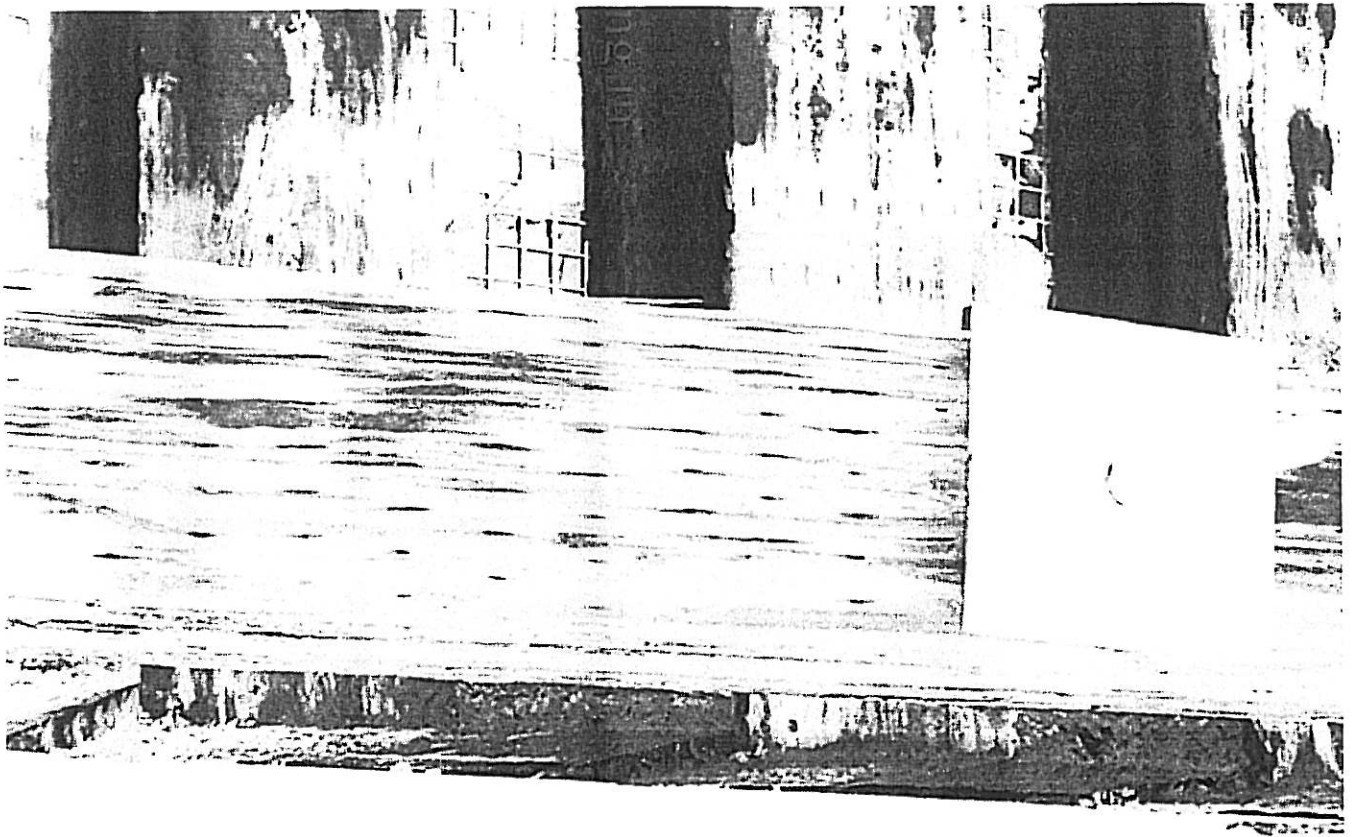
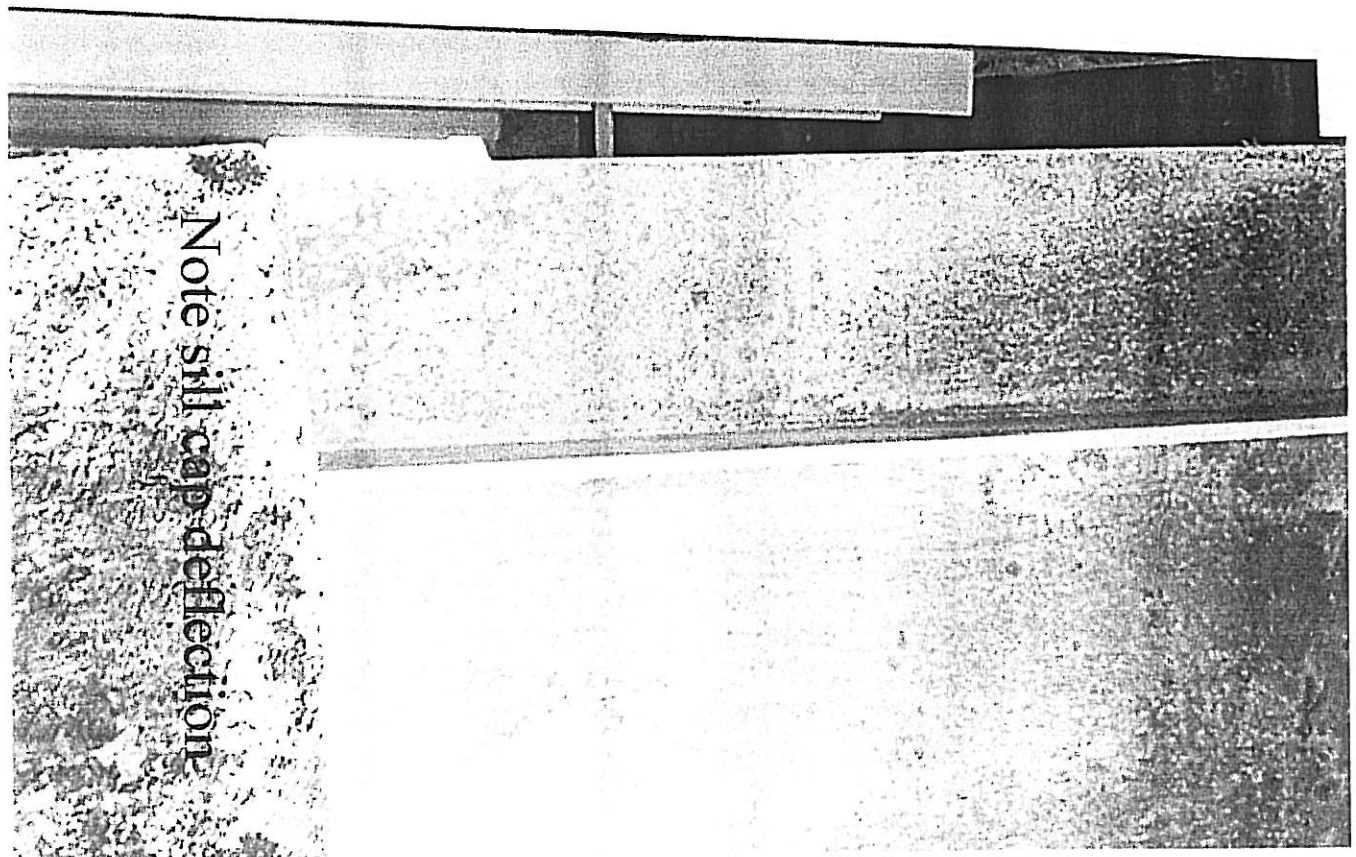
Note sill cap deflection

by bolts and timber crib and  
From contact point to top of  
down chain is 2.25 inches at c  
3 inches

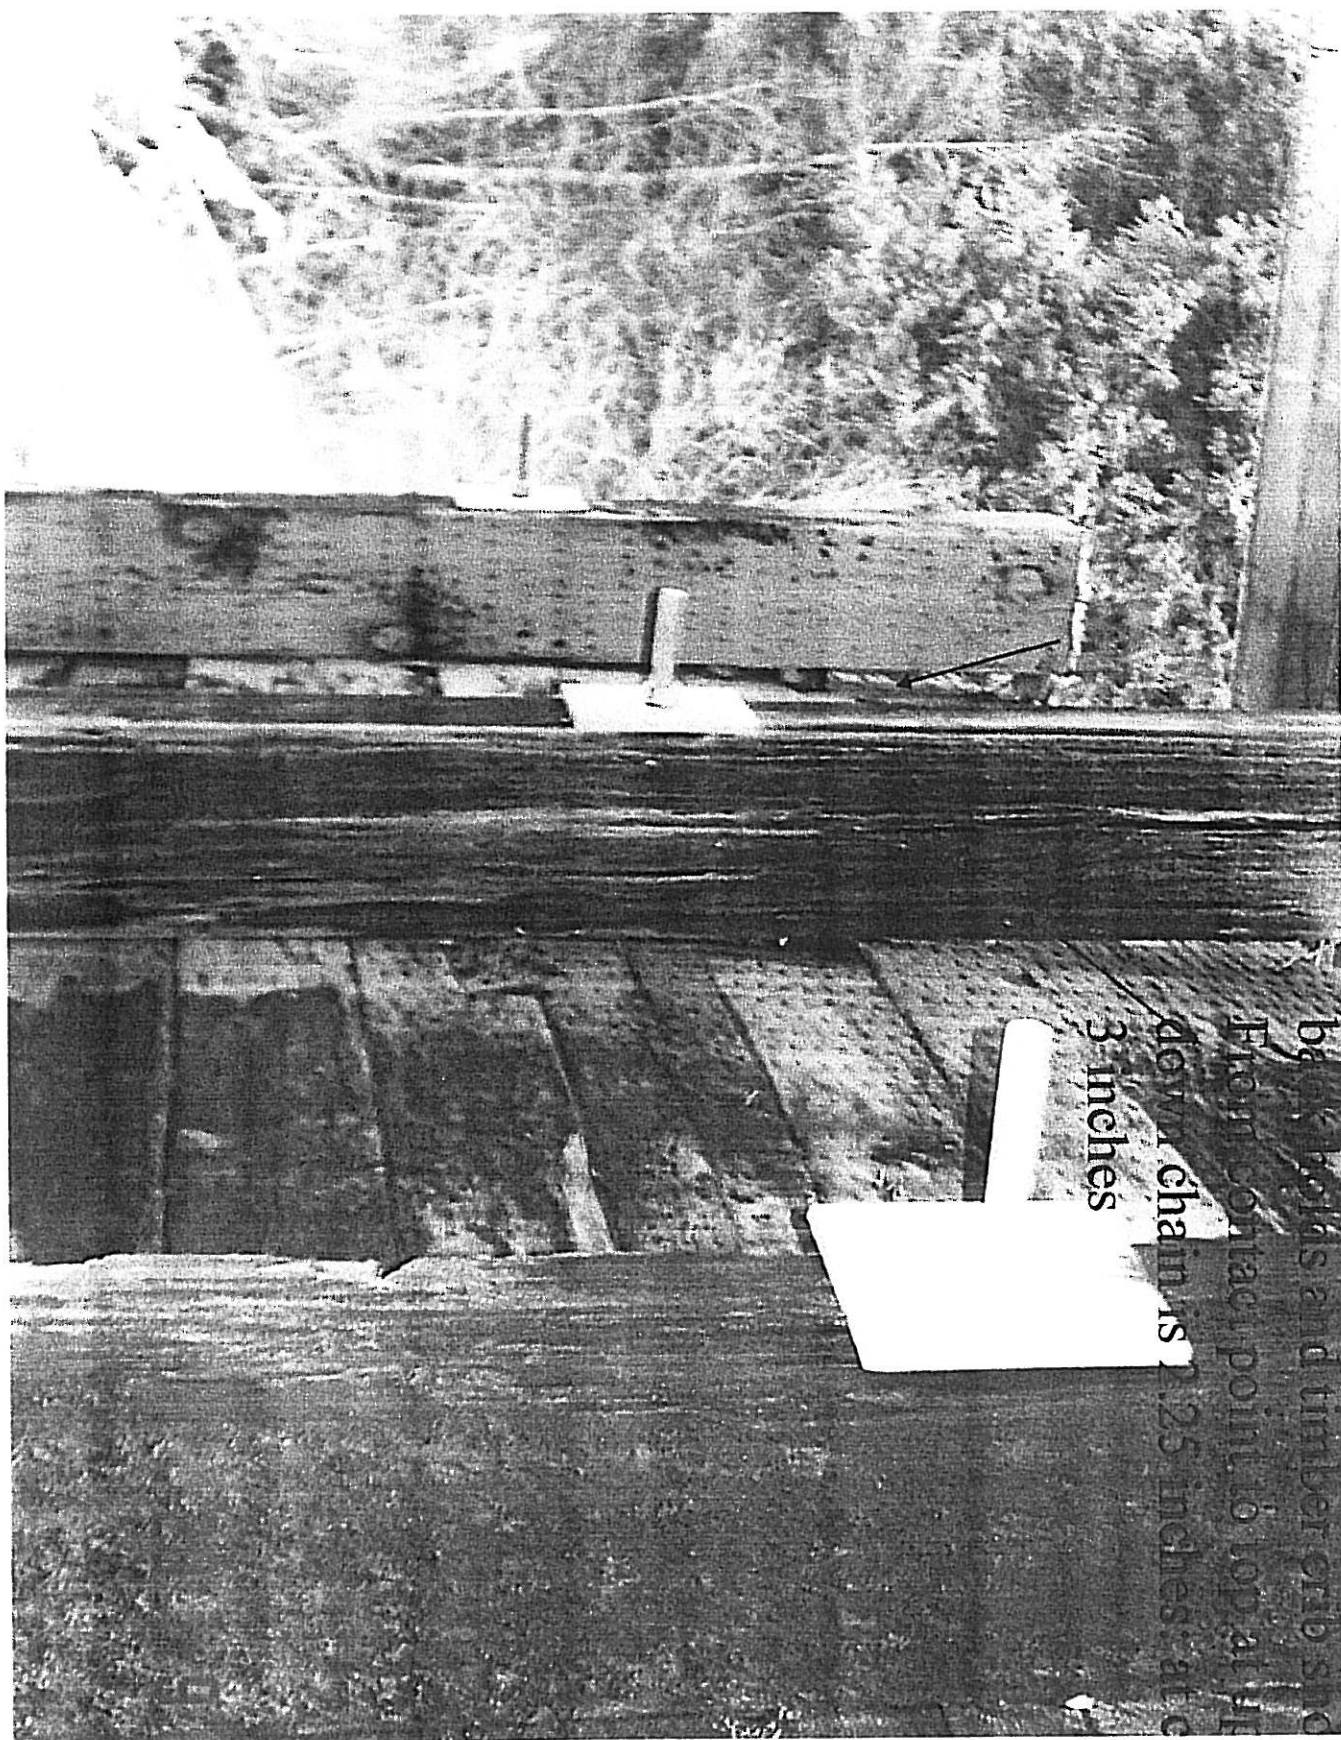
Note deflection in  
horizontal timbers and roll  
in cross ties
