**From:** "Scott Loptson" <sloptson@mcelhanney.com>  
**To:** "Tom Olafson" <tom.olafson@westfraser.com>  
**Date:** 4/17/2006 11:51:24 AM  
**Subject:** Chelaslie Inspection Report

*Chelaslie River Bridge Inspection*

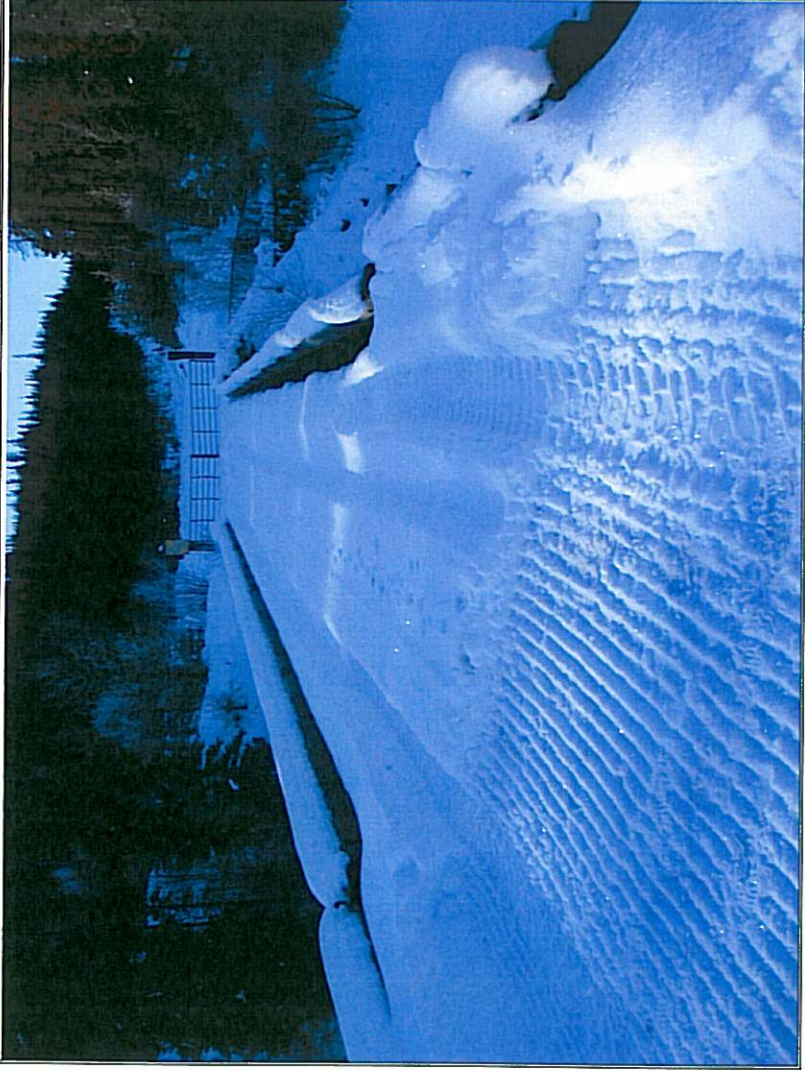
**Photo 1**

Looking upchain  
across bridge.

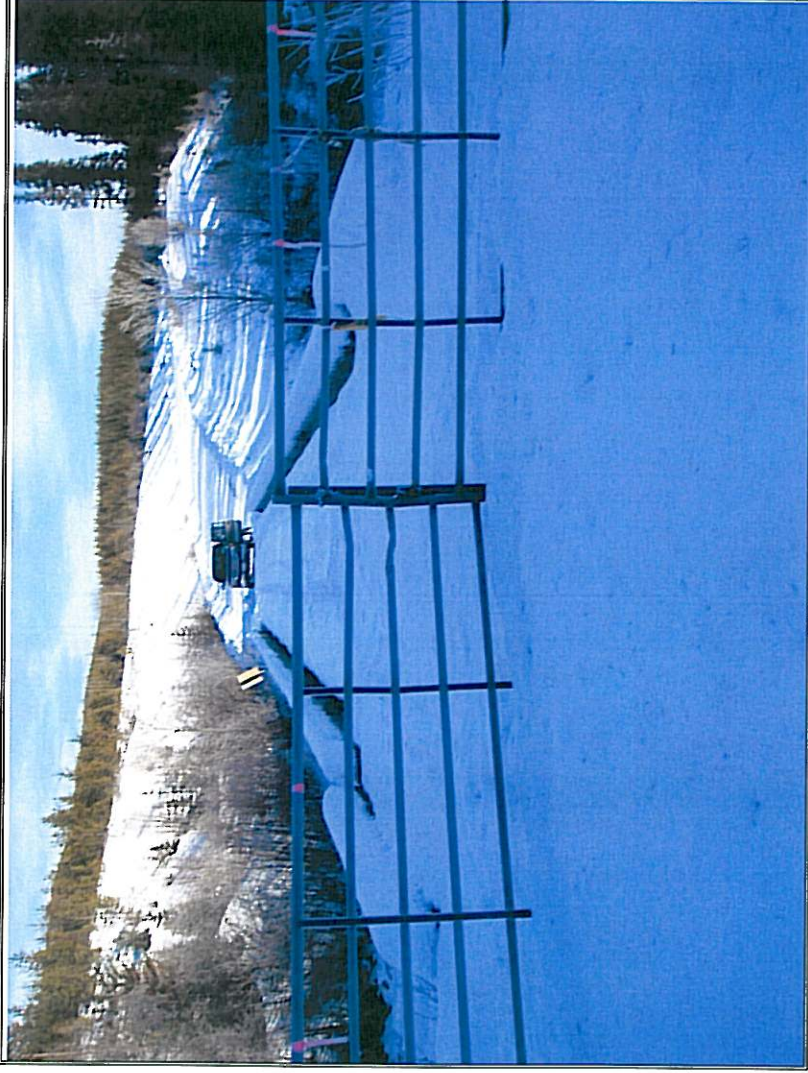
**Photo 2**

Looking downchain  
across bridge.

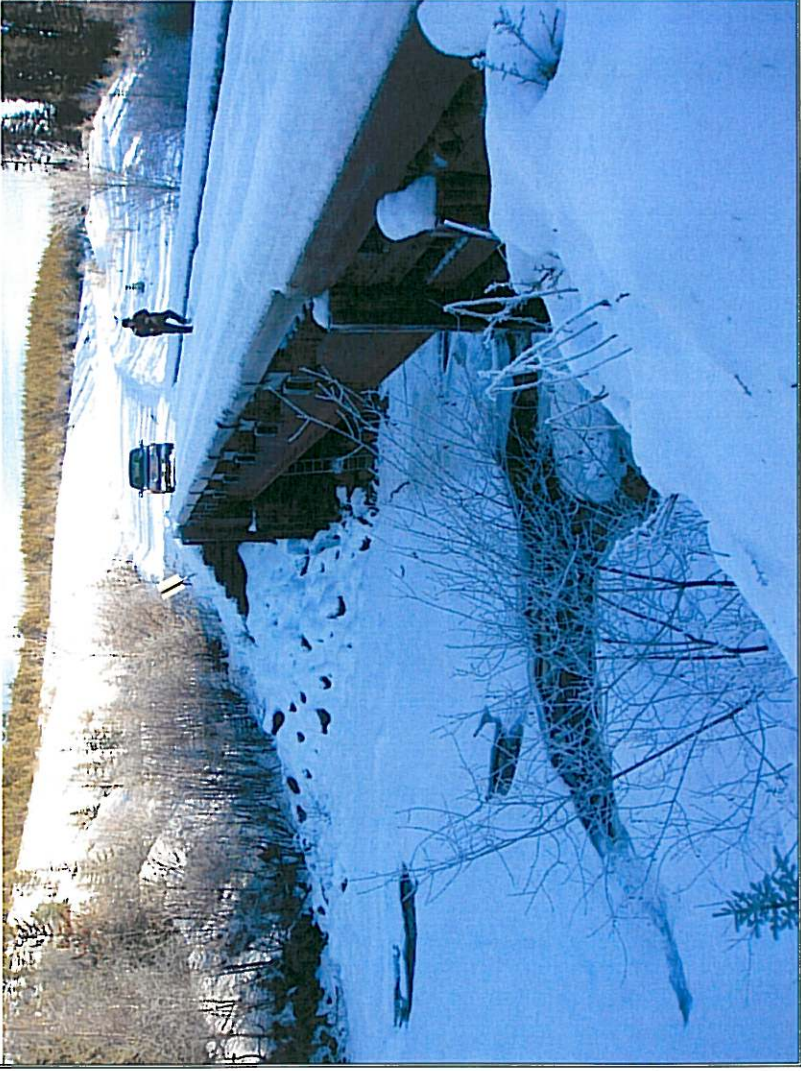
**Photo 3**

Downstream side of bridge.

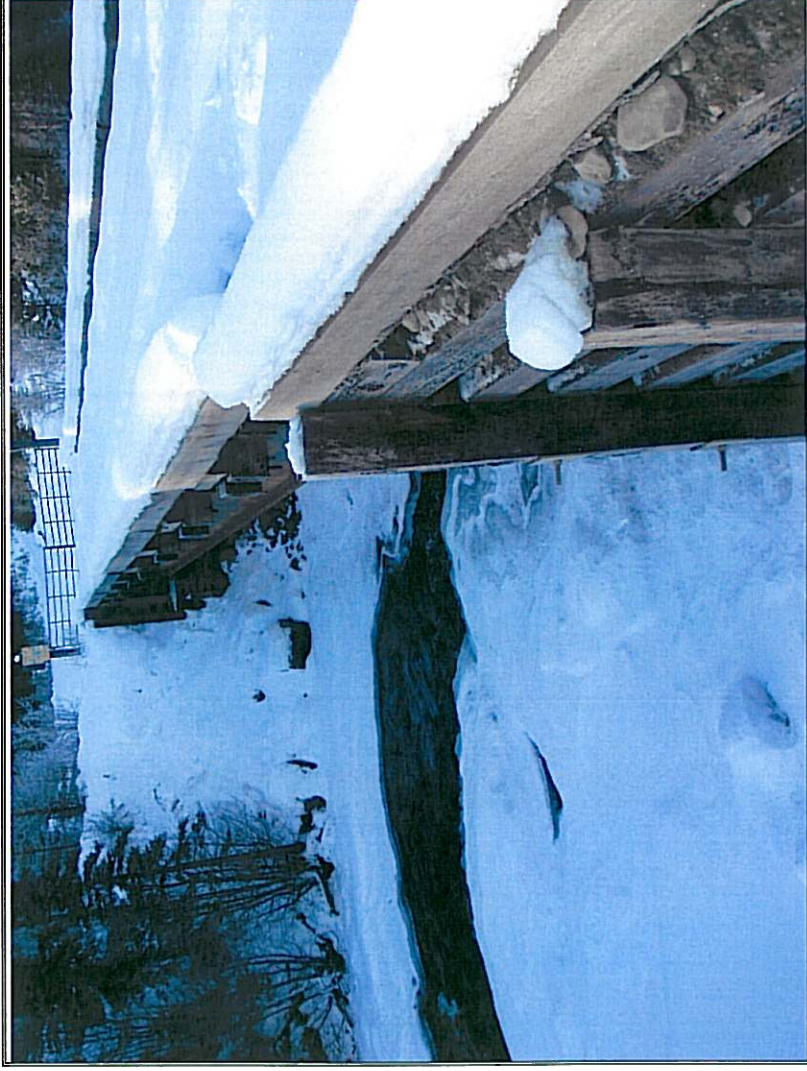
**Photo 4**

Upstream side of bridge.

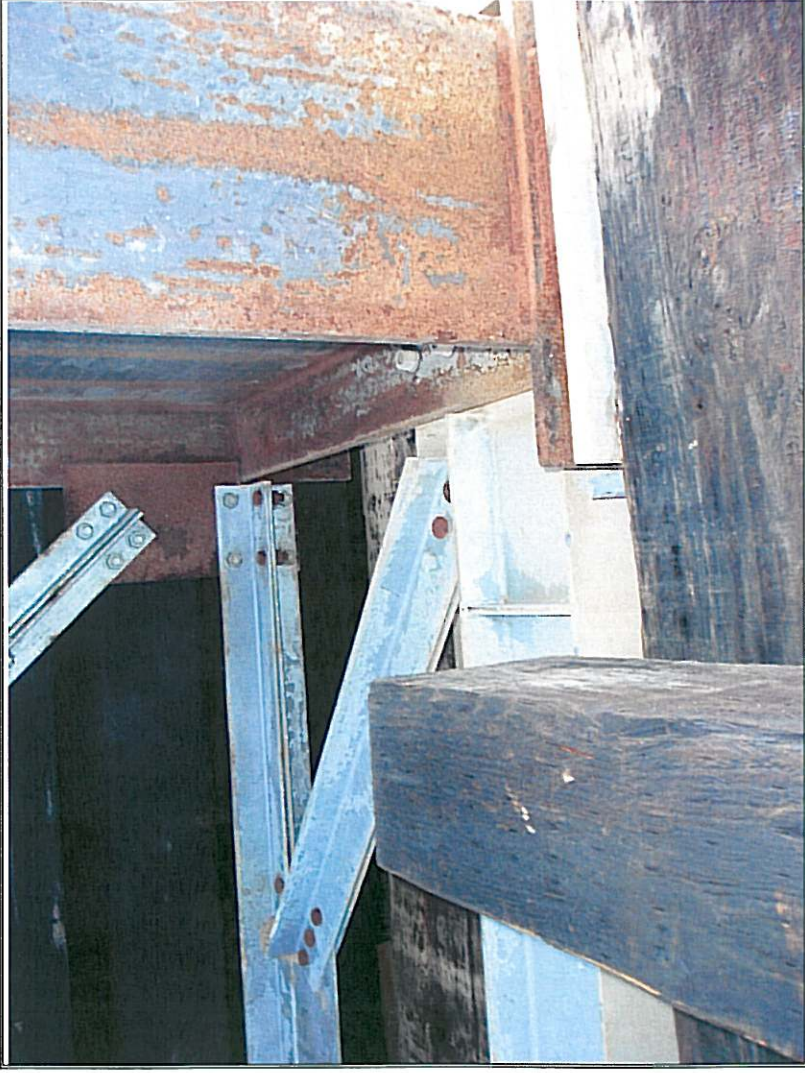
**Photo 5**

| BRIDGE ELEMENT | | CONDITION | REMARKS | |
|---|---|---|---|---|
| | Bracing | 2 | ONE BOLT LOOSE D/C DIAPHRAGM. ONE SPACER PLATE MISSING. | |

Spacer plate missing on D/S D/C corner bracing. Not a structural concern.

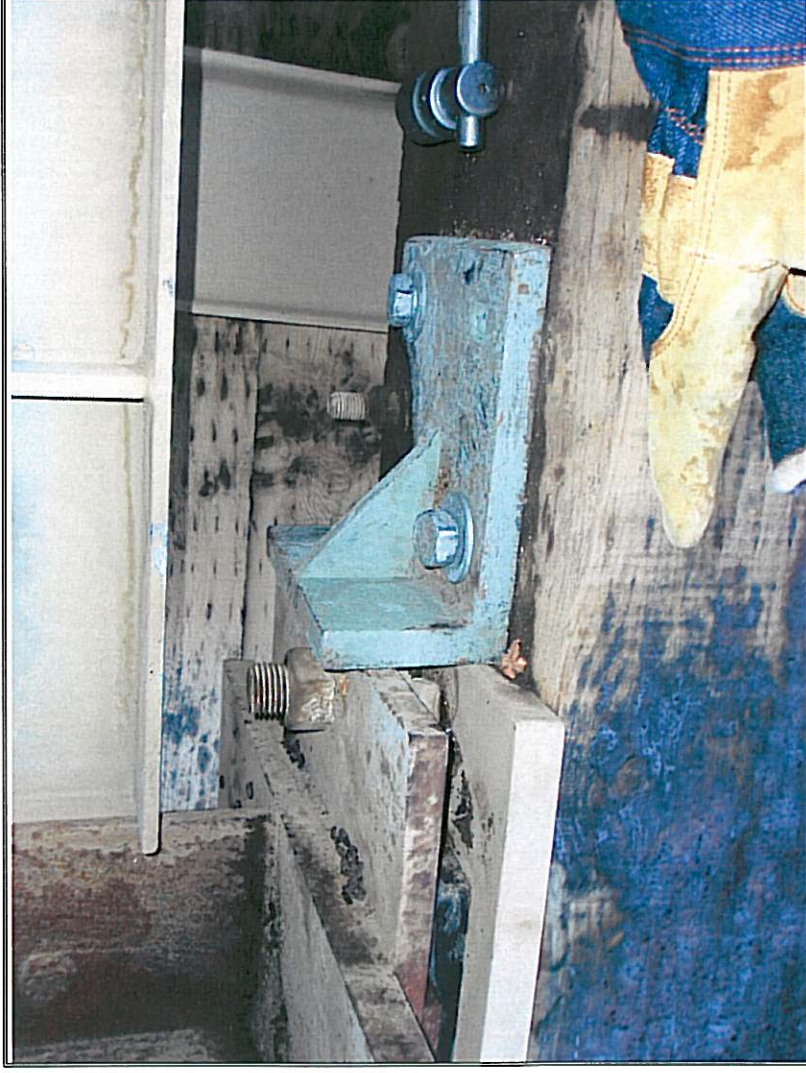
**Photo 6**

U/S D/C inside bearing plate keeper.

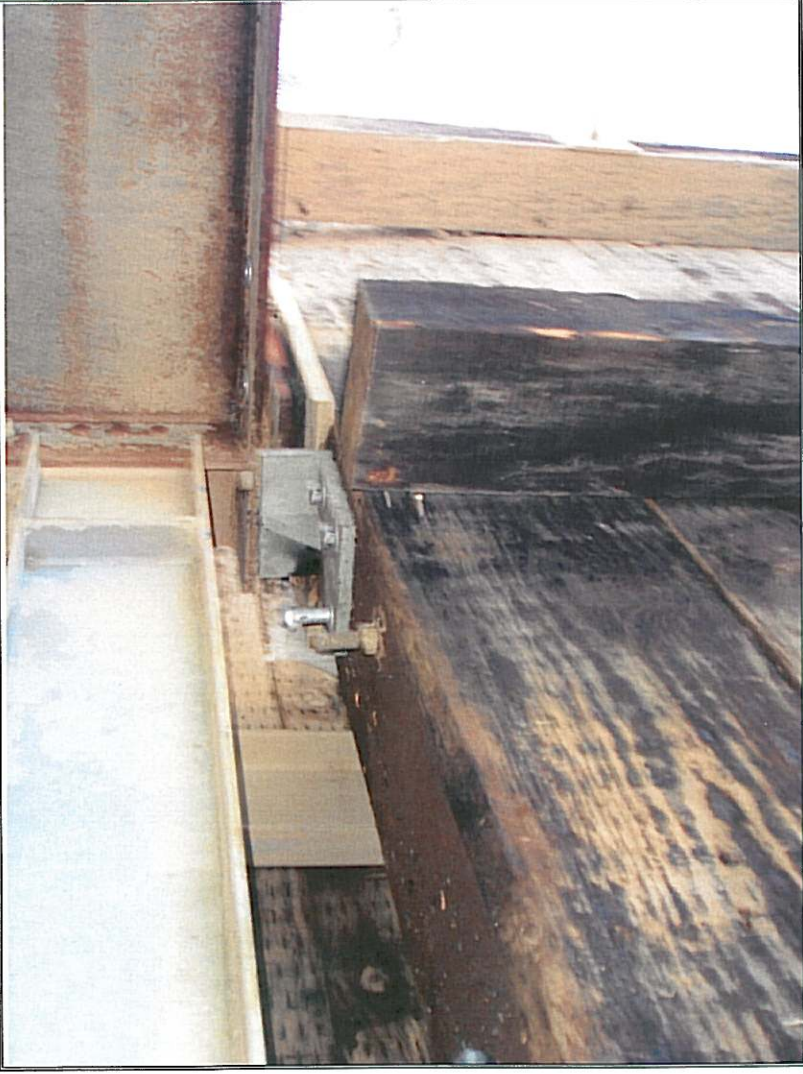
**Photo 7**

I apologize for taking so long to get this to you. Attached are PDF versions of the Inspection Photos and Bridge Inspection Report. Again, it looks like there has been no significant movement of the town-side abutment cribbing (see the last two photos). The lateral bearing restraints were installed correctly (with a couple of the lag screws still to be tightened when the inspector left the site).

D/S D/C bearing plate keeper. 1 bolt still to be tightened.

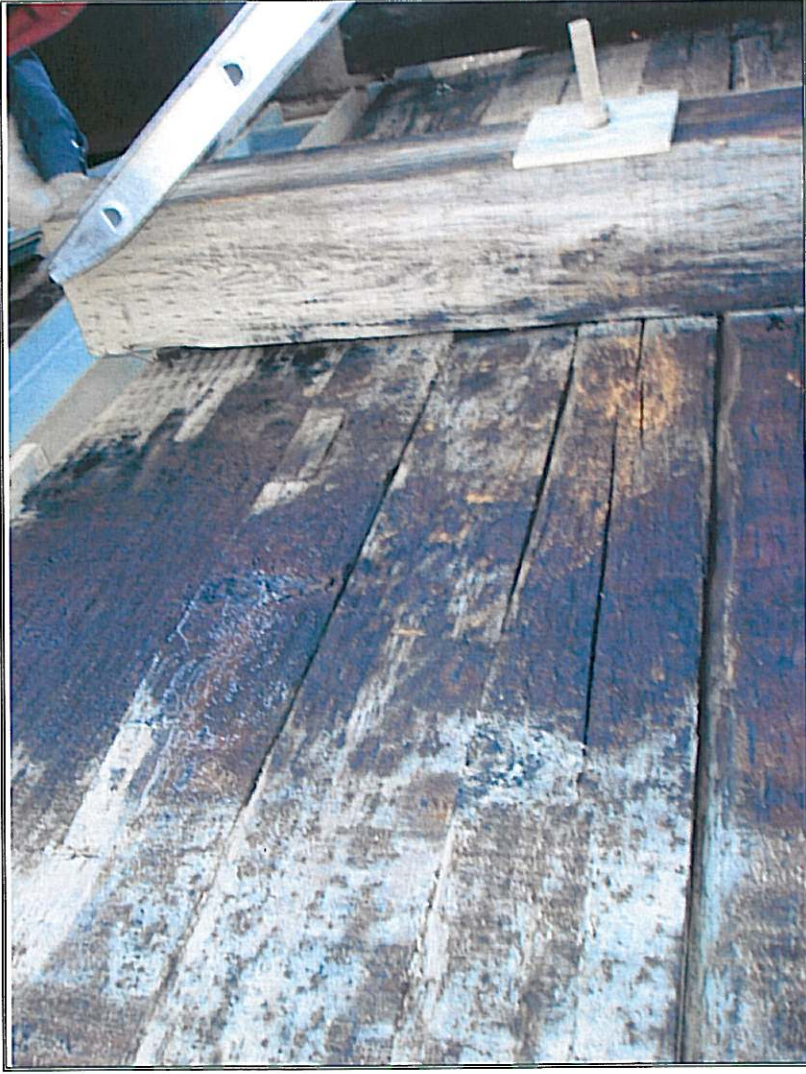
**Photo 8**

Separation between abutment planks and vertical post

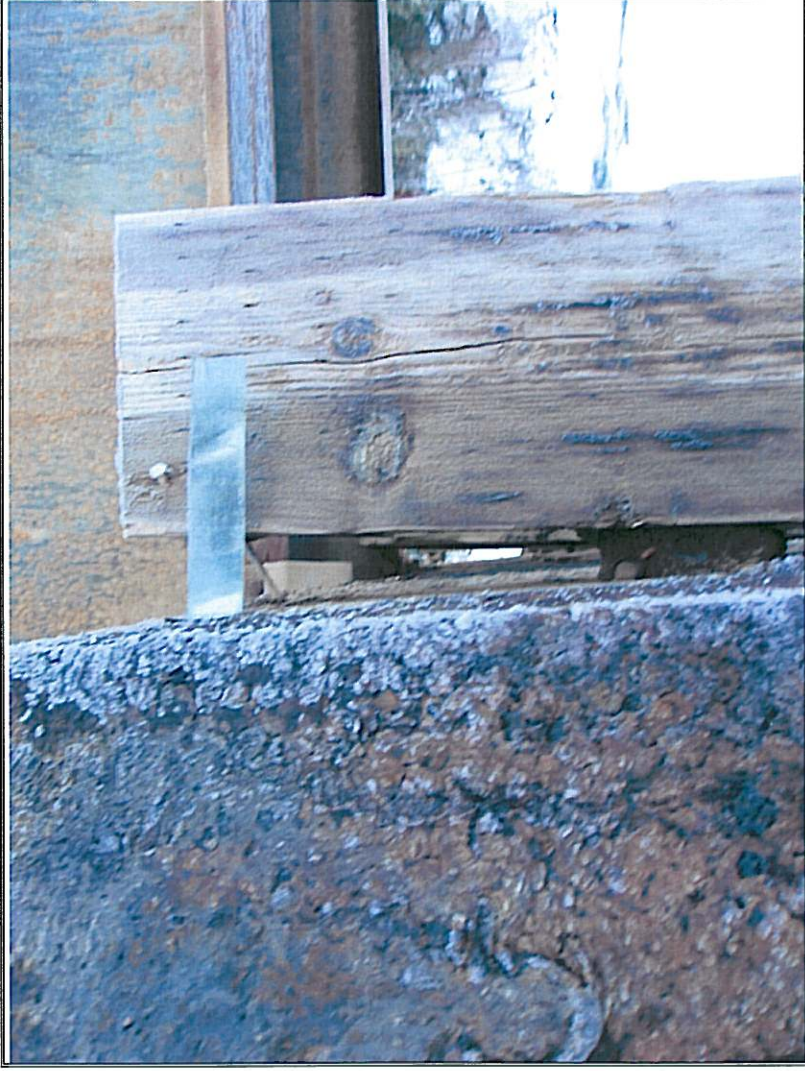
**Photo 9**

| BRIDGE ELEMENT | | CONDITION | REMARKS | |
|---|---|---|---|---|
| | Cribs | 2 | TREATED. LEANING TOWARDS RIVER, BUT STABLE SINCE 2003. | |
| | REPAIR DESCRIPTION AND COST ESTIMATE:<br>ADD BRIDGE HAZARD DELINEATOR SIGNS<br>DOWNCHAIN ABUTMENT SHOWING SIGNS OF MOVEMENT, BEING MONITORED:<br>US MONITOR 2 3/8"<br>DS MONITOR 2 9/16" | | | |

U/S monitoring device on D/C abutment. Not much change since 2003 (see Photo 10).

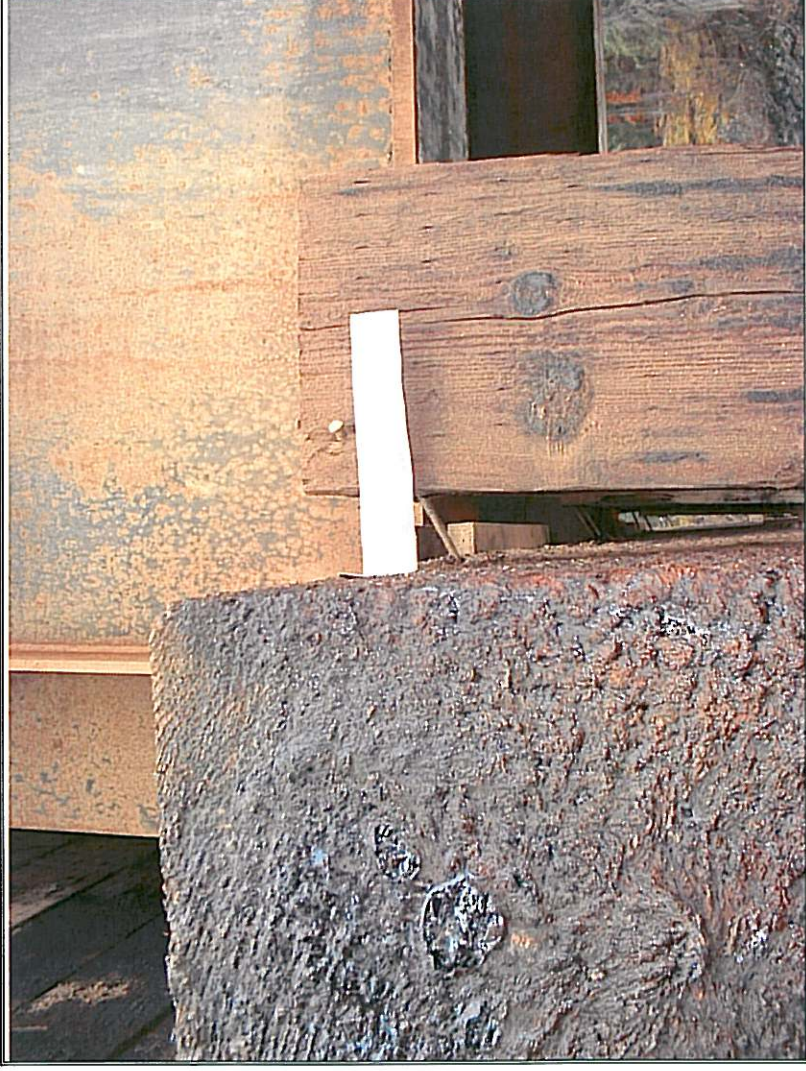
**Photo 10**

Photo at same location as Photo 9 from October 22, 2003.
