BRIDGE INSPECTION REPORT  
STEEL/CONCRETE/GLULAM, INSPECTION SUMMARY

| STRUCTURE NO. | | ROAD: CHESLASLIE FSR | | KM: 18 | | PAGE 1 | | OF 1 | |
| CROSSING: CHELASLIE RIVER | | | | DISTRICT: LAKES | | PROJECT NO.2331-00505-1 | | | |

## Chelaslie River Bridge Inspection

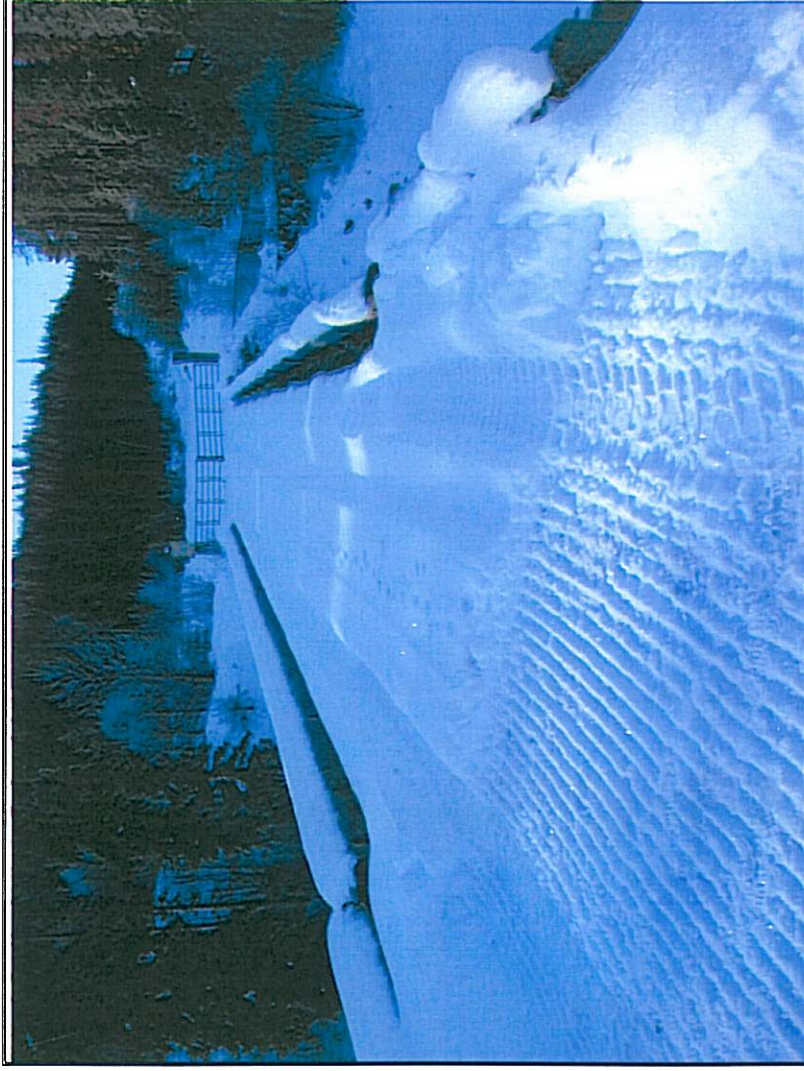
**Photo 1**

Looking upchain  
across bridge.

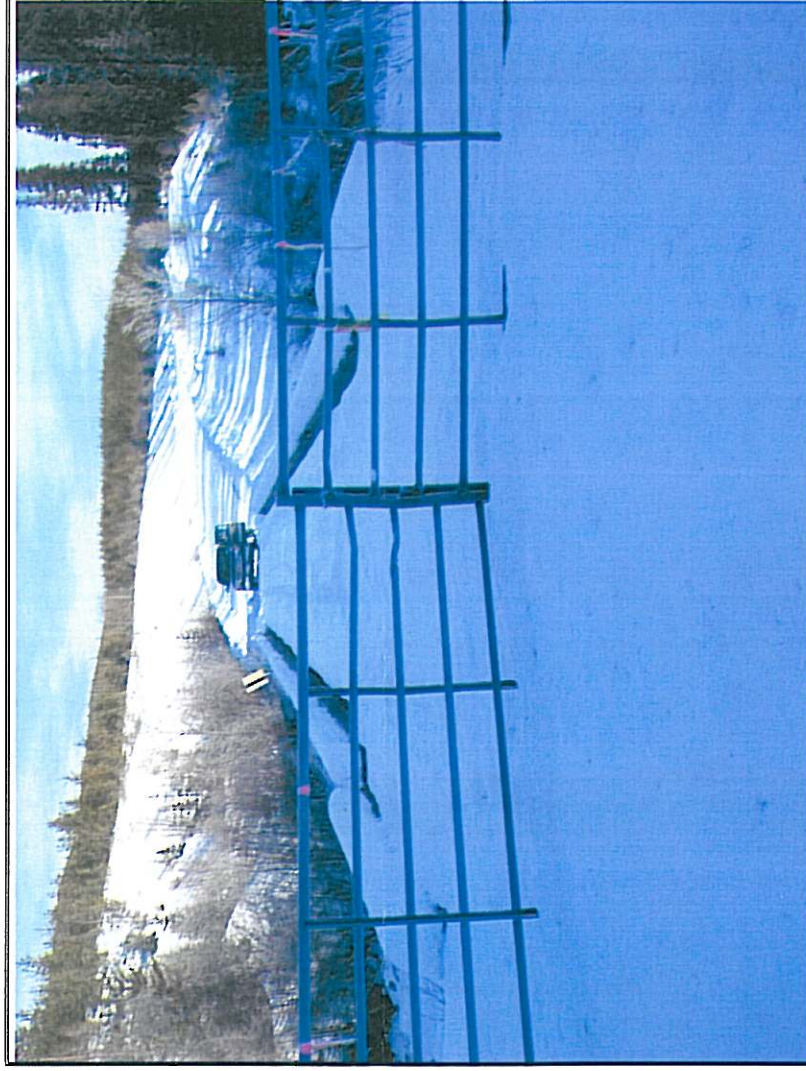
**Photo 2**

Looking downchain  
across bridge.

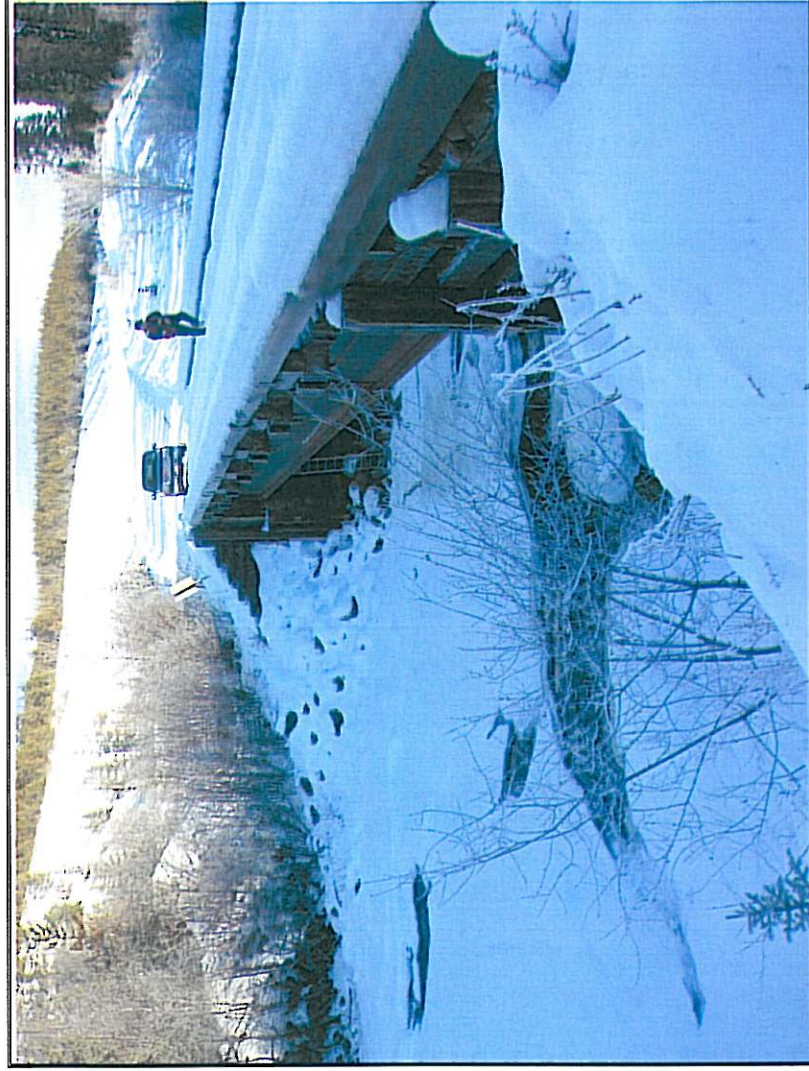
Photo 3

Downstream side of bridge.

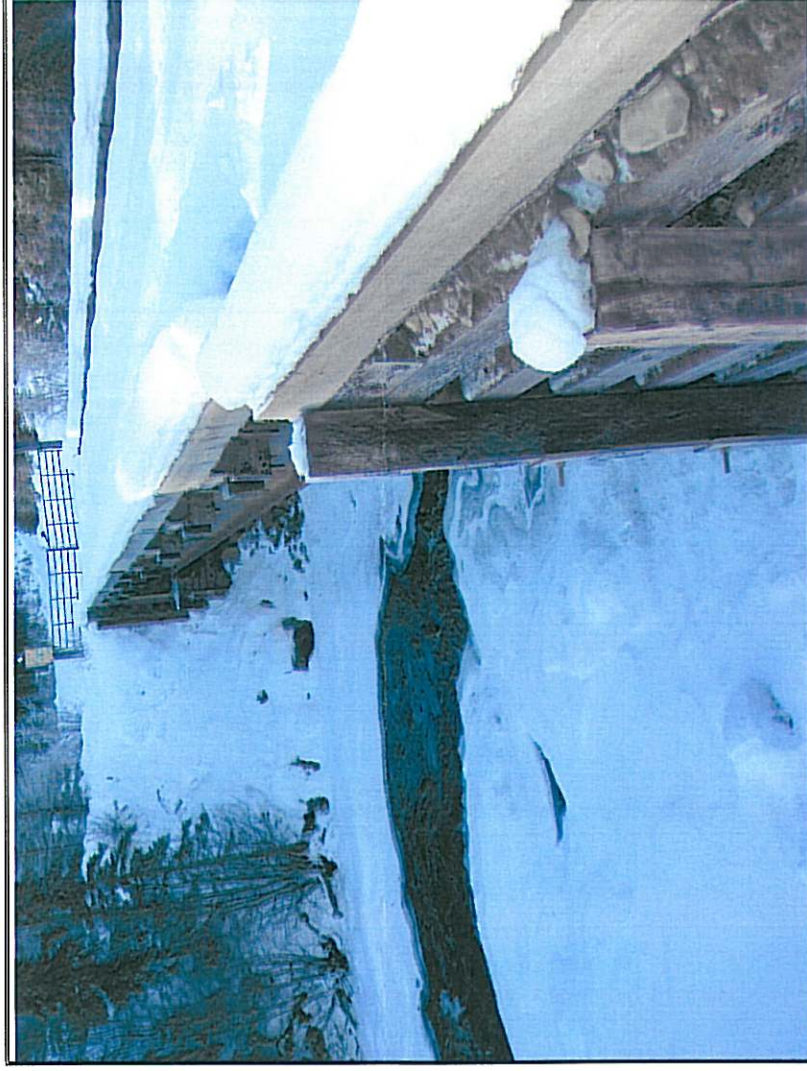
Photo 4

Upstream side of bridge.

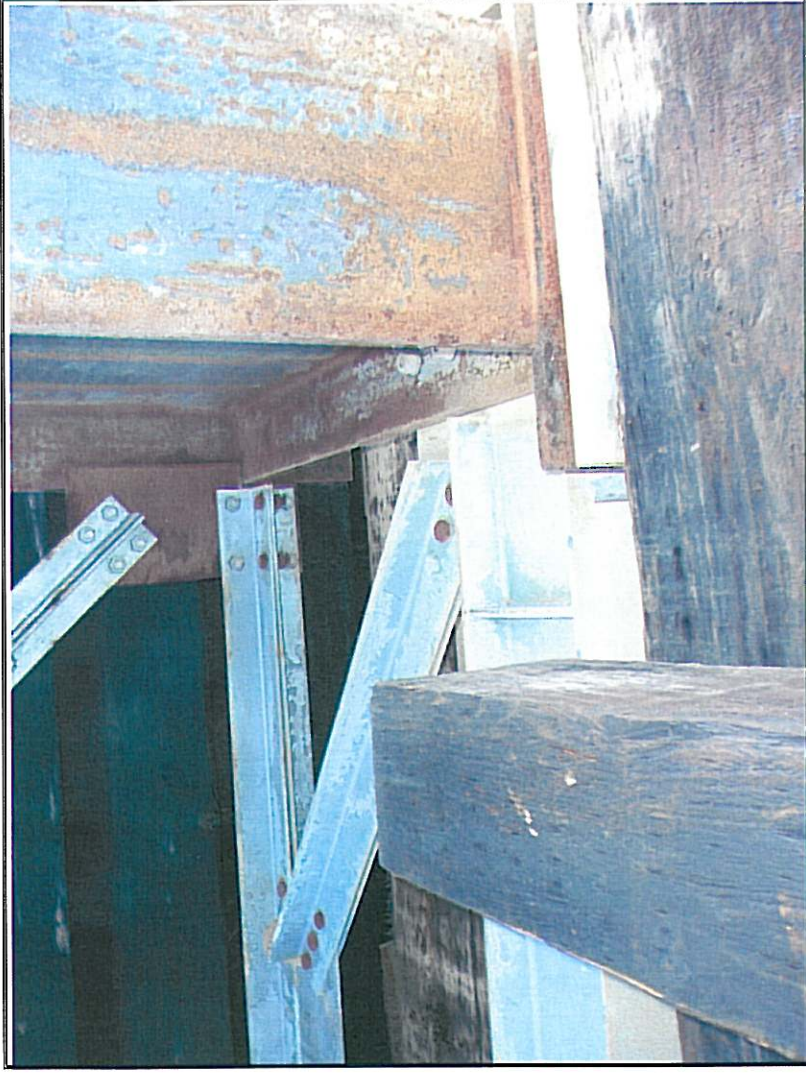
**Photo 5**

| | | | | Bracing | | 2 | | ONE BOLT LOOSE DIC DIAPHRAGM. ONE SPACER PLATE MISSING. | |

Spacer plate  
missing on D/S  
D/C corner bracing.  
Not a structural  
concern.

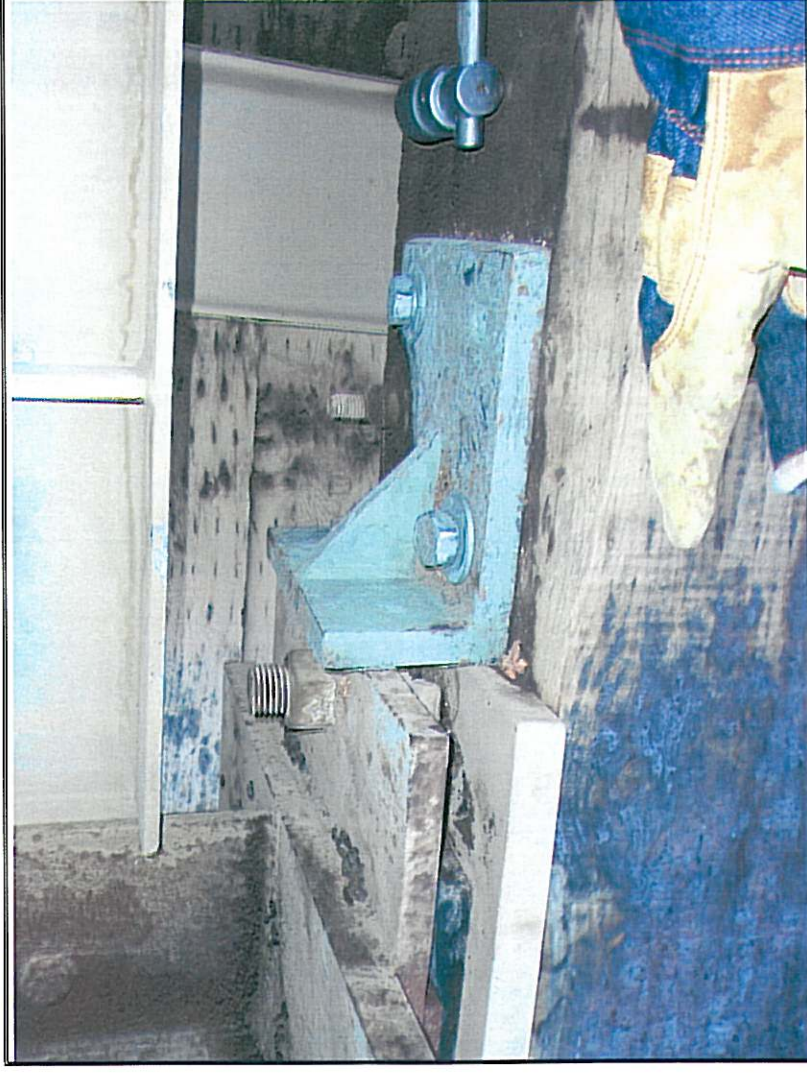
**Photo 6**

U/S D/C inside  
bearing plate  
keeper.

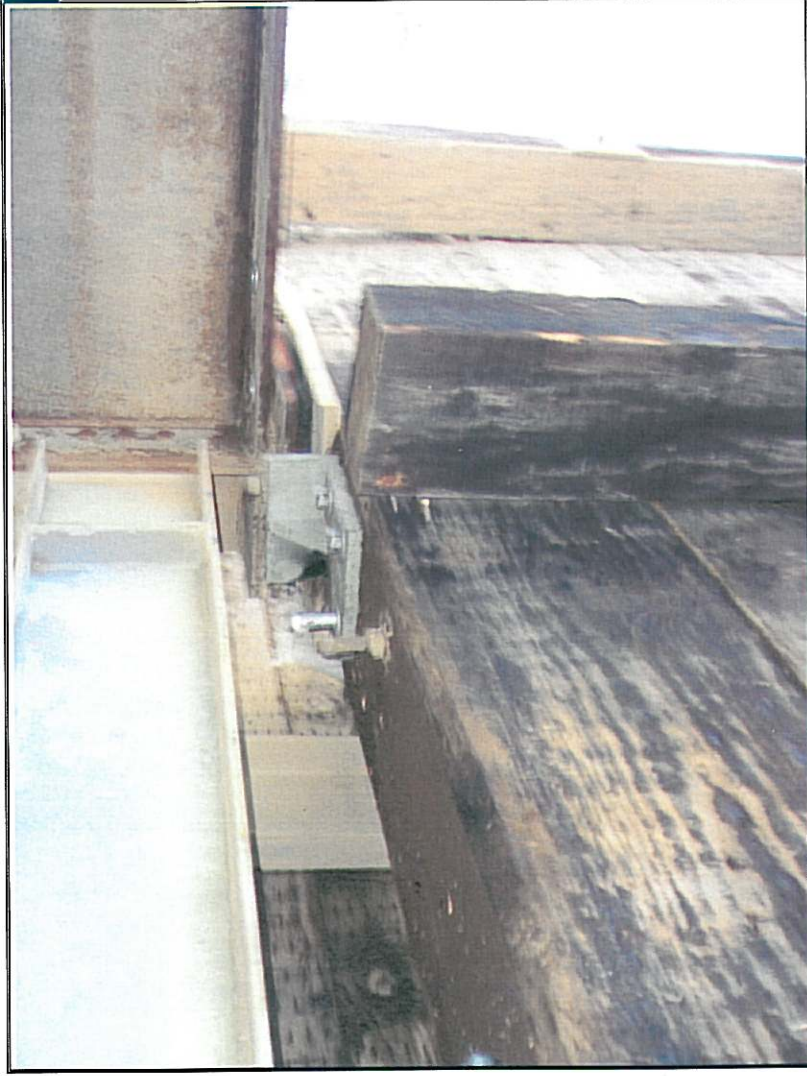
**Photo 7**

D/S D/C bearing plate keeper. 1 bolt still to be tightened.

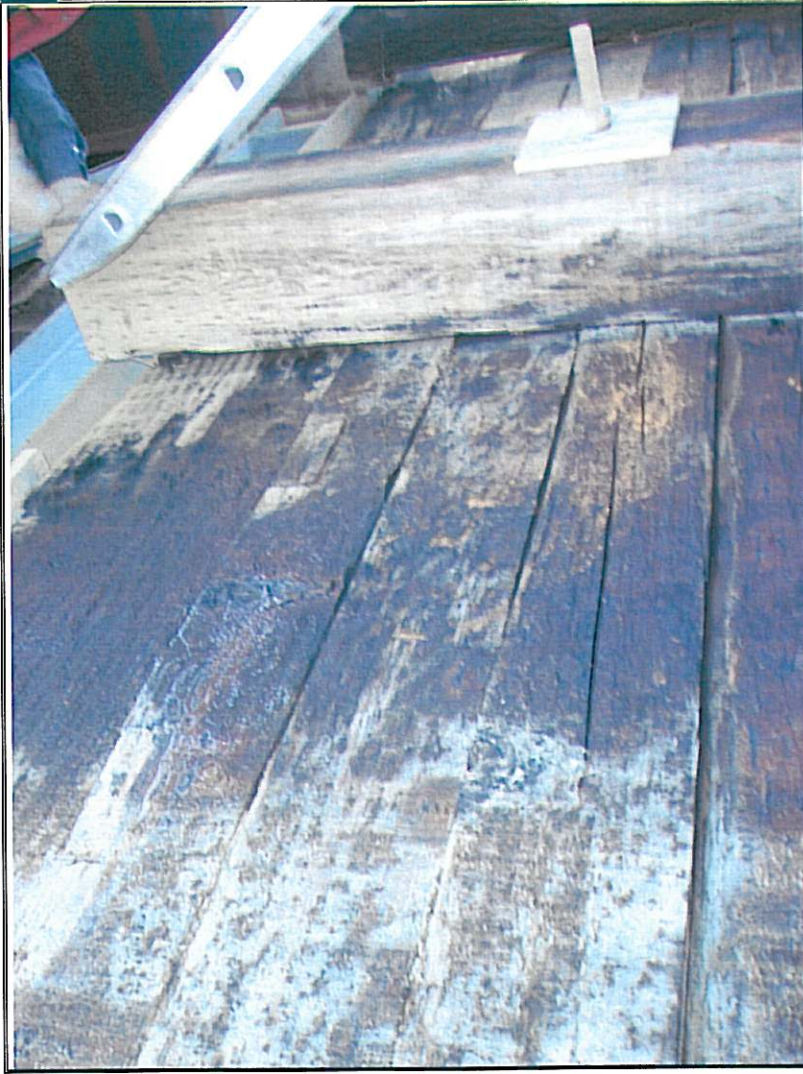
**Photo 8**

Separation between abutment planks and vertical post

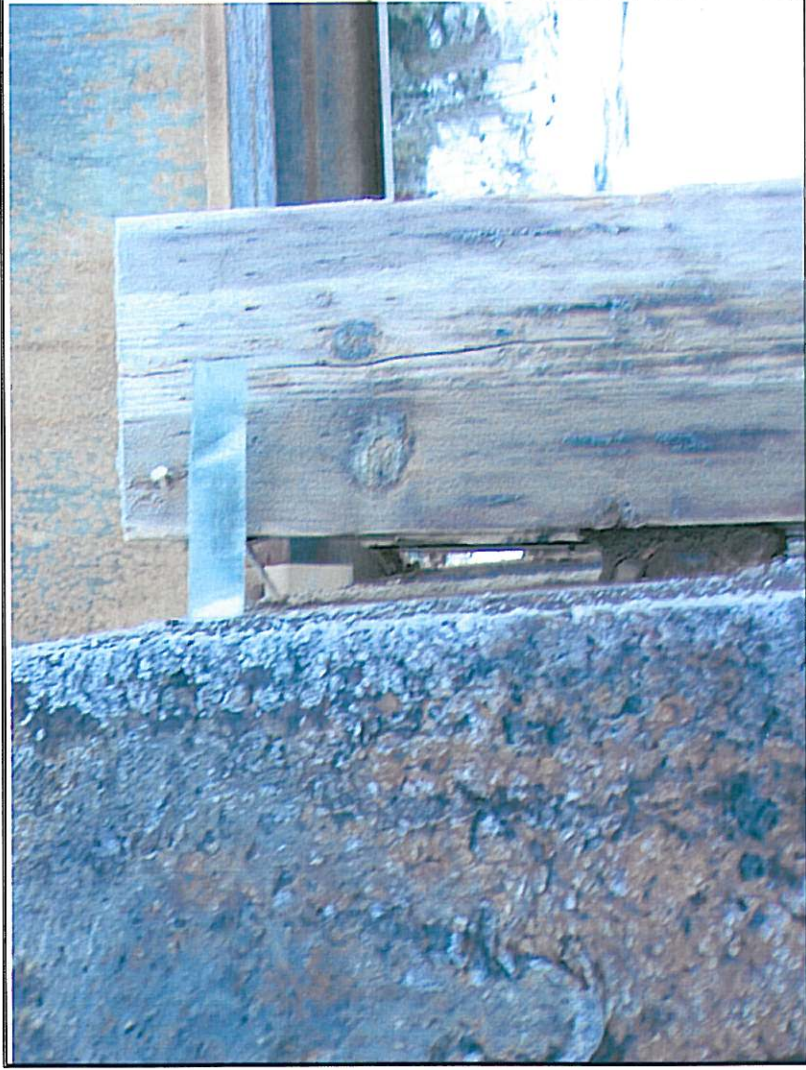
**Photo 9**

| | | | | Cribs | | 2 | | TREATED. LEANING TOWARDS RIVER, BUT STABLE SINCE 2003 | |

U/S monitoring device on D/C abutment. Not much change since 2003 (see Photo 10).

| REPAIR REQUIRED: <input checked="" type="checkbox"/> YES <input type="checkbox"/> NO | | REPAIR DESCRIPTION AND COST ESTIMATE:<br>ADD BRIDGE HAZARD DELINEATOR SIGNS<br>DOWNCHAIN ABUTMENT SHOWING SIGNS OF MOVEMENT, BEING MONITORED:<br>US MONITOR 2 3/8"<br>DS MONITOR 2 9/16" | | | | | | | |

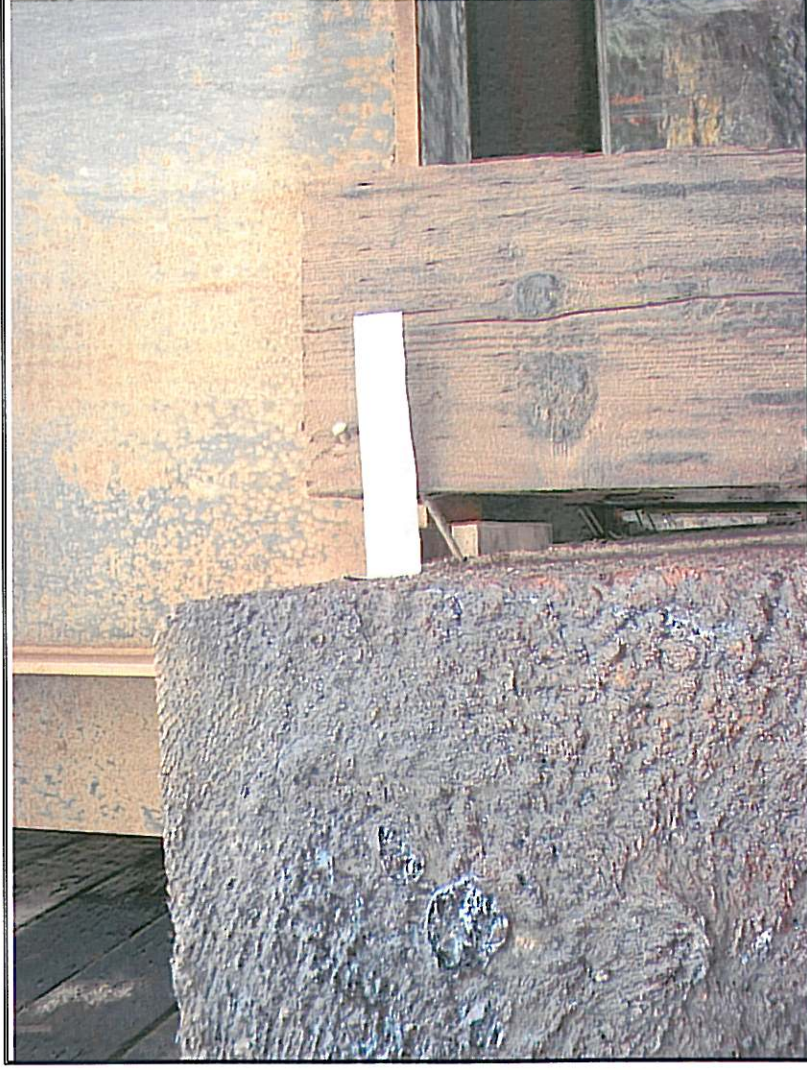
**Photo 10**

Photo at same location as Photo 9 from October 22, 2003.
