Our Job #: 2331-00505-0 Task 2000

November 14, 2003

**Chelaslie River Bridge @ 18 km on the Chelaslie FSR  
ABUTMENT INSPECTION REPORT**

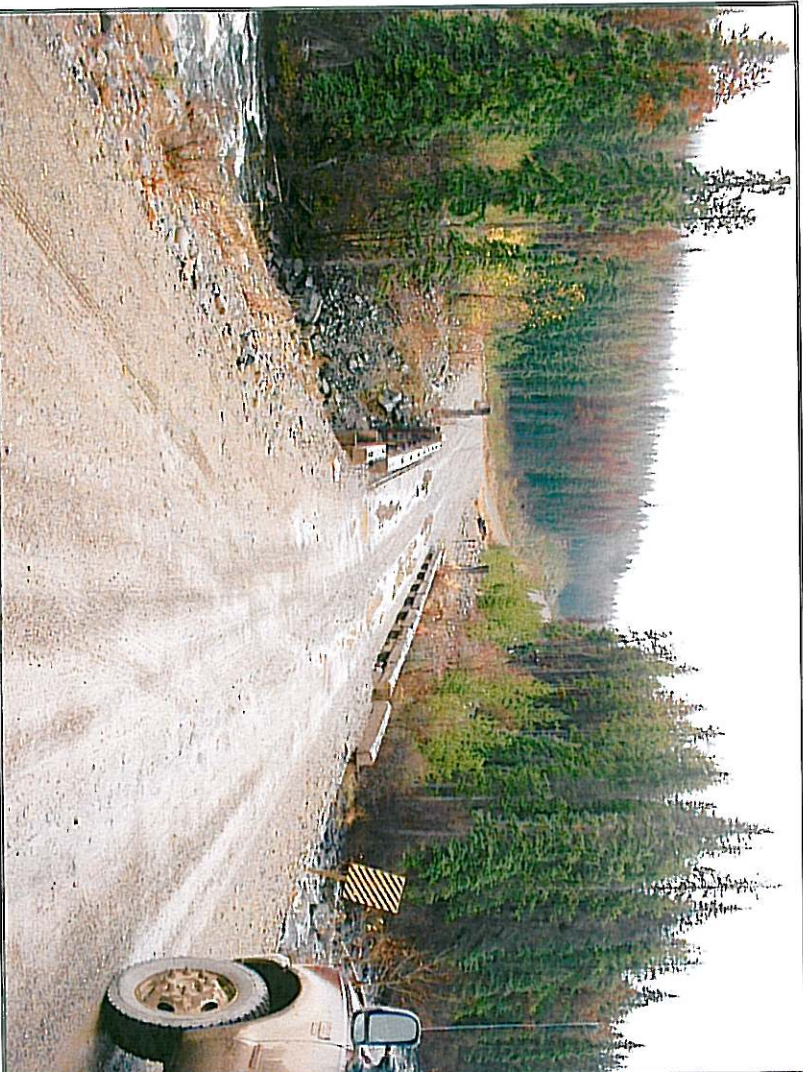
**Photo 1**

Chelaslie River Bridge, looking west across the bridge.

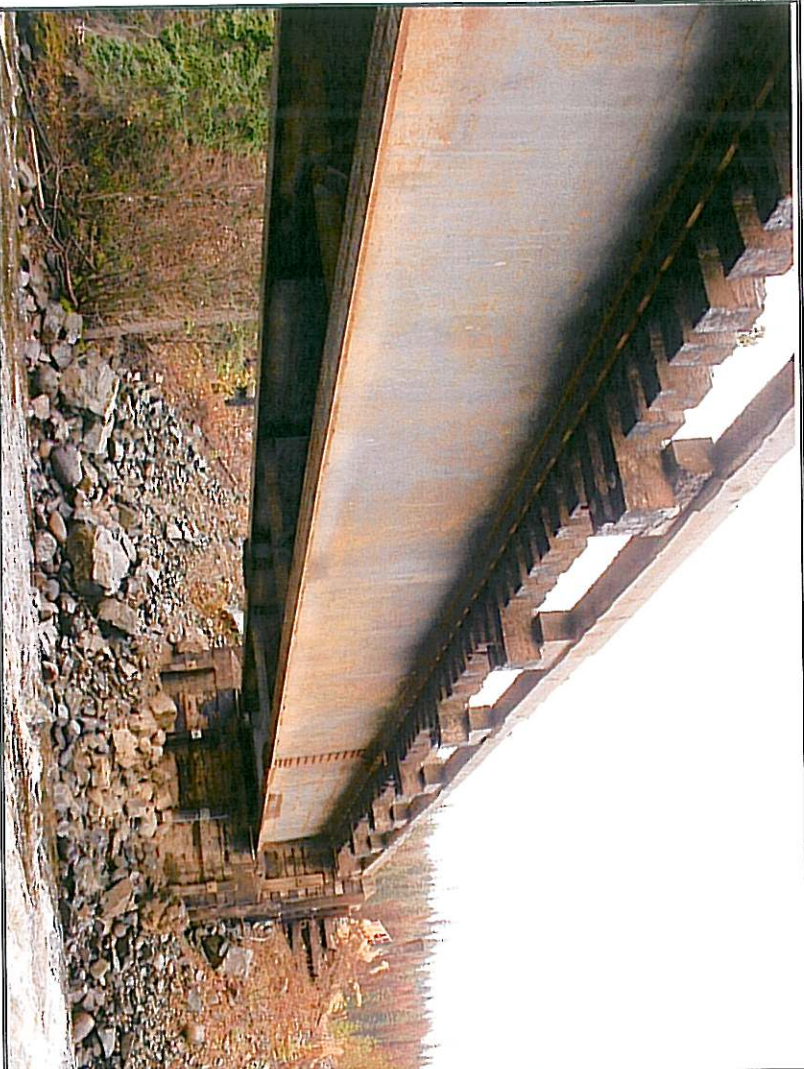
**Photo 2**

North (upstream) side of the bridge, looking towards the west abutment.

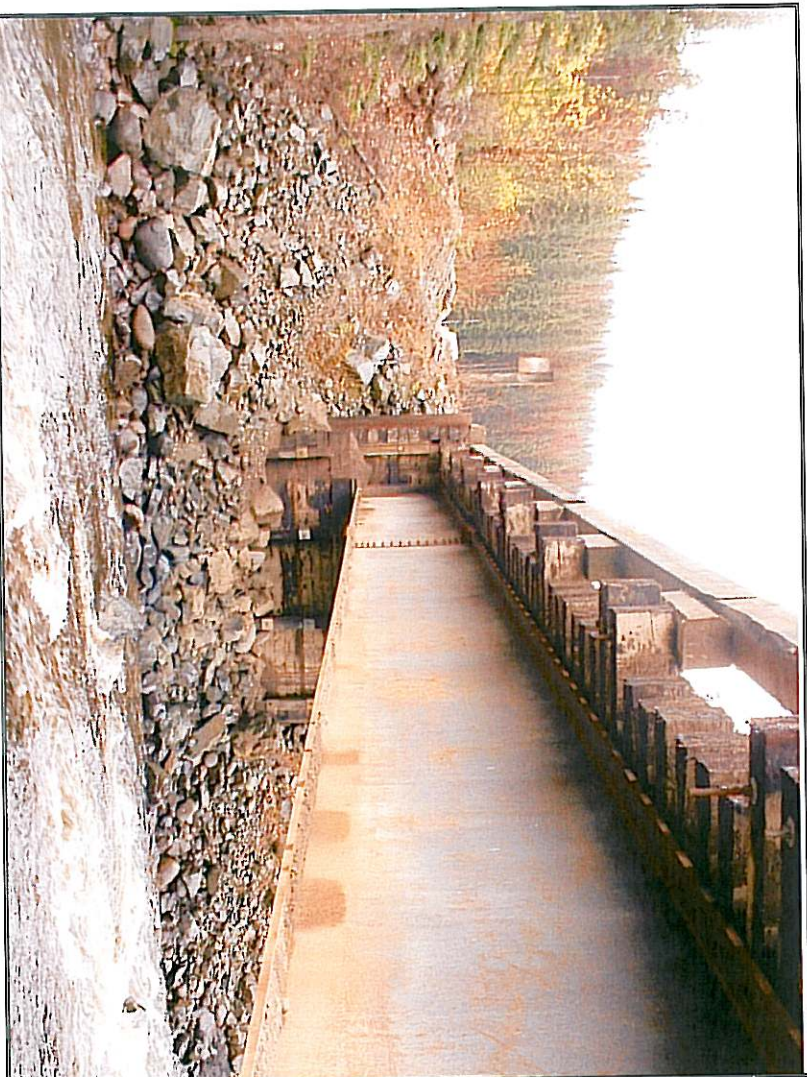
**Photo 3**

South (downstream)  
side of the bridge,  
looking towards the  
west abutment.

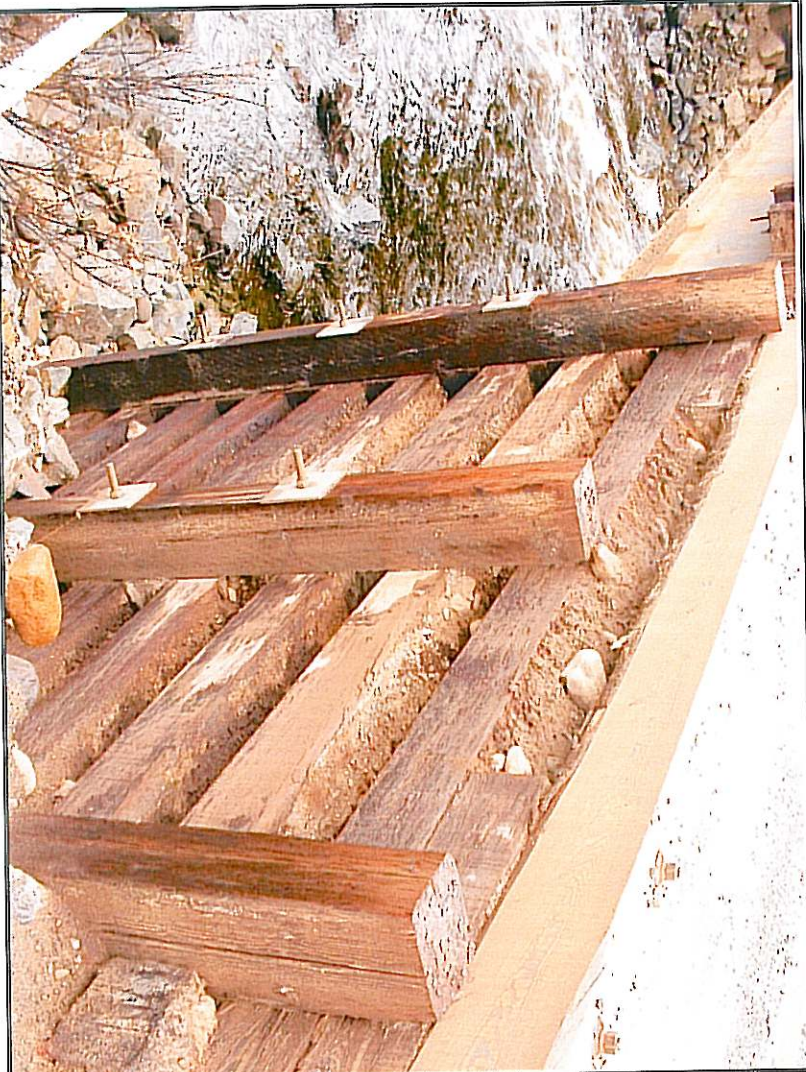
**Photo 4**

Southeast abutment  
crib wall.

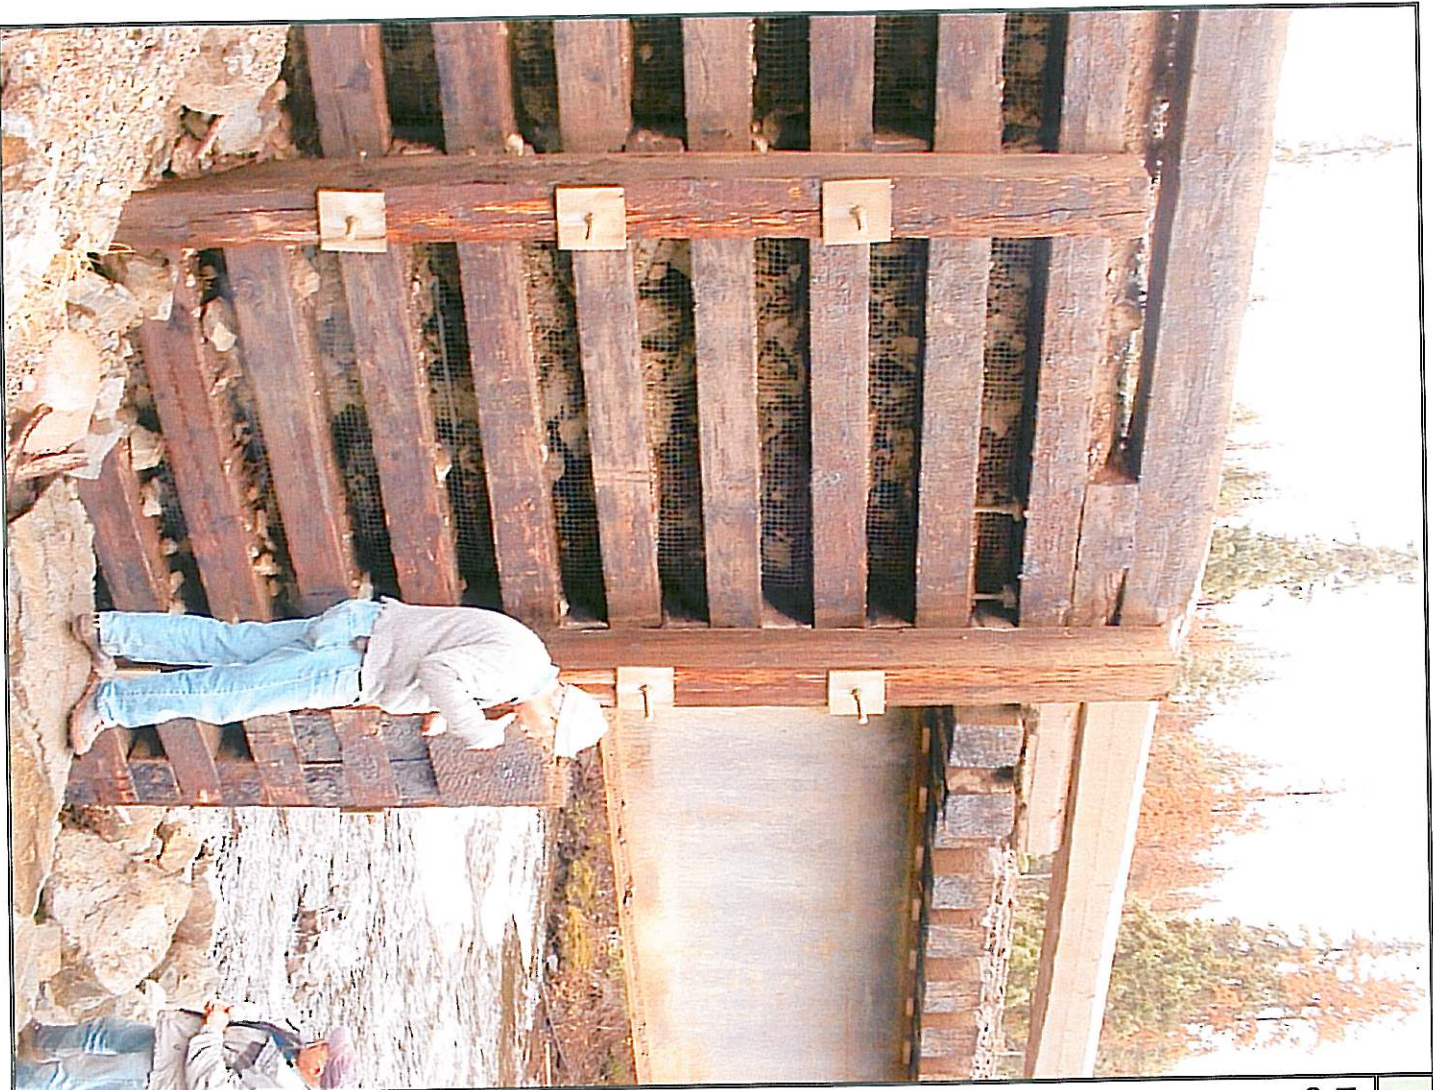
**Photo 5**

Northeast abutment  
crib wall.

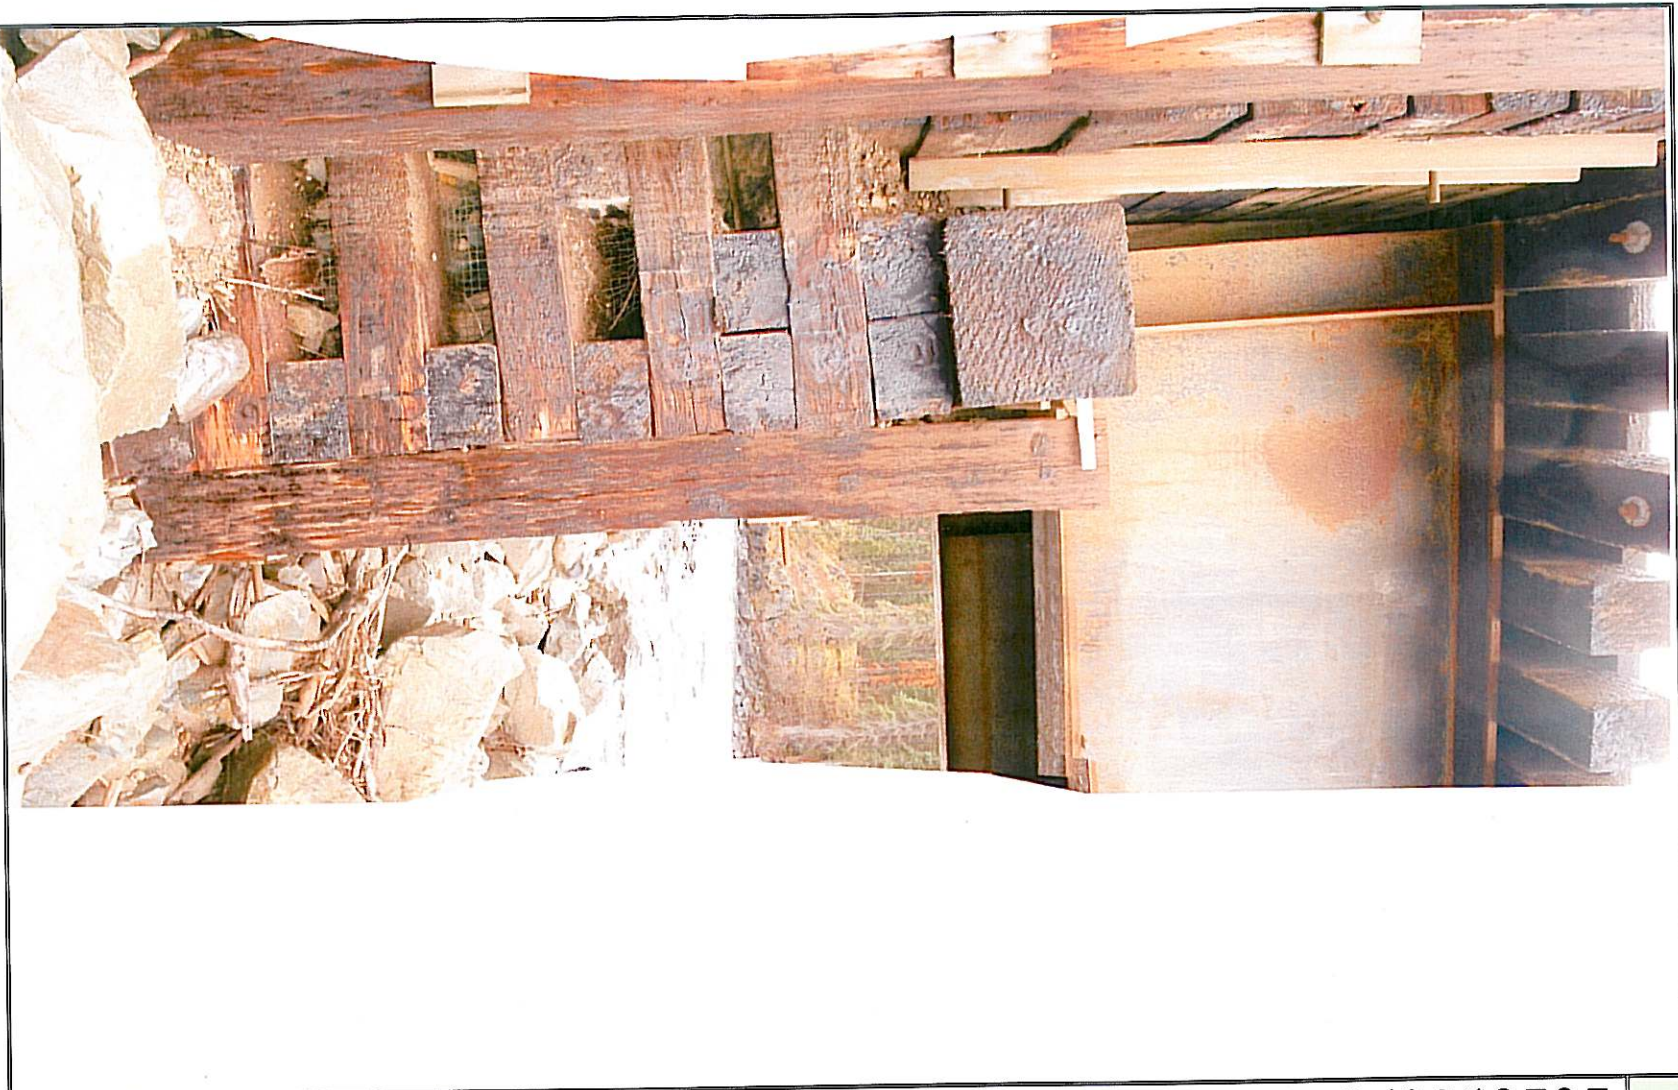
**Photo 6**

The anchor bolts are at their maximum position in the slotted holes on the east abutment due to the shifting. The restraint provided by the bridge girders and the slotted holes in the base plates is causing the timber sill to separate from the crib. The fact that one of the west abutment anchor bolts has failed and the others appear bent indicates that the bridge has, in the past, reached the maximum position at the west abutment as well. However, at the moment, the west abutment anchor bolts are approximately centered in the slotted holes. This would seem to indicate that at the time of the inspection, the bearings were not overstressed. The thermal expansion and contraction of the bridge superstructure is not sufficient to cause the damage to the anchor bolts as there would only be 21 mm of movement between -36°C and +26°C (maximum and minimum mean temperatures for the area taken from the Canadian Highway Bridge Design Code). Thermal expansion and contraction would also not be sufficient to pull the abutments in towards the river because the slotted holes have more than 21 mm of gap available.

Looking south at the east abutment bearing. Abutment crib is leaning in towards the bridge (the photo is distorted slightly). This 18" x 18" timber sill is being restrained by the steel girder and is separating from the crib.

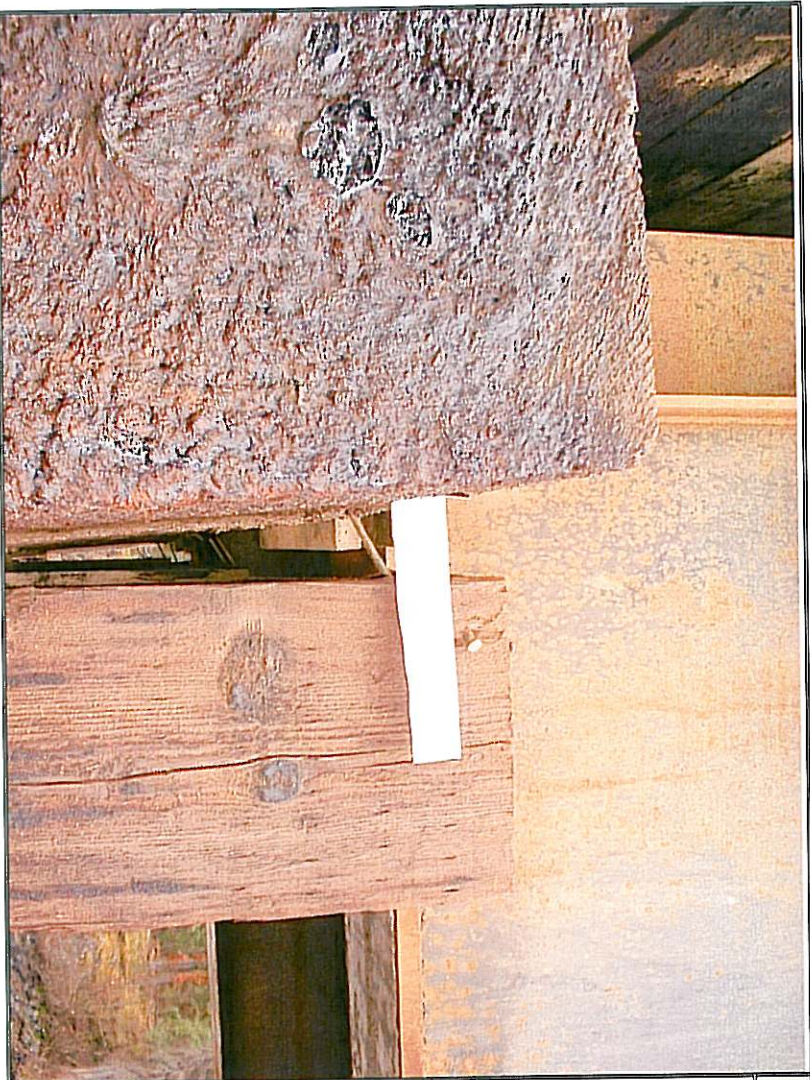
**Photo 7**

The structure was constructed in 1983. The structures were inspected by others in 1999 and 2001, and there were no reports of movement at the abutments. This spring, FLS noticed the separation between the timber sills and the east abutment cribbing (Photo 7) and installed measuring strips on the abutment to monitor the amount of movement. FLS reports that since May, there has been an additional 1/8" of movement of the measuring strips on the east abutment.

Close-up photo showing the separation of the timber sill from the vertical member of the crib on the north side of the east abutment. A measuring strip has been installed to monitor the separation.

The east abutment should be monitored every three months from the date of the last inspection to determine the rate of movement. Readings from the measurement strips installed on the east abutment should be taken along with the temperature at the time of the reading. If the structure continues to move, an engineer should be notified.

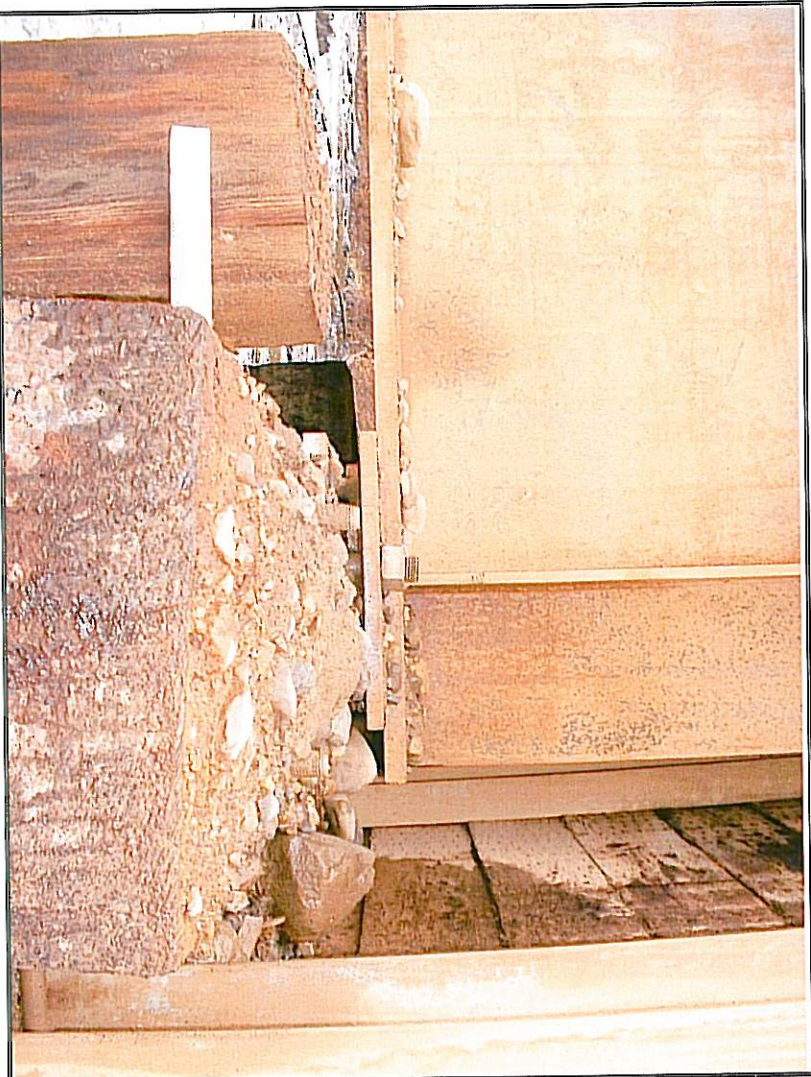
**Photo 8**

Looking north along the top of the east abutment timber sill. A measuring strip has been installed on this side of the bridge as well to monitor the separation. The sloping of the crib towards the girder can be seen accurately in this photo.

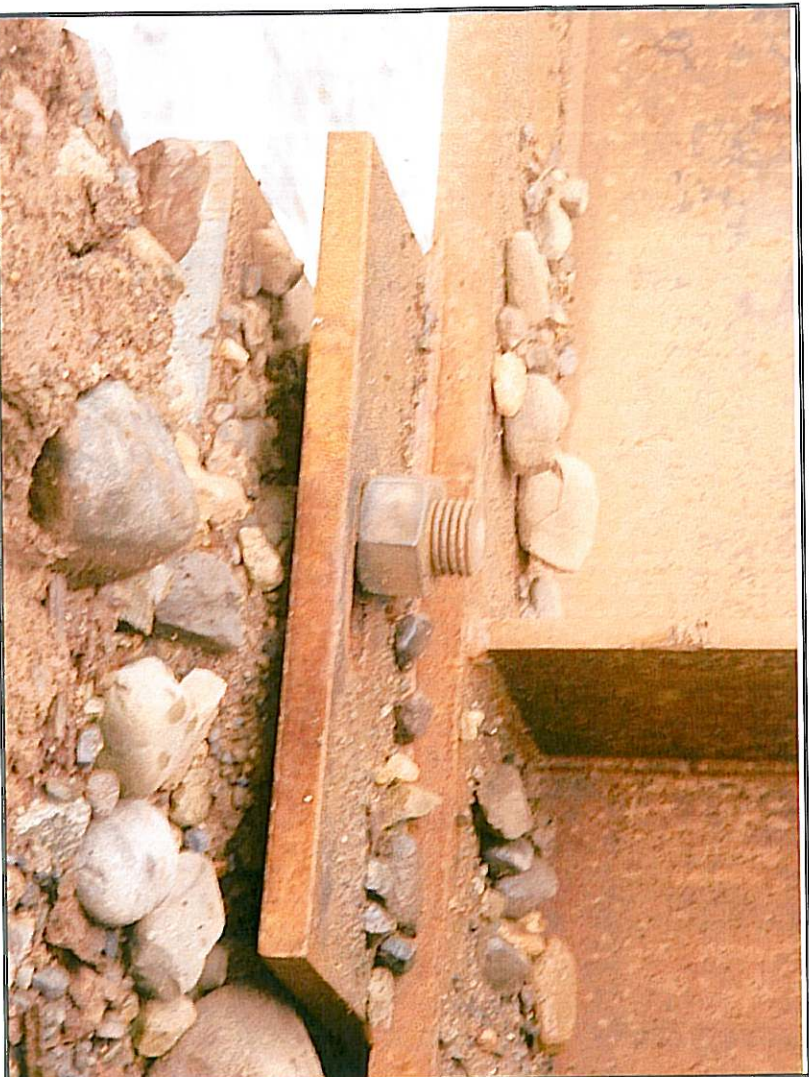
**Photo 9**

Top of the anchor bolt on the south side of the east abutment. The bolt is at its maximum position in the slotted hole and appears to be slightly bent.

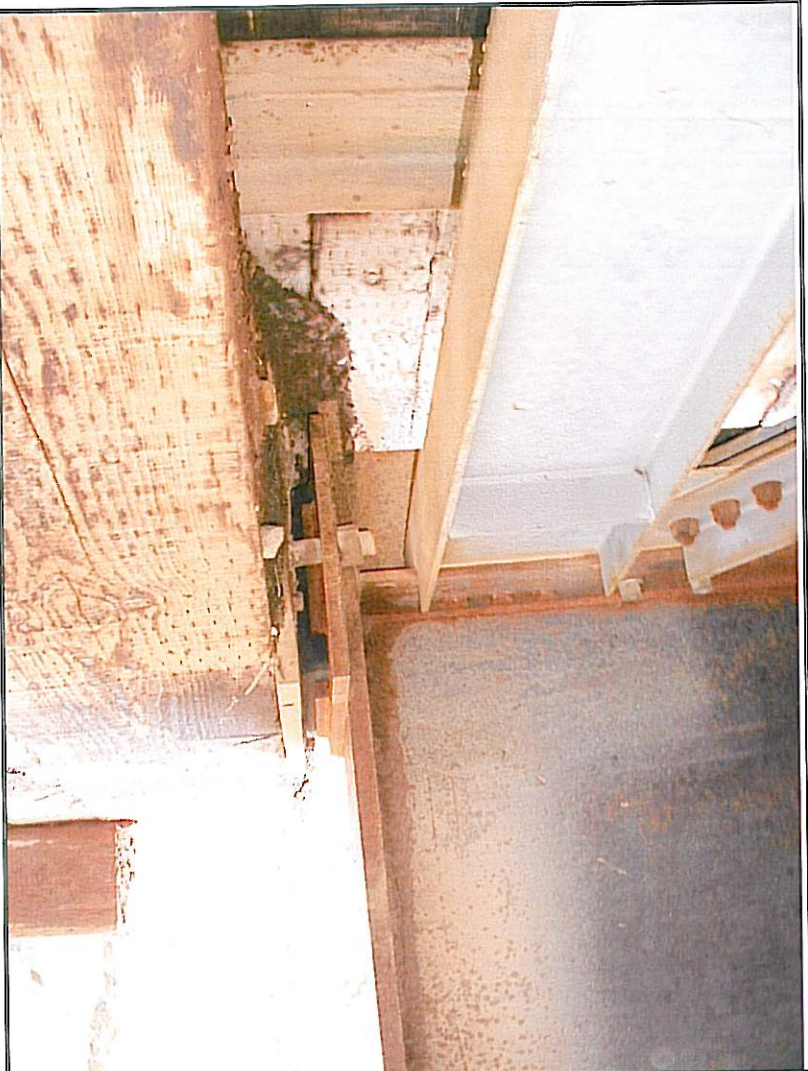
**Photo 10**

Anchor bolt on the north girder at the west abutment. Bolt appears to be bent, but it is centered in the slotted hole indicating that it has previously been maxed out. The anchor bolt on the other side of this girder has been snapped off.

Rather than replacing the broken anchor bolt at the west abutment, horizontal guides angles could be easily installed on the outsides of the bearings to allow longitudinal movement of the bridge and provide lateral restraint. This would be a more effective fix than replacing the broken anchor bolt.

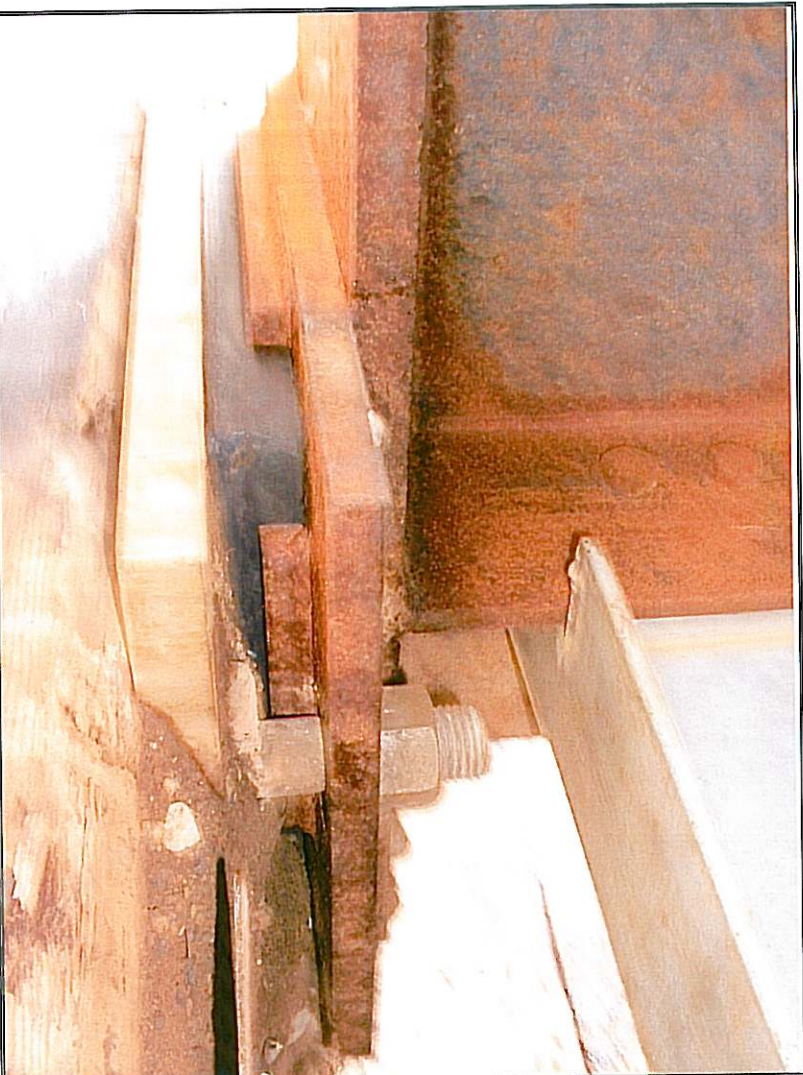
**Photo 11**  
Anchor bolt at the south girder of the west abutment. The bolt is centered in the slotted hole.

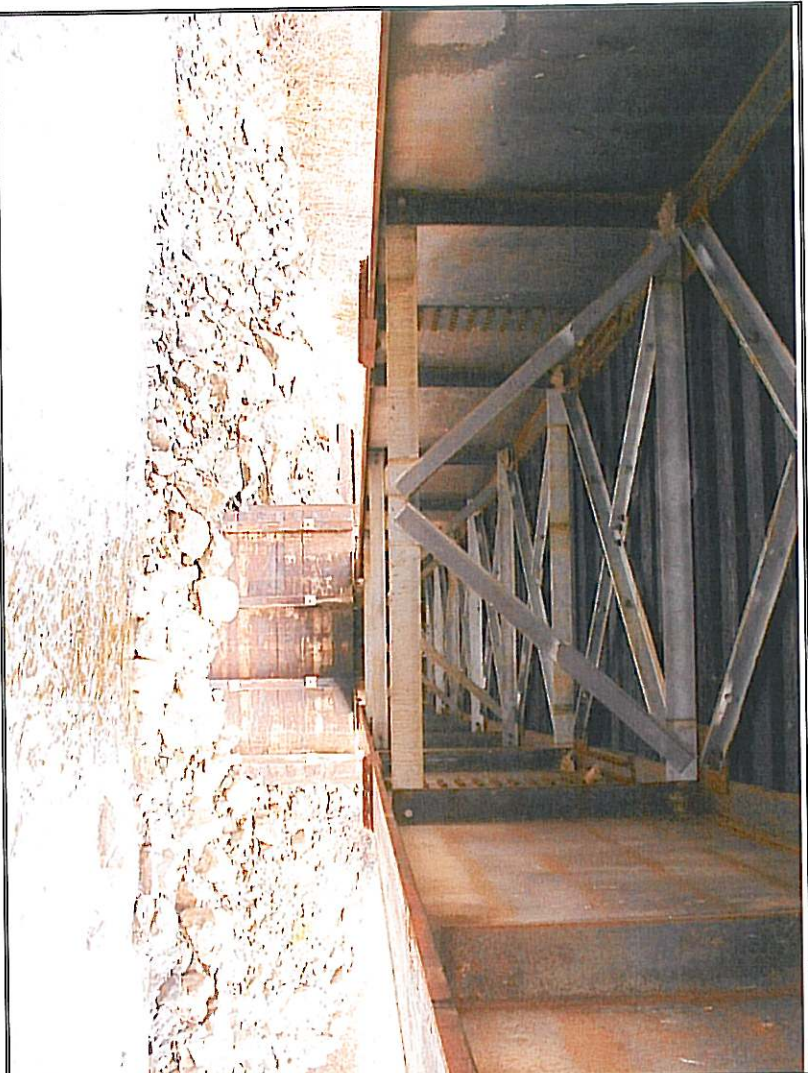
**Photo 12**  
Looking east towards the east abutment underneath the bridge.

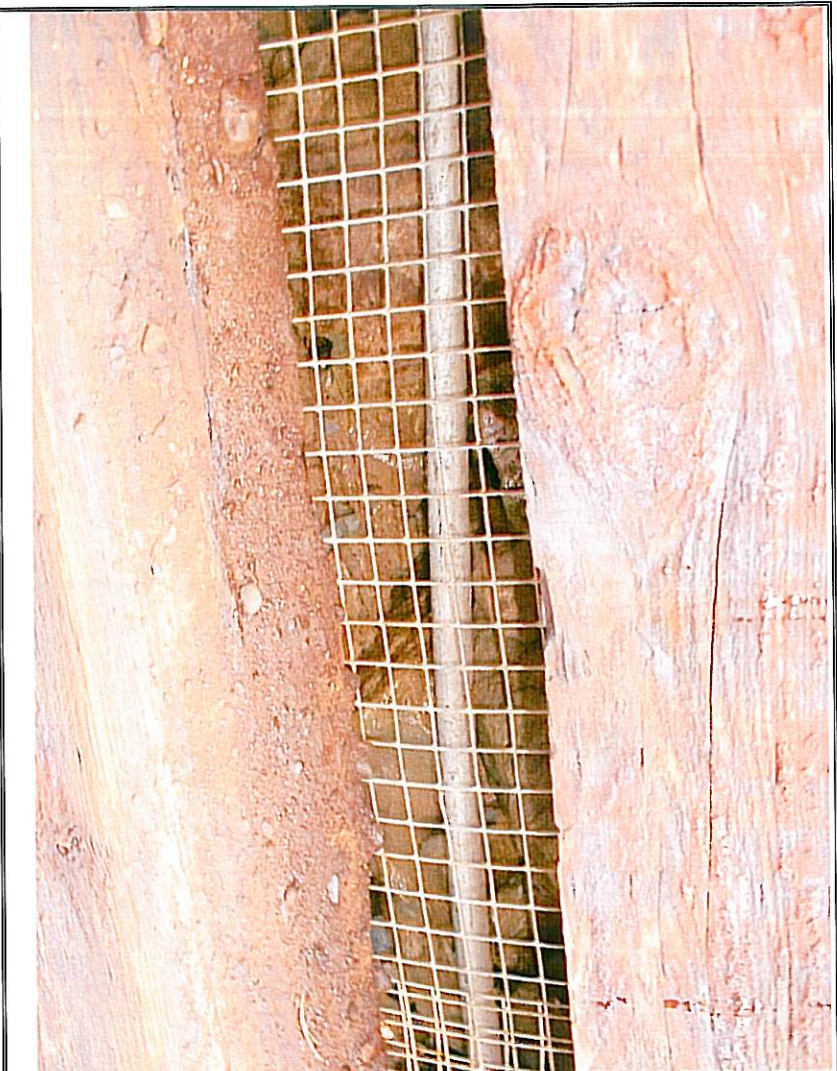
**Photo 13**

Galvanized tie-rod visible inside the abutment cribbing. The rod appears to be in good condition.
