BRIDGE INSPECTION REPORT  
STEEL/CONCRETE/GLULAM, INSPECTION SUMMARY

| STRUCTURE NO. | | ROAD: CHESLASIE FSR | | KM: 18 | | PAGE 1 OF 1 | |
| CROSSING: CHELASIE RIVER | | DISTRICT: LAKES | | PROJECT NO 2331-00505-1 | | | |

## Chelastlie River Bridge Inspection

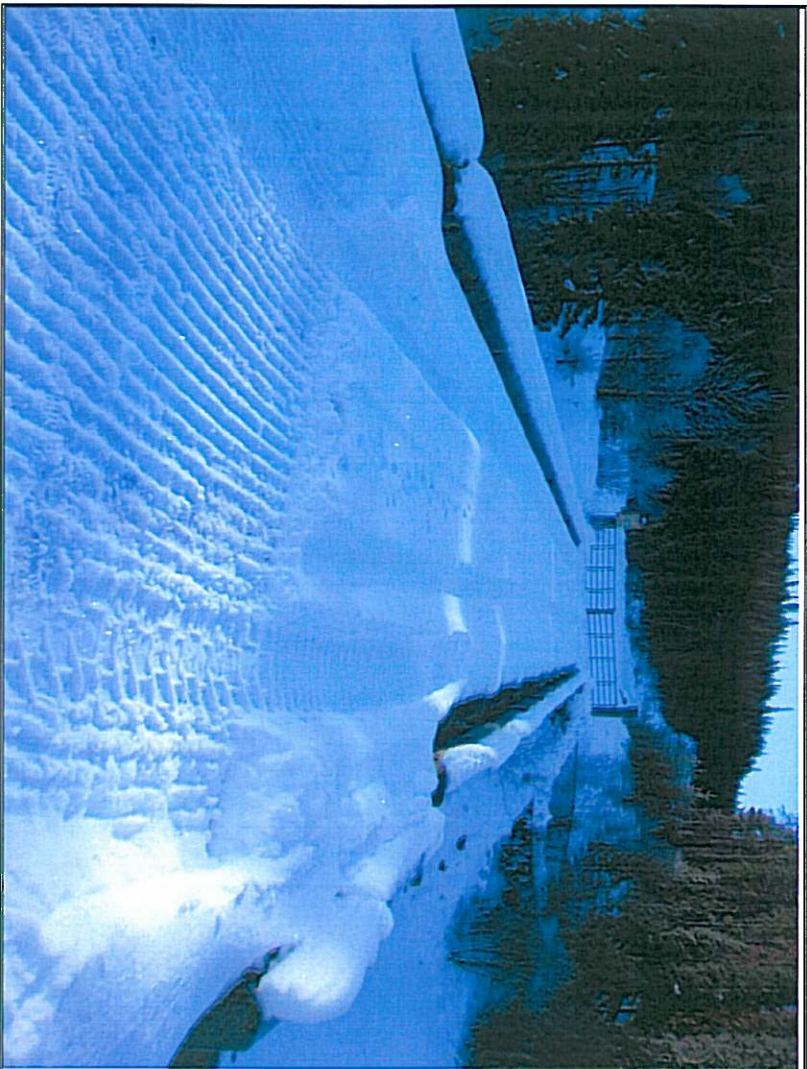
**Photo 1**

Looking upchain  
across bridge.

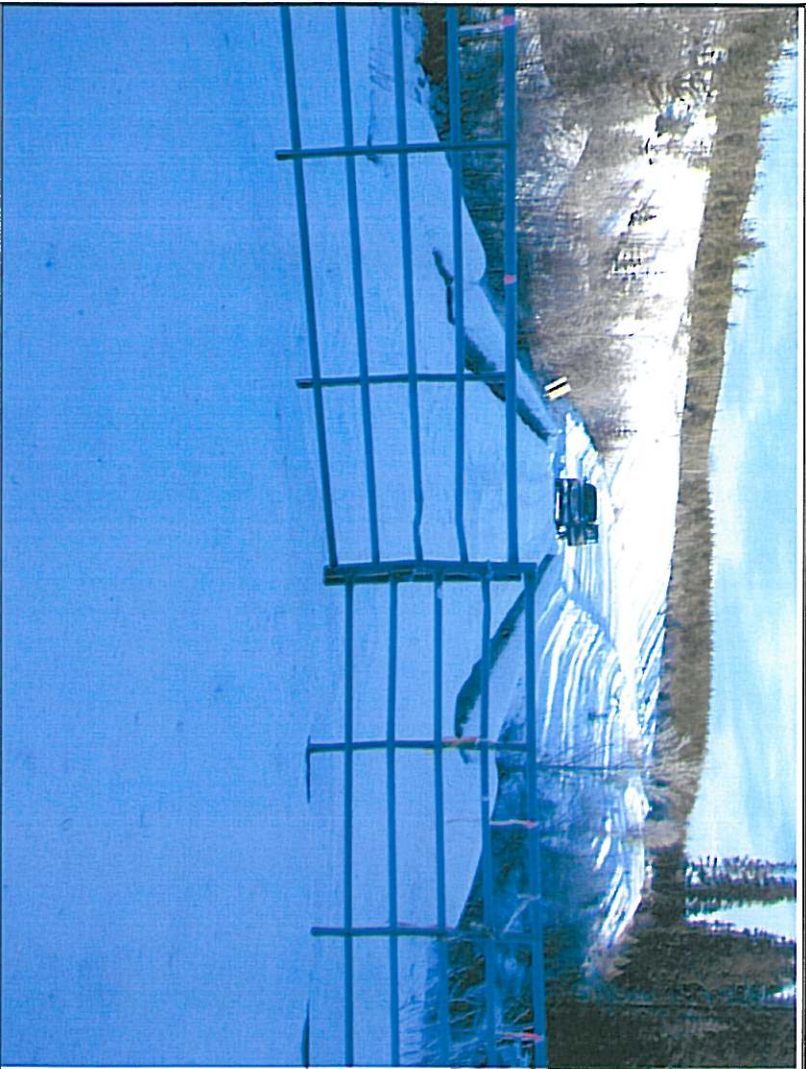
**Photo 2**

Looking downchain  
across bridge.

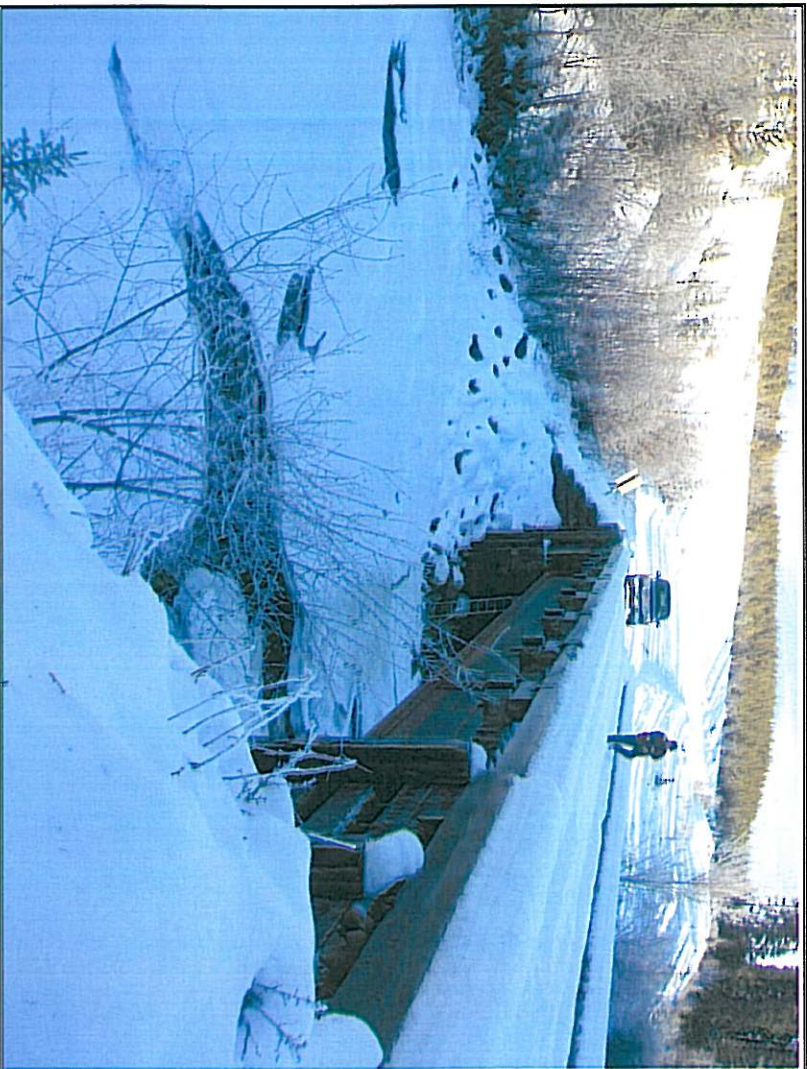
**Photo 3**

Downstream side of bridge.

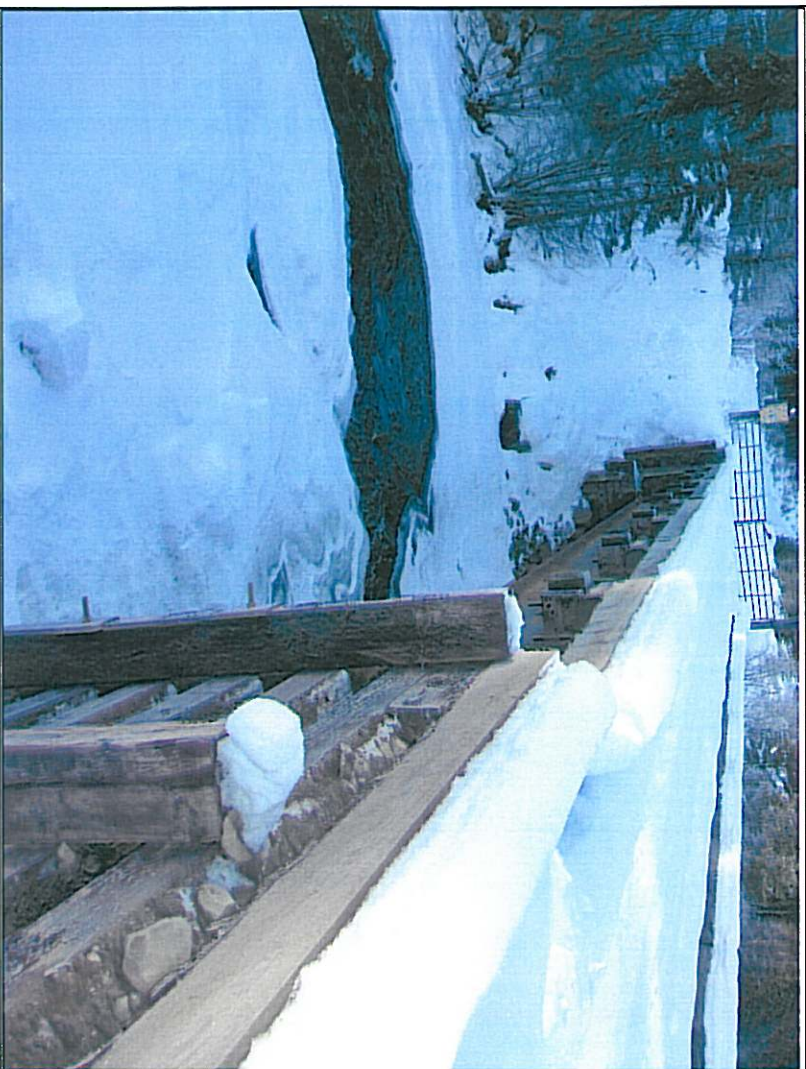
**Photo 4**

Upstream side of bridge.

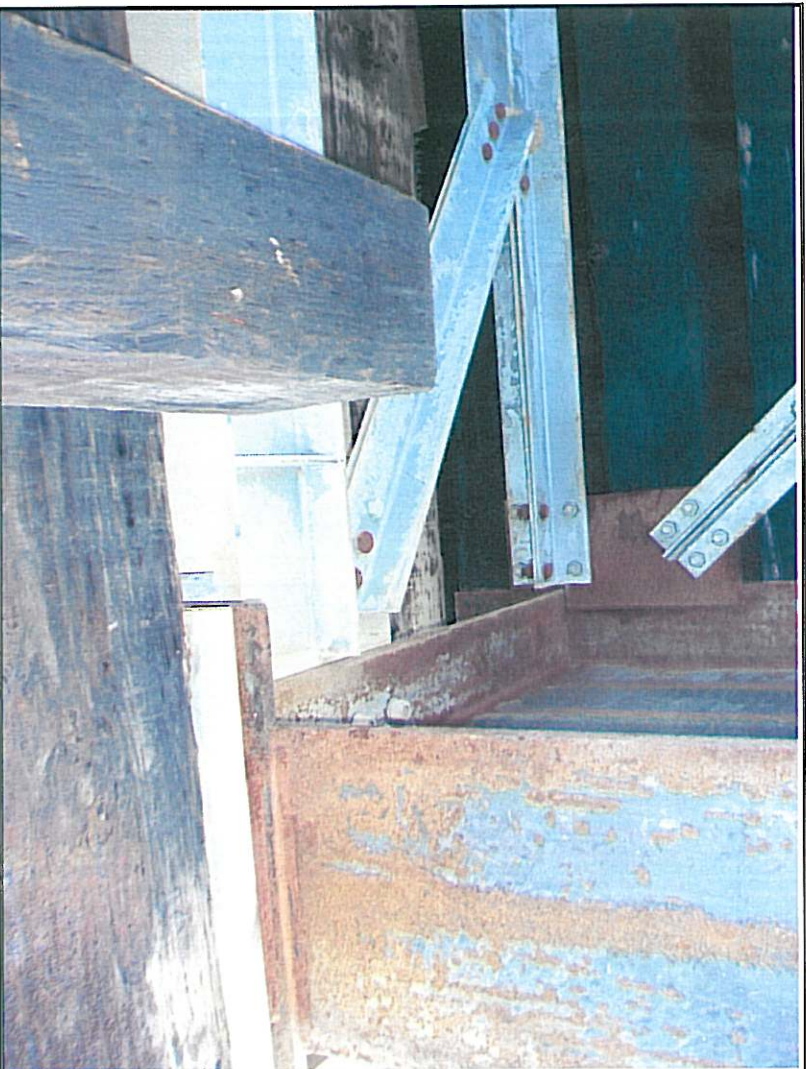
**Photo 5**

| Bracing | | 2 | | ONE BOLT LOOSE D/C DIAPHRAGM. ONE SPACER PLATE MISSING. | | | |

Spacer plate missing on D/S D/C corner bracing. Not a structural concern.

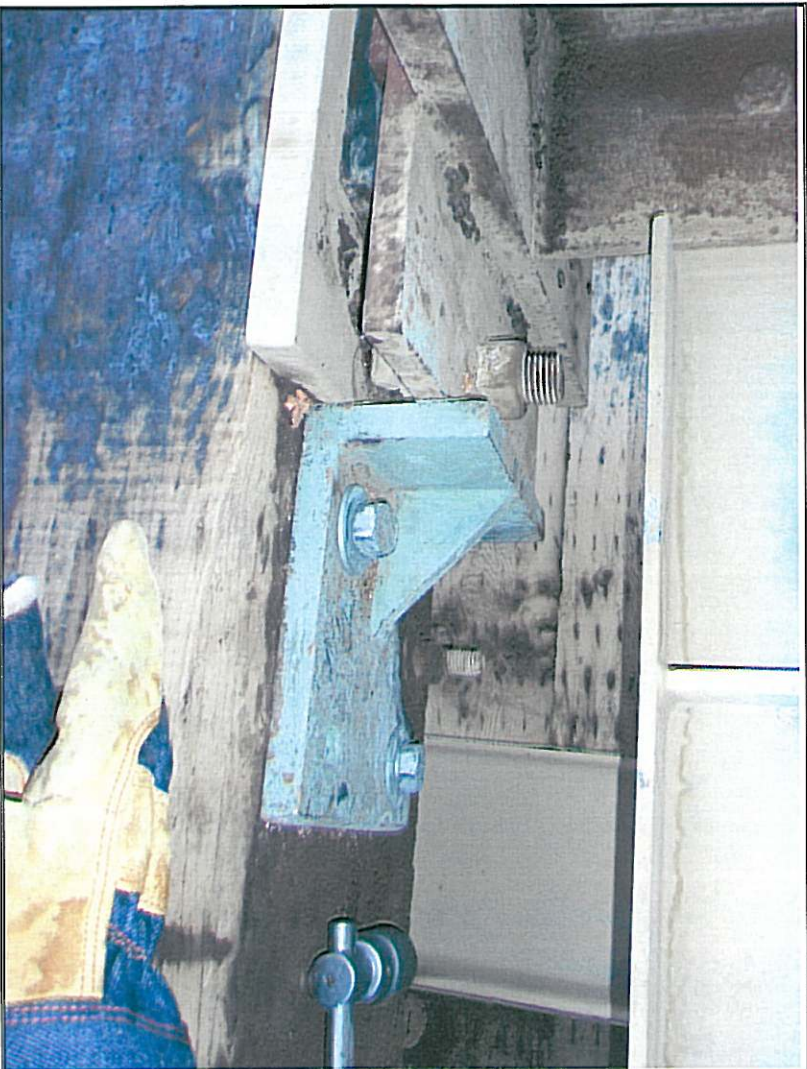
**Photo 6**

U/S D/C inside bearing plate keeper.

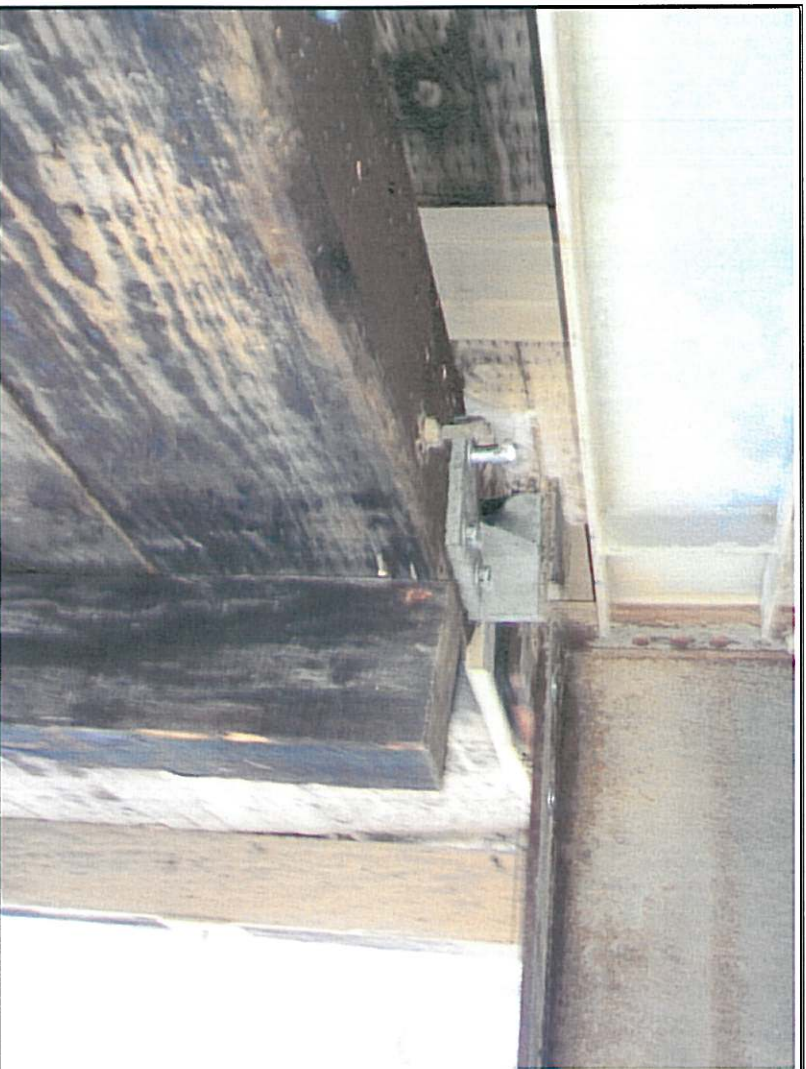
**Photo 7**

D/S D/C bearing plate keeper. 1 bolt still to be tightened.

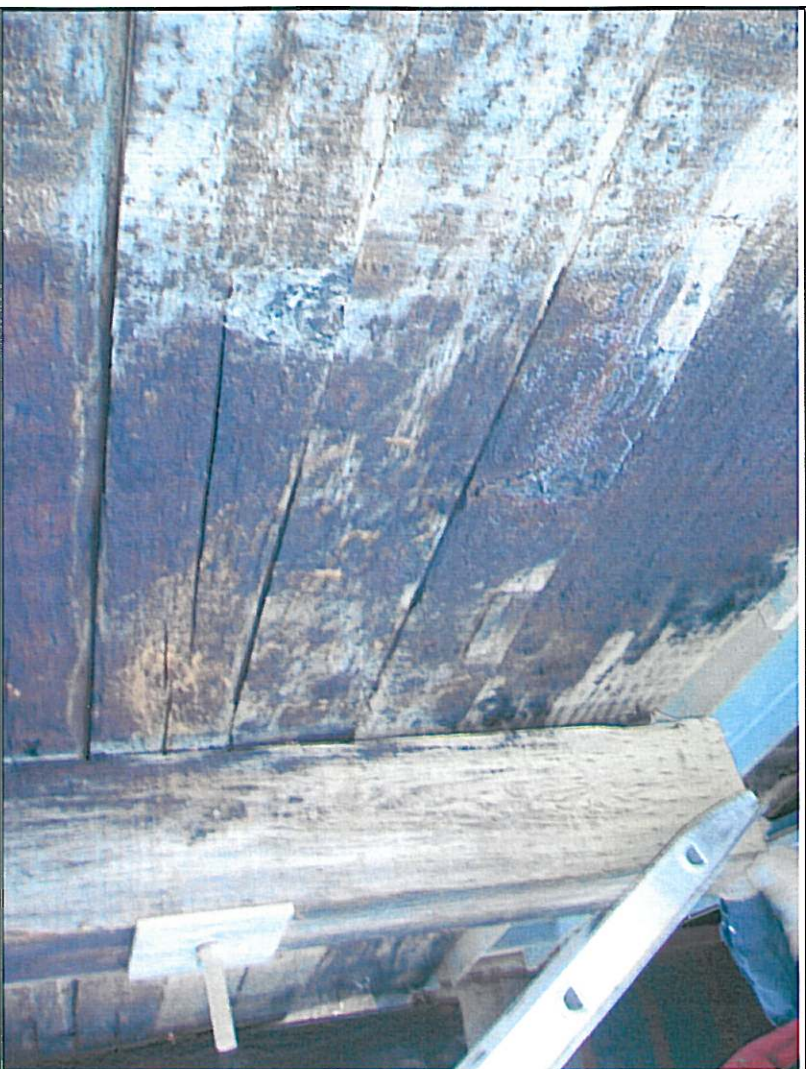
**Photo 8**

Separation between abutment planks and vertical post

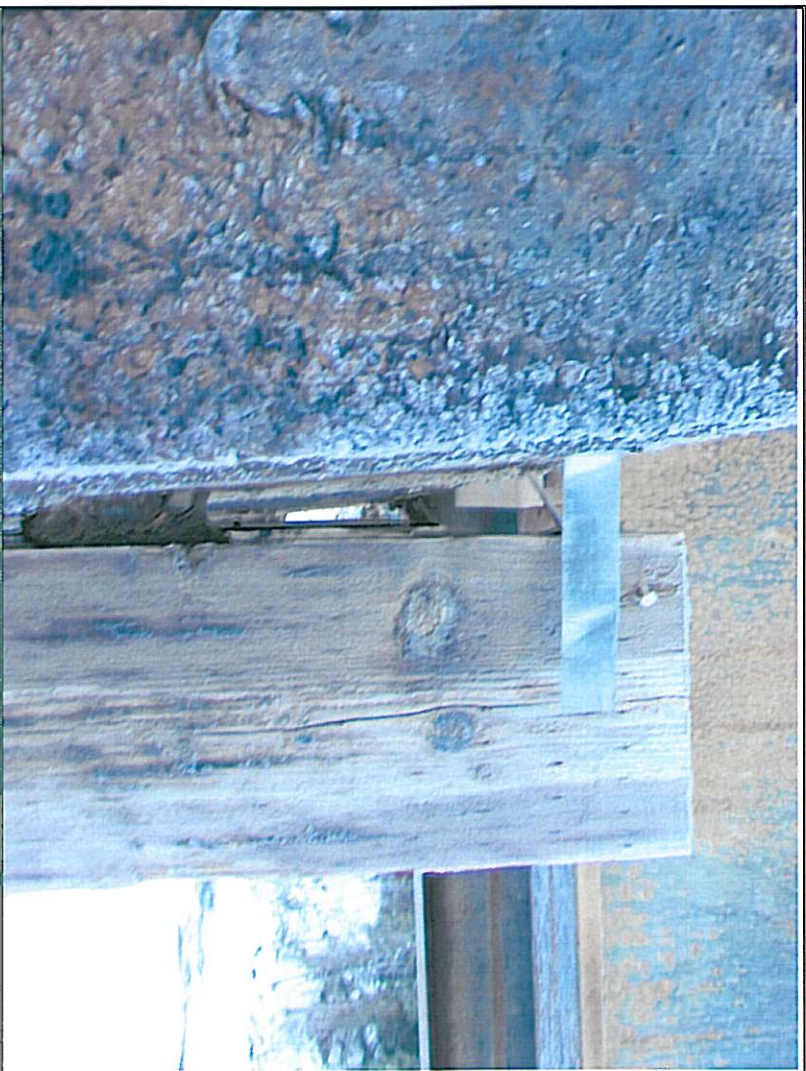
**Photo 9**

| PROFESSIONAL INSPECTION <input type="checkbox"/> YES <input checked="" type="checkbox"/> NO | ADD BRIDGE HAZARD DELINEATOR SIGNS DOWNCHAIN ABUTMENT SHOWING SIGNS OF MOVEMENT. BEING MONITORED: US MONITOR 2 3/8" DS MONITOR 2 9/16" | | | | | | |

U/S monitoring device on D/C abutment. Not much change since 2003 (see Photo 10).

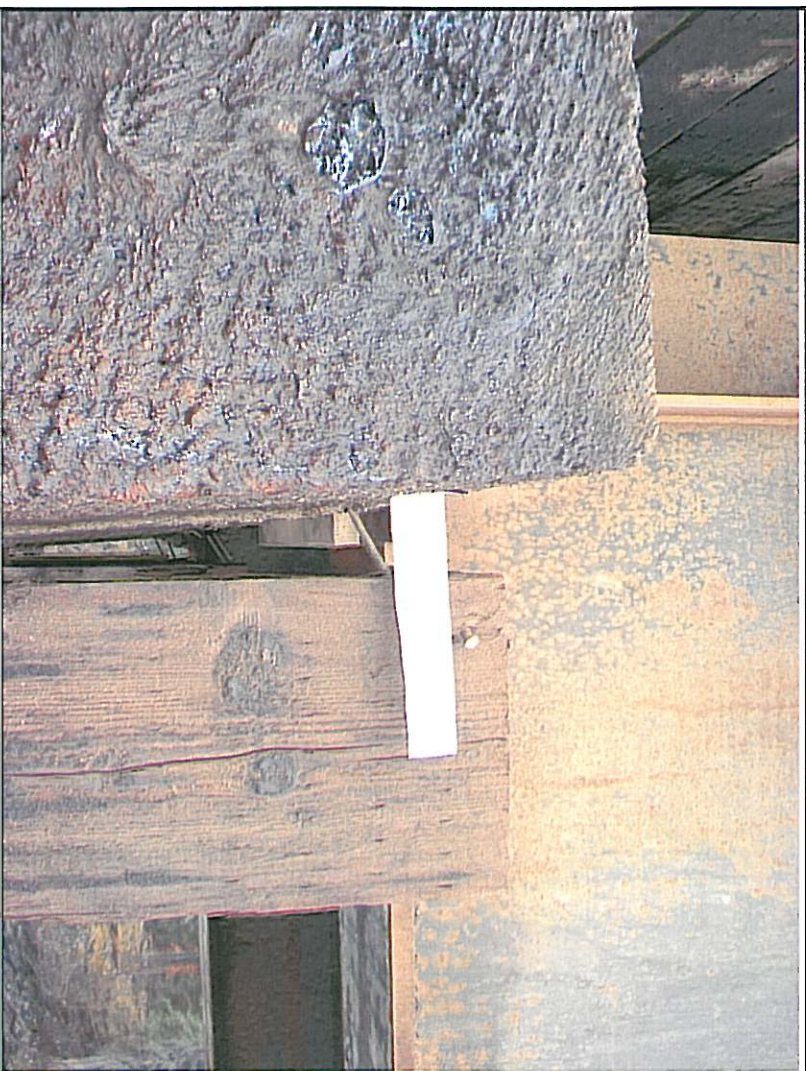
**Photo 10**

Photo at same location as Photo 9 from October 22, 2003.
