**From:** "Scott Loptson" <sloptson@mcelhanney.com>  
**To:** "Tom Olafson" <tom.olafson@westfraser.com>  
**Date:** 4/17/2006 11:51:24 AM  
**Subject:** Chelaslie Inspection Report

## Chelaslie River Bridge Inspection

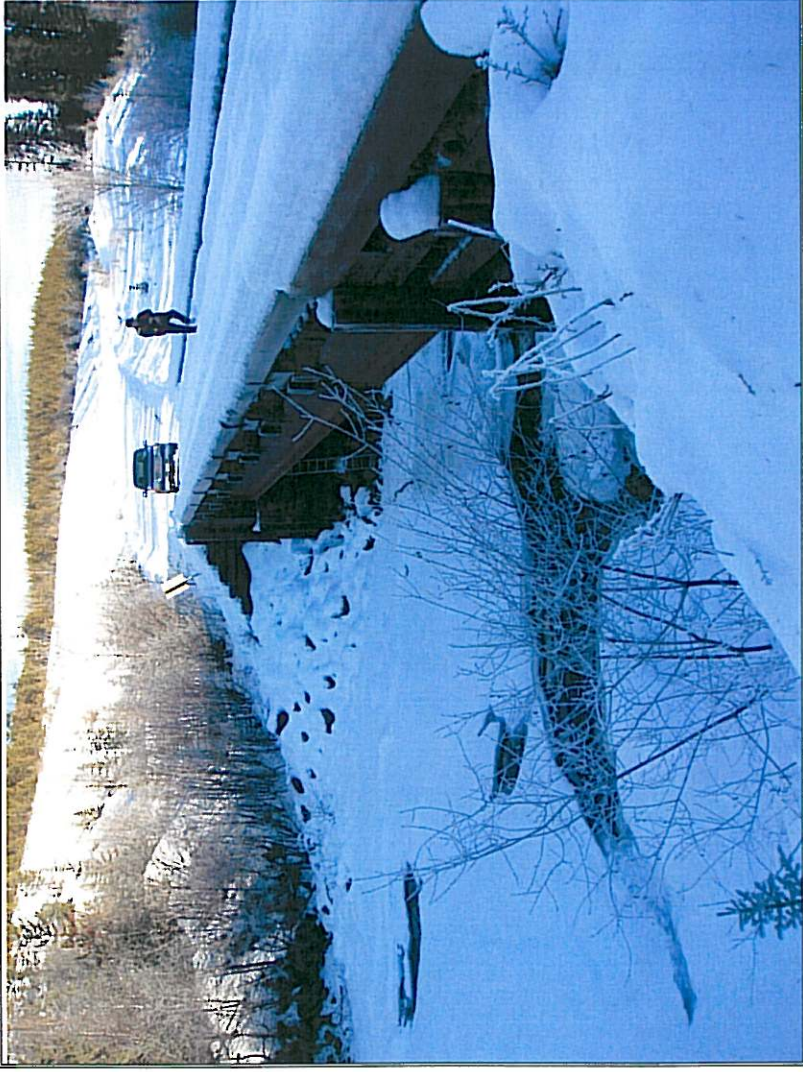
**Photo 3**

Downstream side of bridge.

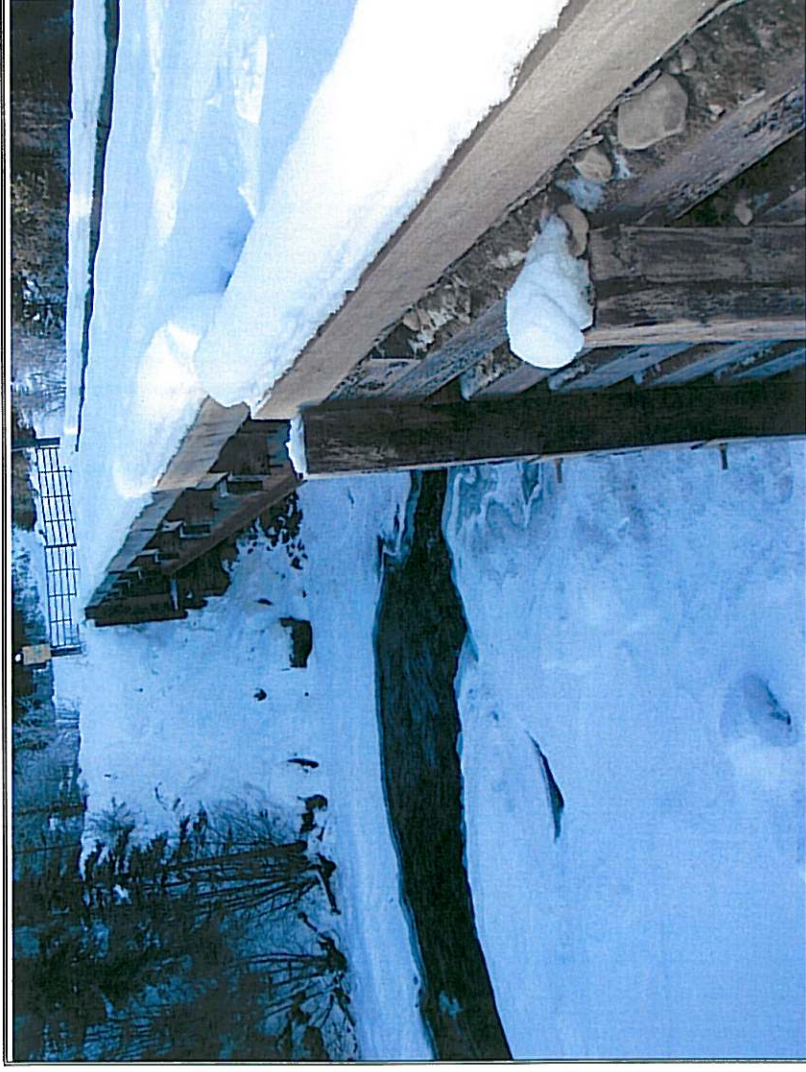
**Photo 4**

Upstream side of bridge.

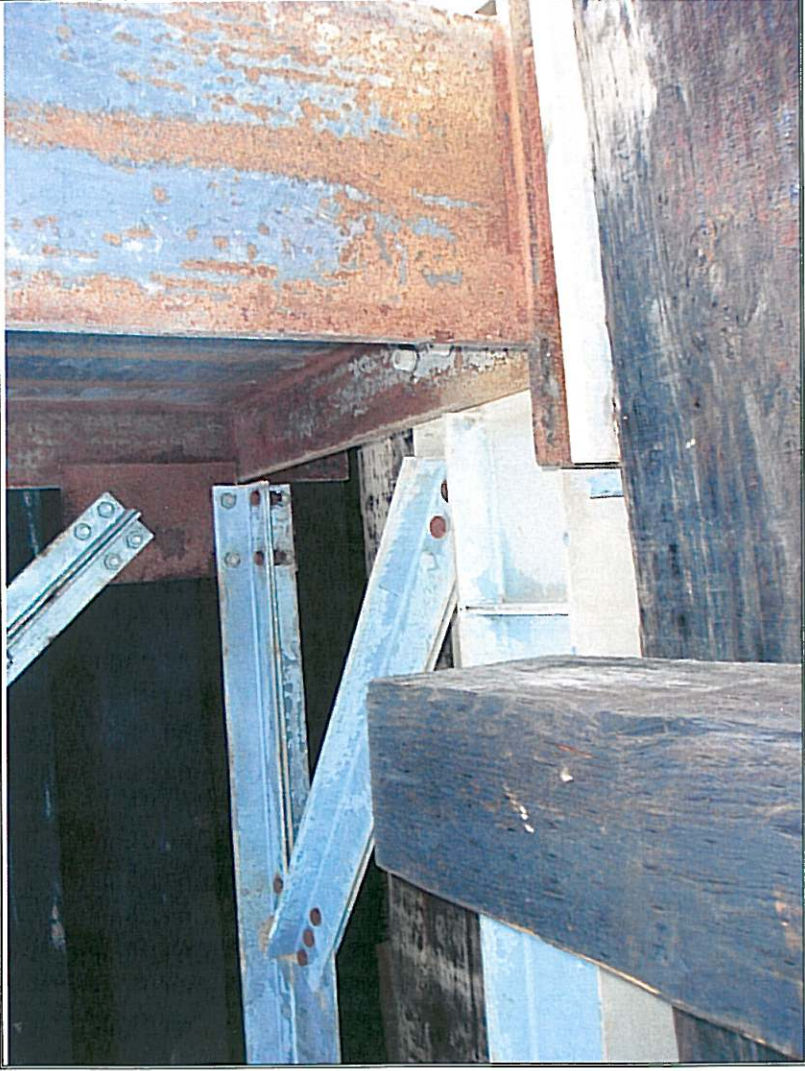
**Photo 5**

| BRIDGE ELEMENT | | CONDITION | REMARKS |
|---|---|---|---|
| | Bracing | 2 | ONE BOLT LOOSE D/C DIAPHRAGM. ONE SPACER PLATE MISSING. |

Spacer plate missing on D/S D/C corner bracing. Not a structural concern.

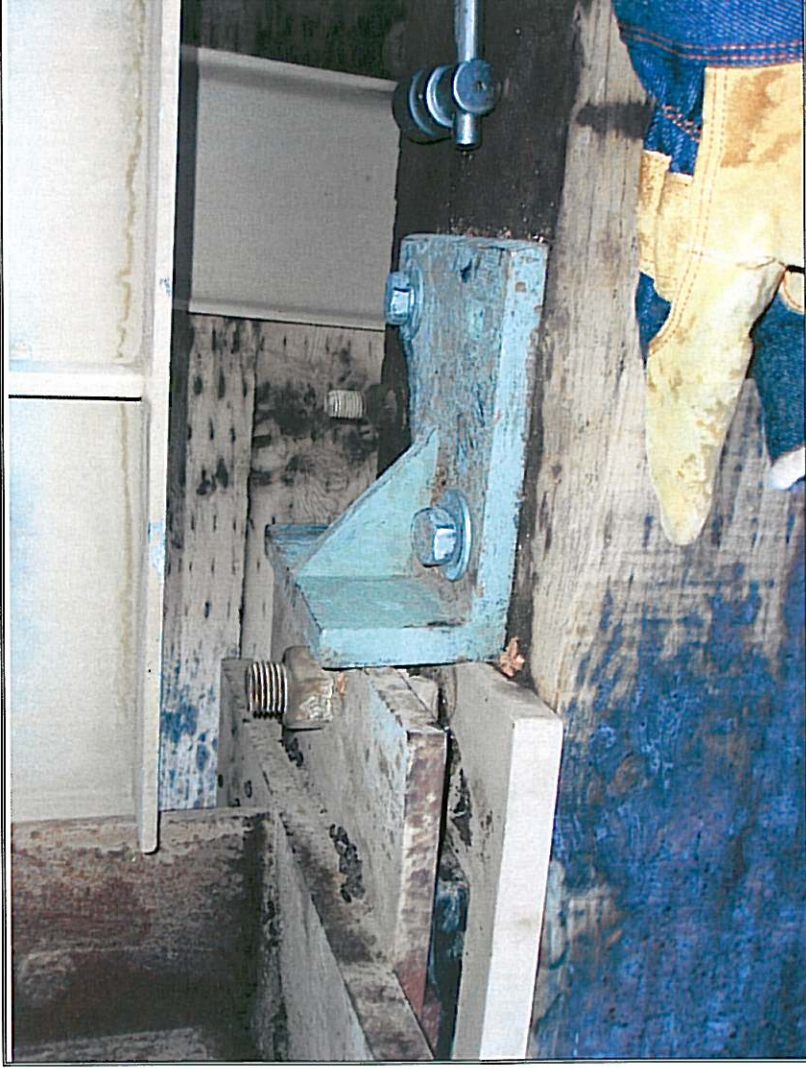
**Photo 6**

U/S D/C inside bearing plate keeper.

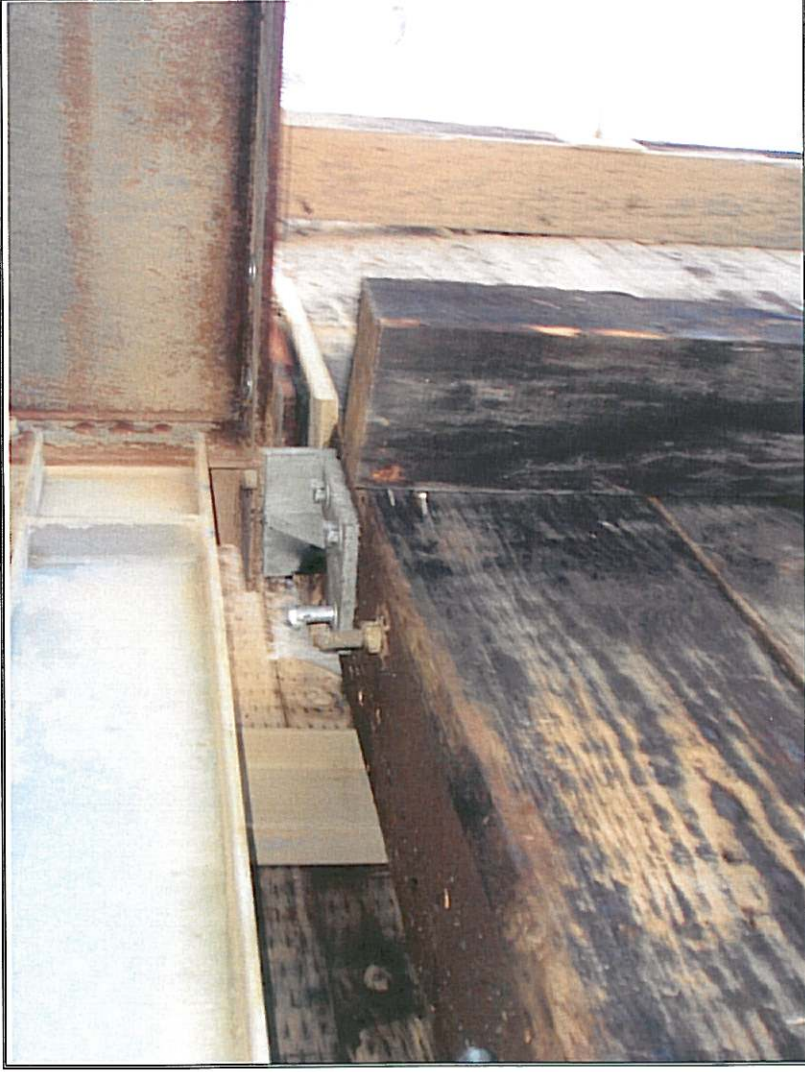
**Photo 7**

D/S D/C bearing plate keeper. 1 bolt still to be tightened.

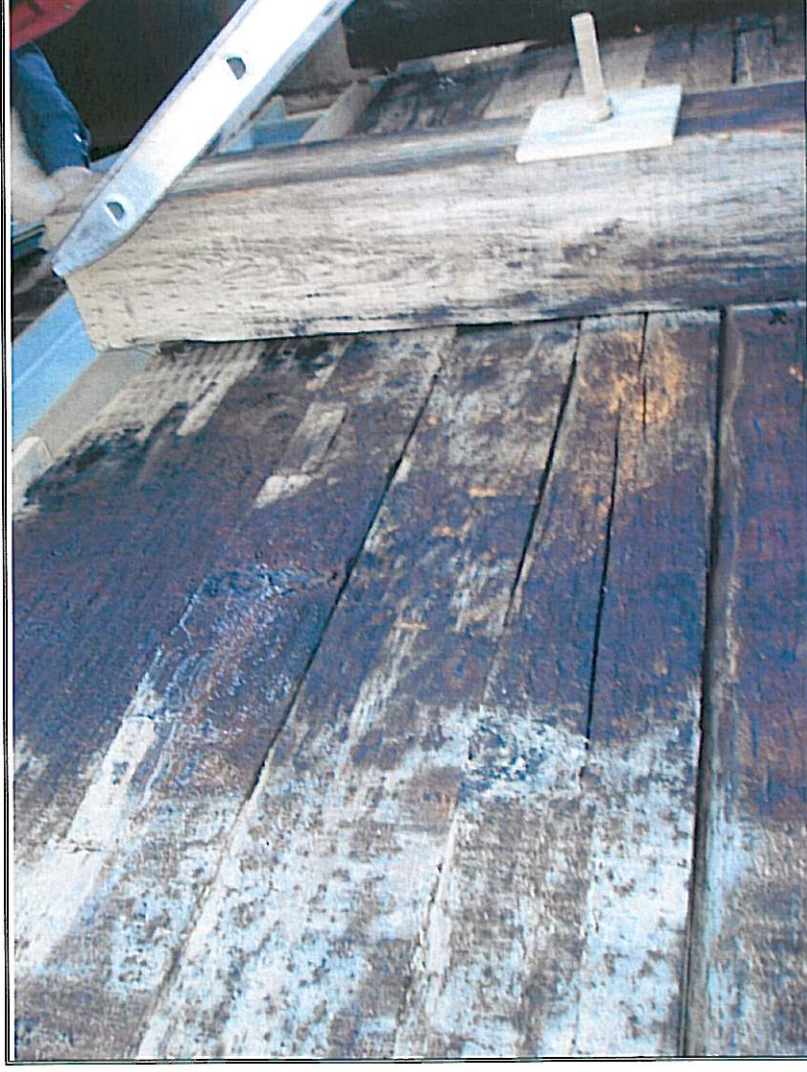
**Photo 8**

Separation between abutment planks and vertical post

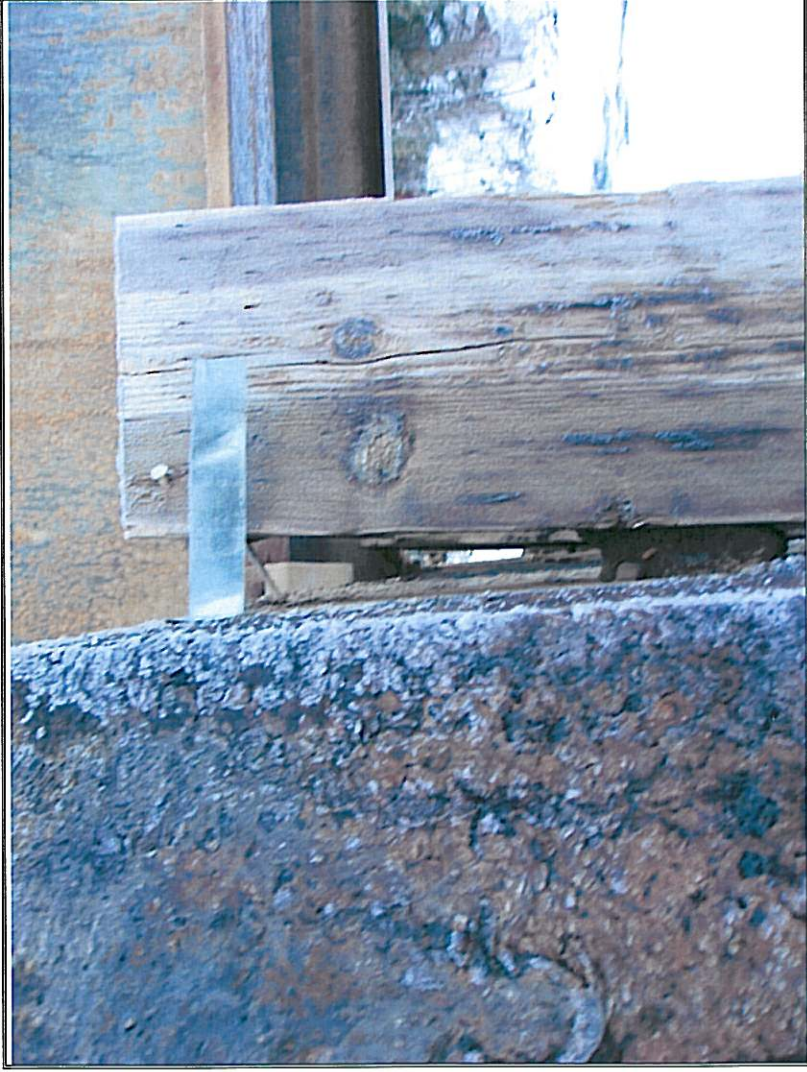
**Photo 9**

I apologize for taking so long to get this to you. Attached are PDF versions of the Inspection Photos and Bridge Inspection Report. Again, it looks like there has been no significant movement of the town-side abutment cribbing (see the last two photos). The lateral bearing restraints were installed correctly (with a couple of the lag screws still to be tightened when the inspector left the site).

| BRIDGE ELEMENT | | CONDITION | REMARKS |
|---|---|---|---|
| | Cribs | 2 | TREATED. LEANING TOWARDS RIVER, BUT STABLE SINCE 2003. |

| PRESENT WATER m | 1.5 | PRESENT WATER CLEARANCE: | 5 | m | ESTIMATED HIGH WATER LEVEL: | 3 | m | HAZARD(S) DESCRIPTION: |
|---|---|---|---|---|---|---|---|---|
| REPAIR REQUIRED: | <input checked="" type="checkbox"/> YES | <input type="checkbox"/> NO | REPAIR DESCRIPTION AND COST ESTIMATE:<br>ADD BRIDGE HAZARD DELINEATOR SIGNS<br>DOWNCHAIN ABUTMENT SHOWING SIGNS OF MOVEMENT, BEING MONITORED:<br>US MONITOR 2 3/8"<br>DS MONITOR 2 9/16" | | | | | |

U/S monitoring device on D/C abutment. Not much change since 2003 (see Photo 10).

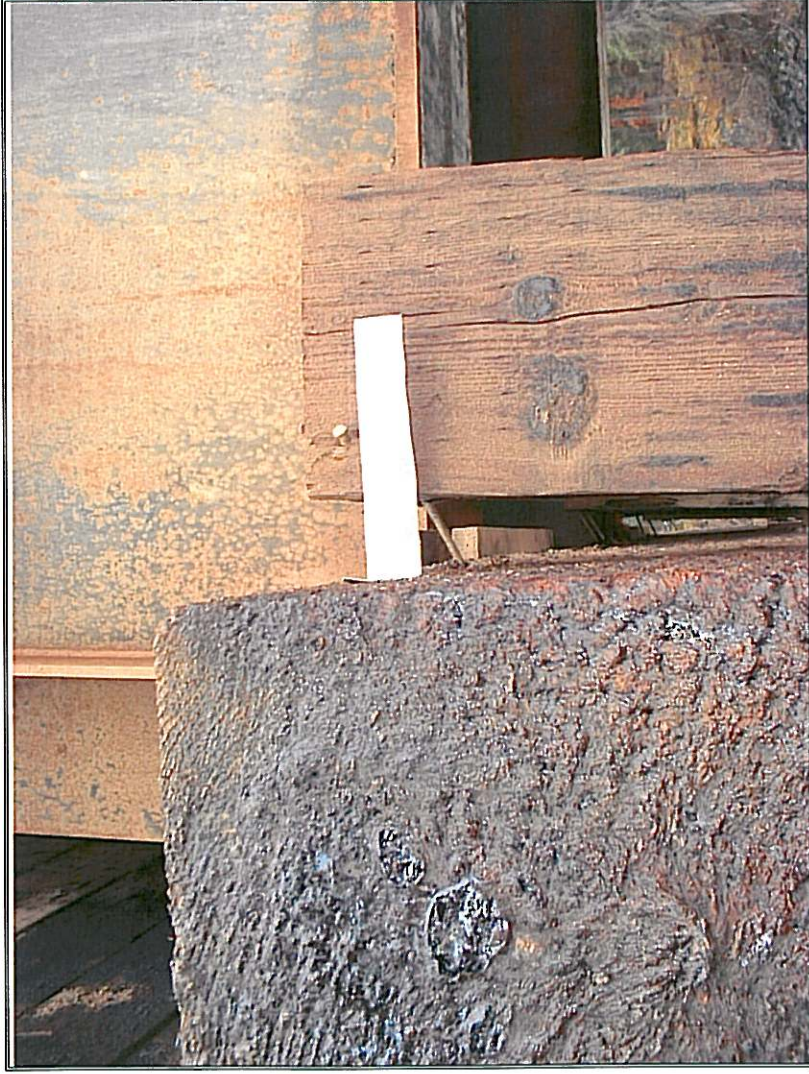
**Photo 10**

Photo at same location as Photo 9 from October 22, 2003.
