# MOUNTAIN BIKE TRAIL & TECHNICAL TRAIL FEATURE INSPECTION

IRON MOUNTAIN, MERRITT, BC

Ministry of Ministry of Forests, Lands and  
Natural Resource Operations

Cascades District – Recreation Sites & Trails  
August 2012

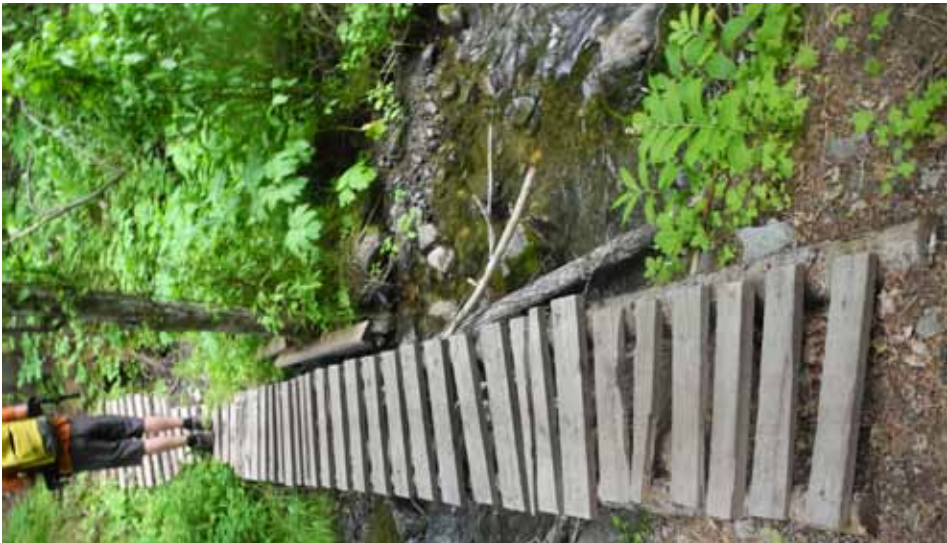
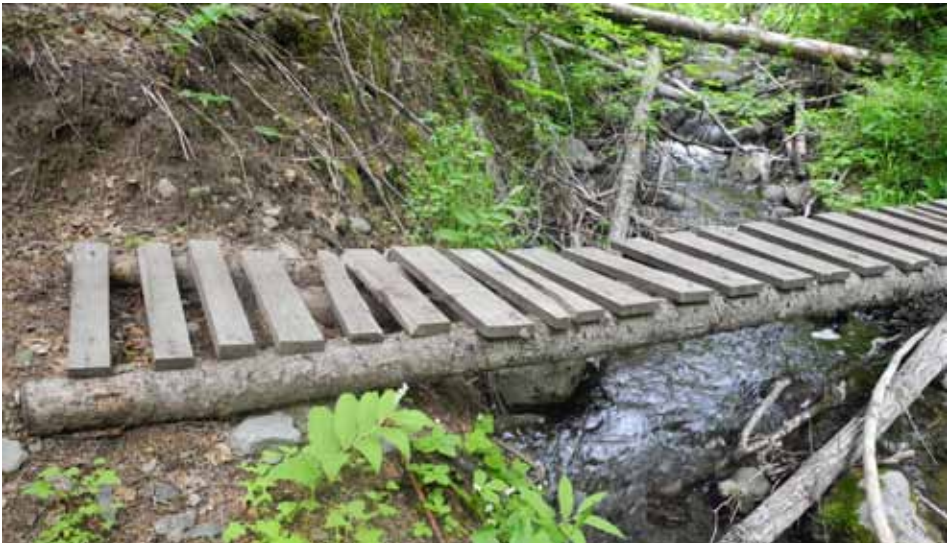
| 9 | Godey Creek | bridge | 610w x 10000l x 650h | replace | broken decking, and stringers deflect greatly with foot traffic and should be improved by replacing the stringers with items of suitable size | n | 2 | y | 1 | DSCN6222.JPG |

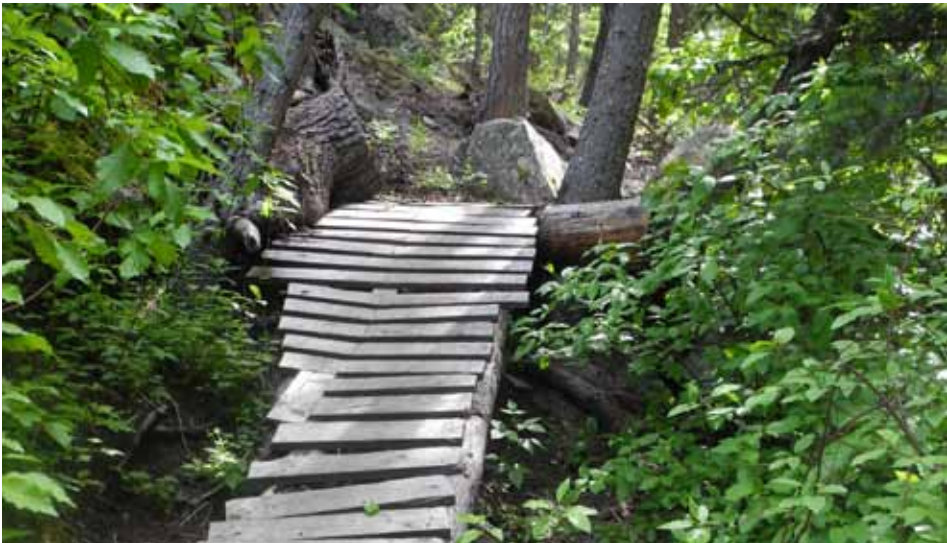
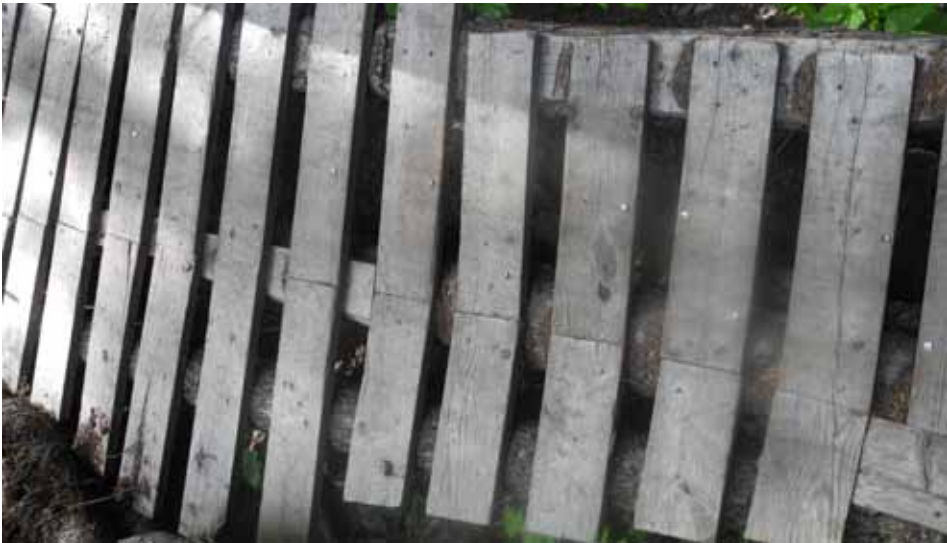
| 64 | Godey Creek | elevated bridge roll | 600w x 5000l x 600h | improve | Improve fall zones, increase the size of the stringers and replace the loose decking | y | 2 | y | 1 | DSCN6742.JPG |

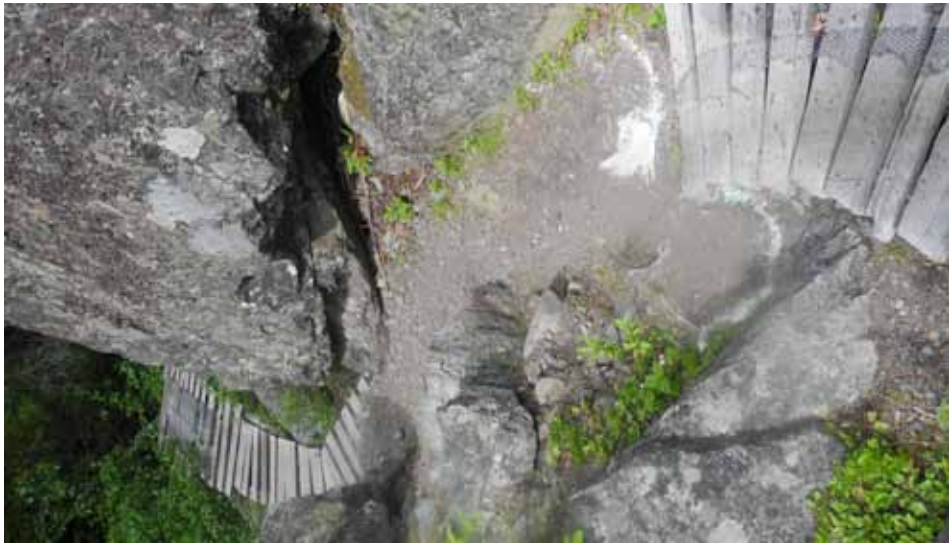
| NO. | TRAIL | ITEM | DIMENSION (MM) | PRESCRIPTION | IMPROVEMNT | MEETS STANDARD | LIFE (YEARS) | MANDATORY | FALL_ZONE (1 - POOR, 5 - GOOD) | IMAGE |
|---|---|---|---|---|---|---|---|---|---|---|
| 65 | Godey Creek | elevated bridge roll | 920w x 12000l x 2000h | replace | stringers deflect under foot traffic, shingles and chicken wire on decking should be replaced with a "cleated" boardwalk, and stringers are broken at base of stunt | y | 2 | y | 1 | DSCN6752.JPG |

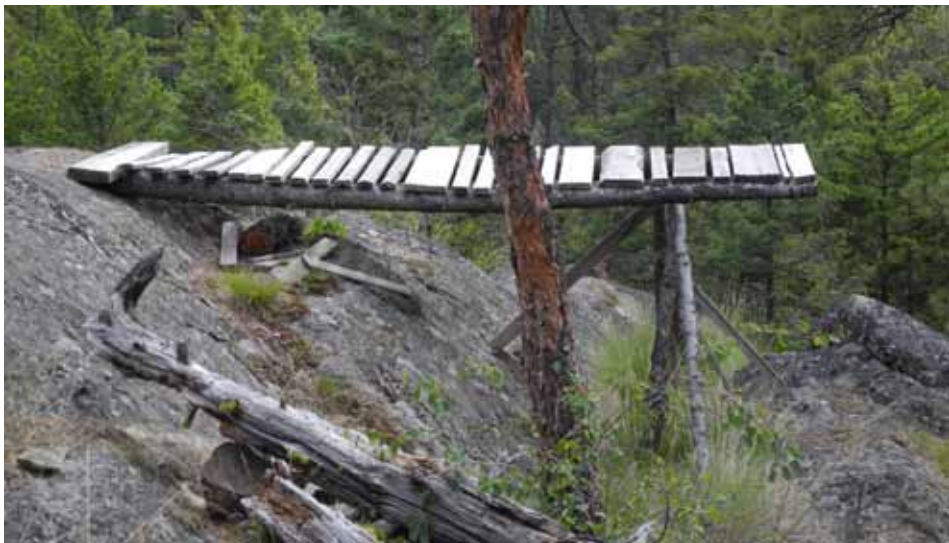
| NO. | TRAIL | ITEM | DIMENSION (MM) | PRESCRIPTION | IMPROVEMNT | MEETS STANDARD | LIFE (YEARS) | MANDATORY | FALL_ZONE (1 - POOR, 5 - GOOD) | IMAGE |
|---|---|---|---|---|---|---|---|---|---|---|
| 6 | Ridge | elevated bridge drop | 700w x 4080l x 1600h | remove | overspanned stringers, poor fall zones, poorly anchored at base of stunt, existing rock down sufficient stunt | n | 2 | y | 1 | DSCN6181.JPG |

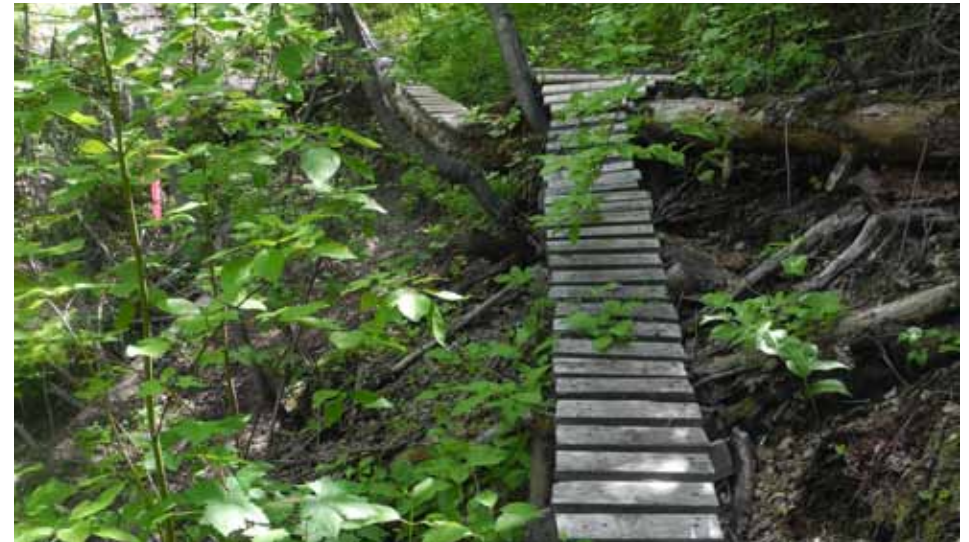
| NO. | TRAIL | ITEM | DIMENSION (MM) | PREScription | IMPROVEMNT | MEETS STANDARD | LIFE (YEARS) | MANDATORY | FALL_ZONE (1 - POOR, 5 - GOOD) | IMAGE |
|---|---|---|---|---|---|---|---|---|---|---|
| 109 | Rotary Wankle | log drop | | replace | complex stunt on fallen log, decking is decaying and stringers deflecting greatly. Recommend replacing or improving dirt trail adjacent to stunt. | n | 2 | n | 2 | DSCN7054.JPG |

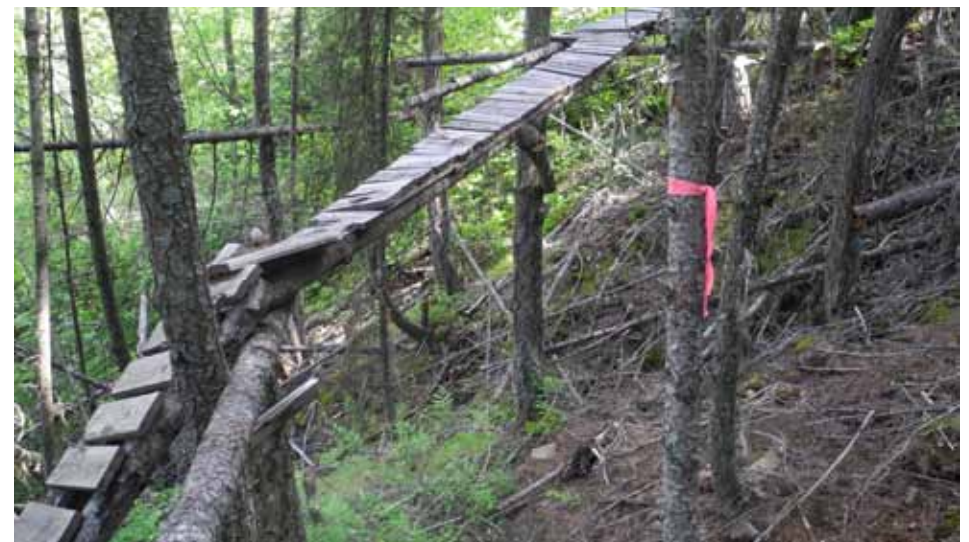
| 111 | Rotary Wankle | elevated bridge roll | | remove | pink tape denotes stunt is closed but stunt should be removed | n | 1 | n | 1 | DSCN7070.JPG |

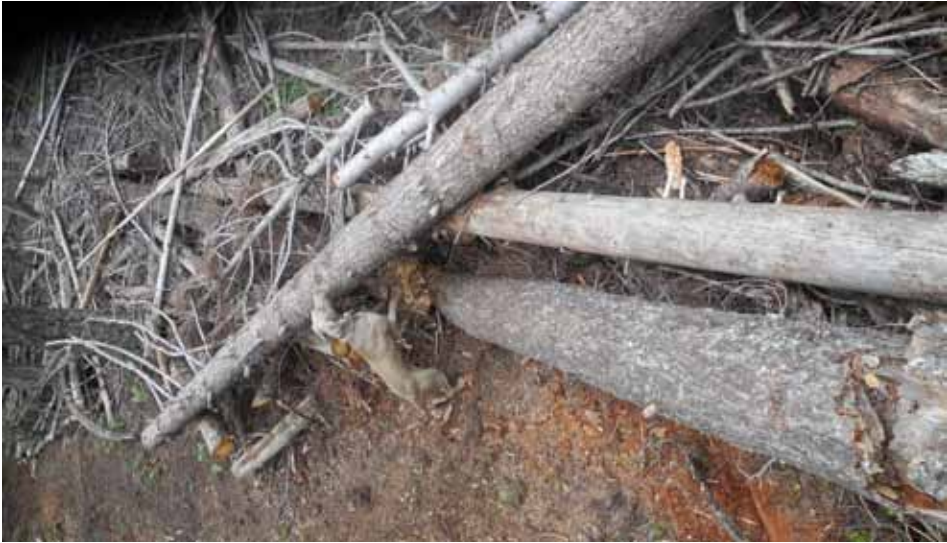
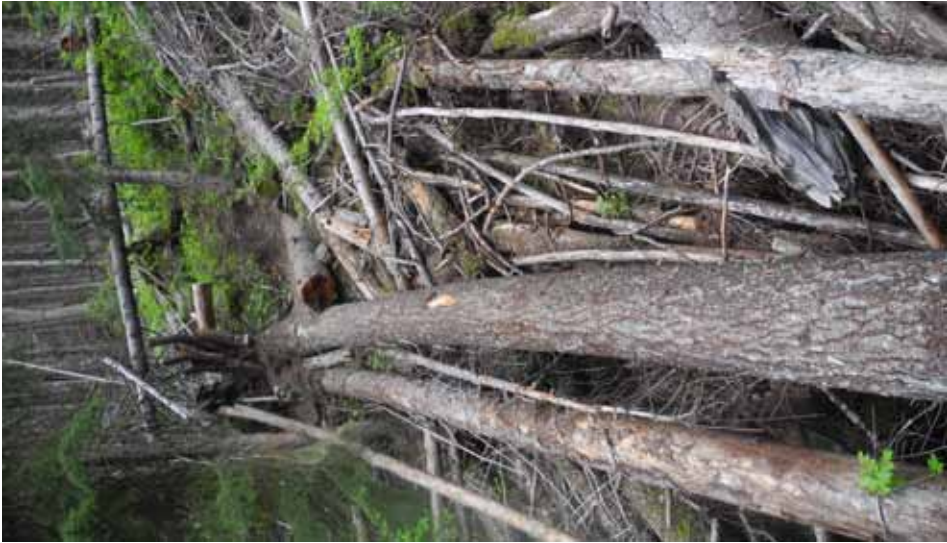
| NO. | TRAIL | ITEM | DIMENSION (MM) | PRESCRIPTION | IMPROVEMNT | MEETS STANDARD | LIFE (YEARS) | MANDATORY | FALL_ZONE (1 - POOR, 5 - GOOD) | IMAGE |
|---|---|---|---|---|---|---|---|---|---|---|
| 93 | The Revival | log drop | 2000 drop | improve | stunt consists of a log ride on a fallen tree with ramp to ground. Tree is broken and moves easily. Recommend anchoring the log, or removing. Improve fall zones. | n | 2 | y | 1 | DSCN6909.JPG |

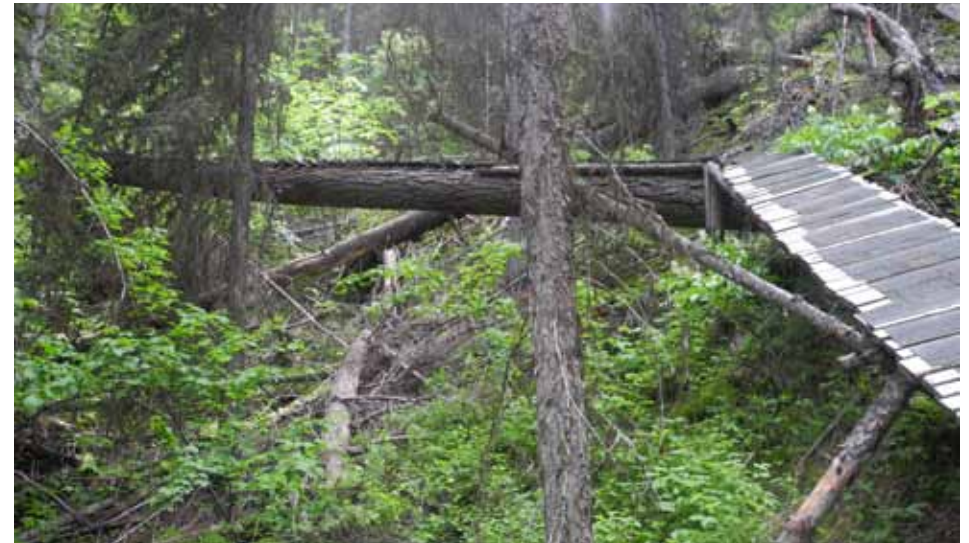
| NO. | TRAIL | ITEM | DIMENSION (MM) | PREScription | IMPROVEMNT | MEETS STANDARD | LIFE (YEARS) | MANDATORY | FALL_ZONE (1 - POOR, 5 - GOOD) | IMAGE |
|---|---|---|---|---|---|---|---|---|---|---|
| 100 | The Tyrant | elevated bridge roll / log ride | 690w x 4200h | remove | complex stunt, recommend replacing decaying deck boards, cleating the boardwalk, and improving fall zones. | n | 1 | y | 1 | DSCN7020.JPG |

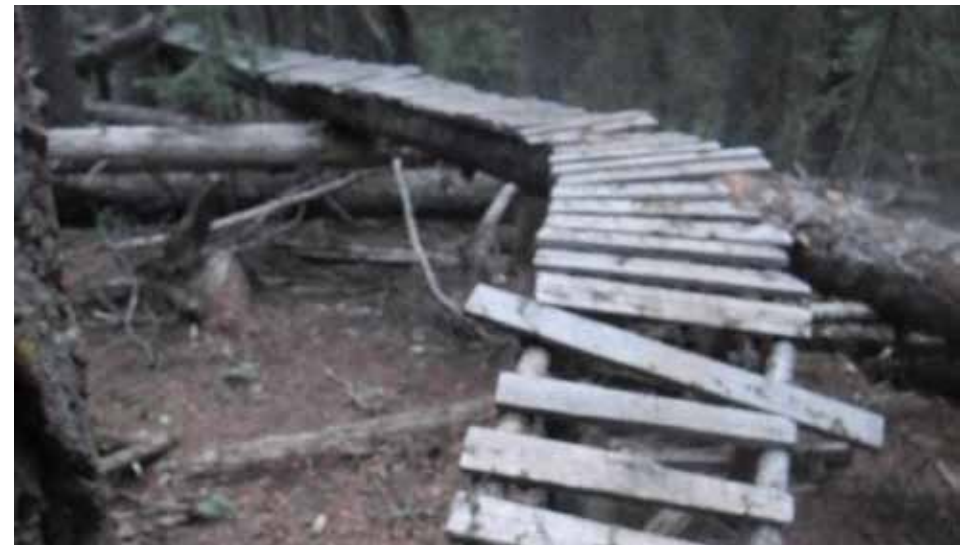
| NO. | TRAIL | ITEM | DIMENSION (MM) | PRESCRIPTION | IMPROVEMNT | MEETS STANDARD | LIFE (YEARS) | MANDATORY | FALL_ZONE (1 - POOR, 5 - GOOD) | IMAGE |
|---|---|---|---|---|---|---|---|---|---|---|
| 49 | Treats | elevated bridge drop | 200w x 2000h x 15000l | remove | major deflection in stringers, uneven riding surface, 1x4 and 2x4 decking failing, recommend removal of stunt | n | 1 | y | 1 | DSCN6609.JPG |

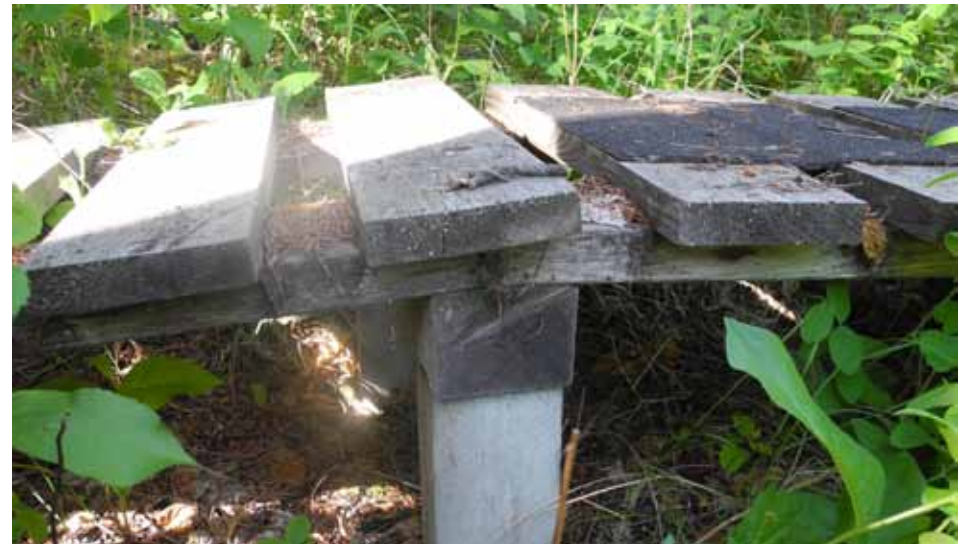
| NO. | TRAIL | ITEM | DIMENSION (MM) | PRESCRIPTION | IMPROVEMNT | MEETS STANDARD | LIFE (YEARS) | MANDATORY | FALL_ZONE (1 - POOR, 5 - GOOD) | IMAGE |
|---|---|---|---|---|---|---|---|---|---|---|
| 34 | Ursa Major | elevated bridge roll | 610w x 3060l x 700h | remove | shakey structure because posts are rotting where touching the ground, shingles are loose - remove or rebuild | y | 2 | n | 2 | DSCN6287.JPG |

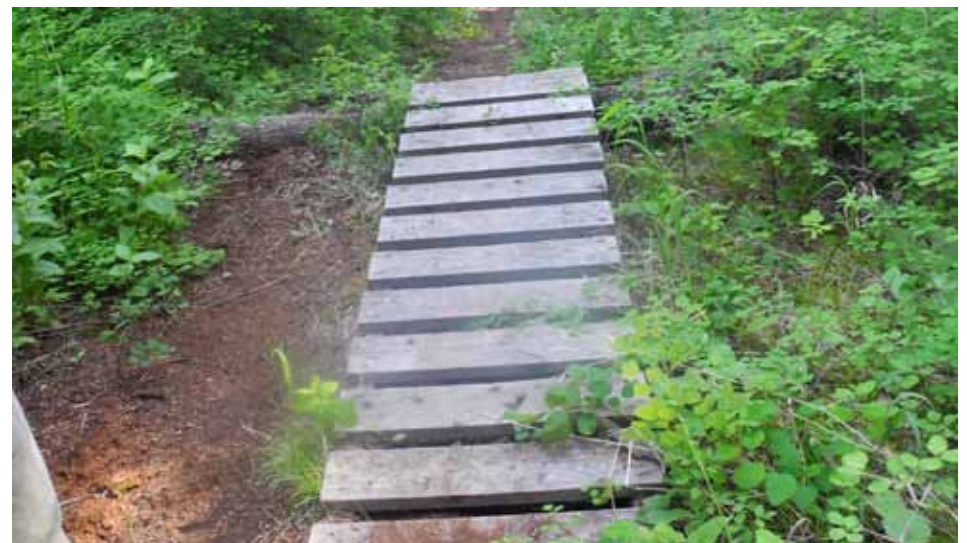
| 35 | Ursa Major | elevated bridge drop | 650w x 2430l x 350h | improve | log on which stunt is situated is broken, recommend removing log and stunt | n | 1 | y | 2 | DSCN6295.JPG |

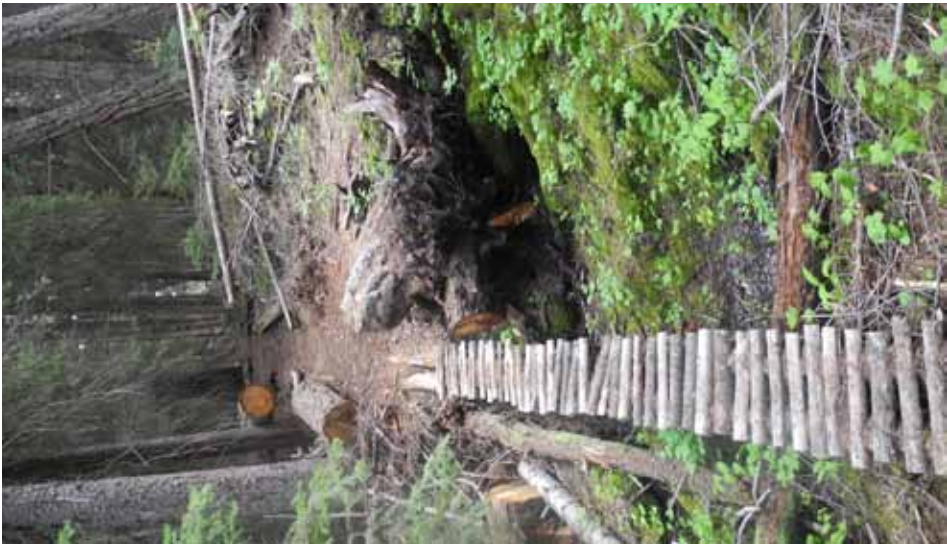
| NO. | ITEM | DIMENSION (MM) | PRESCRIPTION | IMPROVEMNT | MEETS STANDARD | LIFE (YEARS) | MANDATORY | FALL_ZONE (1 - POOR, 5 - GOOD) | IMAGE | NORTHING (UTM10) | EASTING (UTM10) | HEIGHT ABOVE MSL (M) |
|---|---|---|---|---|---|---|---|---|---|---|---|---|
| 97 | elevated bridge roll | 420w x 600h x 6000l | remove | decking and stringers are decaying, recommend removing stunt and using adjacent log, or ground. | n | 1 | y | 1 | DSCN6937.JPG | 5547342 | 660873 | 1445 |

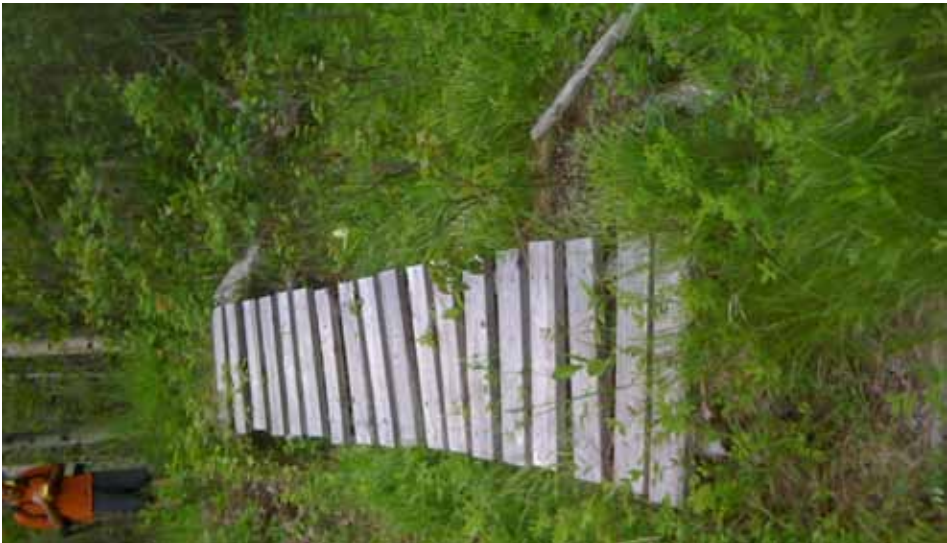
| 28 | elevated<br>bridge roll | 700w x 4500l x<br>500h | remove | lots of deflection with foot traffic, and non-mandatory | y | 1 | n | 3 | IMG_0792.JPG | 5547692 | 662249 | 1245 |

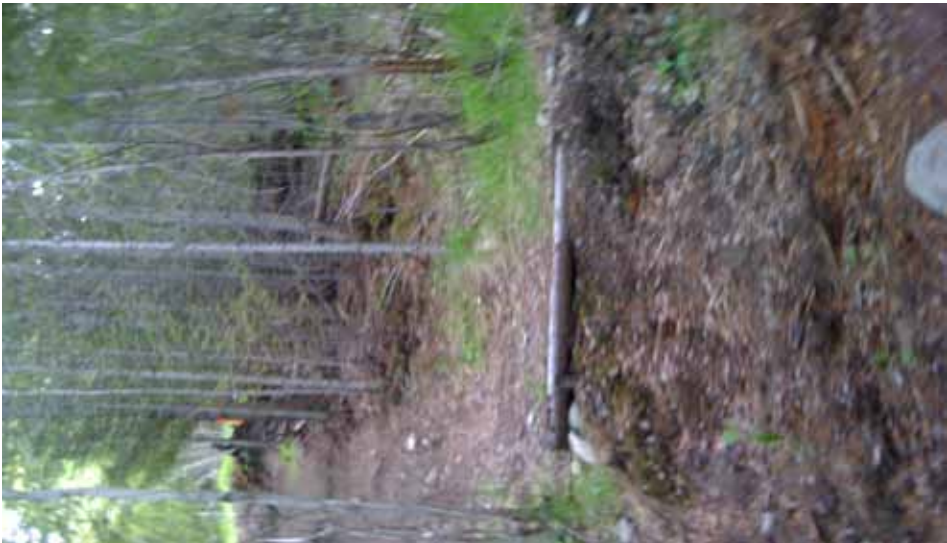
| 29 | log drop | 800h | monitor | natural feature will rot over time | y | 5 | y | 2 | IMG_0800.JPG | 5547510 | 662244 | 1282 |

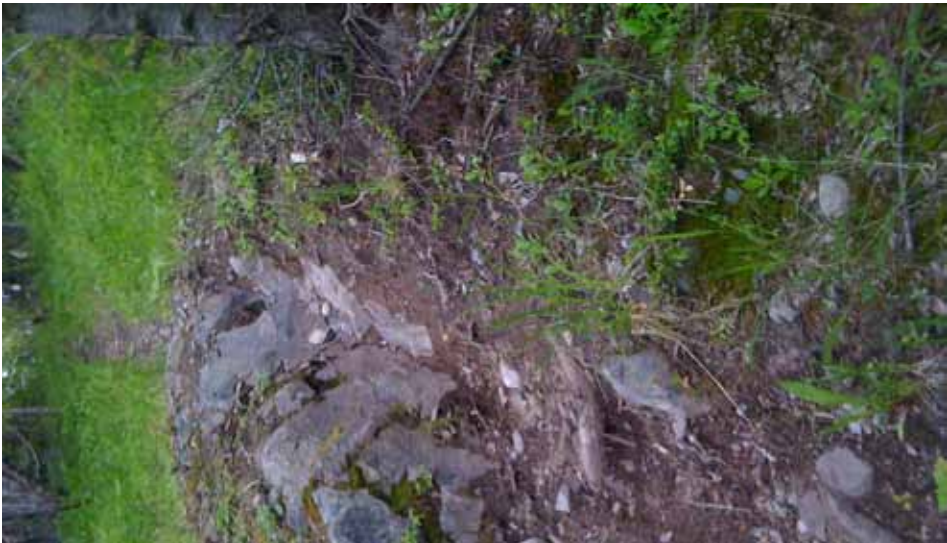
| 31 | rock drop | 1500h | monitor | steep drop could be improved with better ride around | y | 5 | y | 2 | IMG_0804.JPG | 5547484 | 662243 | 1286 |

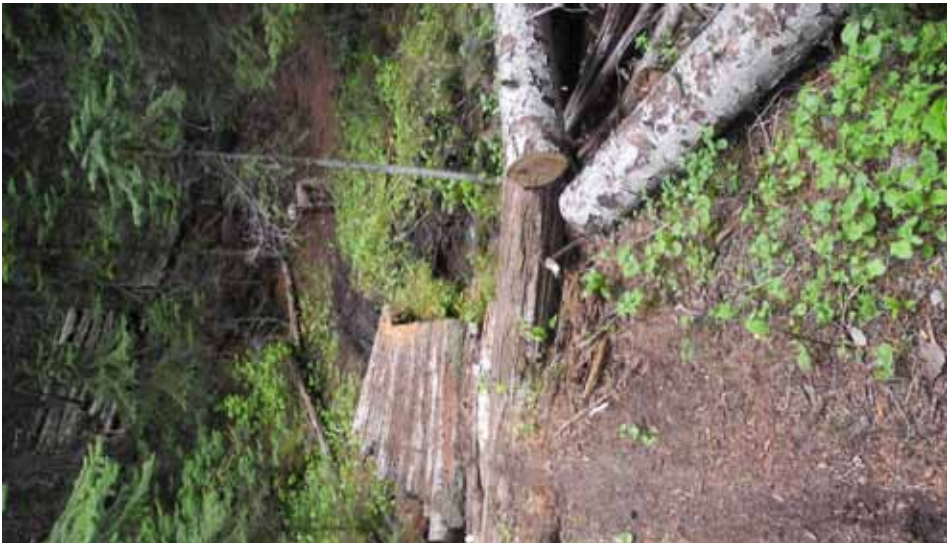
| NO. | ITEM | DIMENSION (MM) | PRESCRIPTION | IMPROVEMNT | MEETS STANDARD | LIFE (YEARS) | MANDATORY | FALL_ZONE (1 - POOR, 5 - GOOD) | IMAGE | NORTHING (UTM10) | EASTING (UTM10) | HEIGHT ABOVE MSL (m) |
|---|---|---|---|---|---|---|---|---|---|---|---|---|
| 81 | puncheon | | replace | mushy logs crossing creek, recommend replacing with bridge or removing altogether | y | 3 | y | 2 | DSCN6843.JPG | 5546929 | 660725 | 1600 |

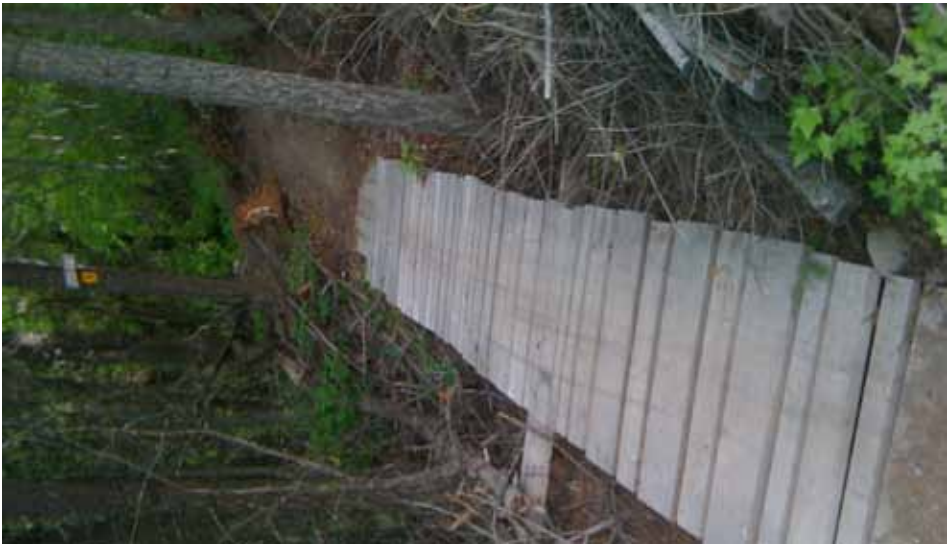
| NO. | ITEM | DIMENSION (MM) | PRESCRIPTION | IMPROVEMNT | MEETS STANDARD | LIFE (YEARS) | MANDATORY | FALL_ZONE (1 - POOR, 5 - GOOD) | IMAGE | NORTHING (UTM10) | EASTING (UTM10) | HEIGHT ABOVE MSL (m) |
|---|---|---|---|---|---|---|---|---|---|---|---|---|
| 14 | elevated bridge roll | 700w x 7080l x 730h | improve | improve by replacing non-galvanized nails, broken deck boards, and clear the fall zone | y | 3 | y | 2 | IMG_0724.JPG | 5548735 | 662671 | 1037 |

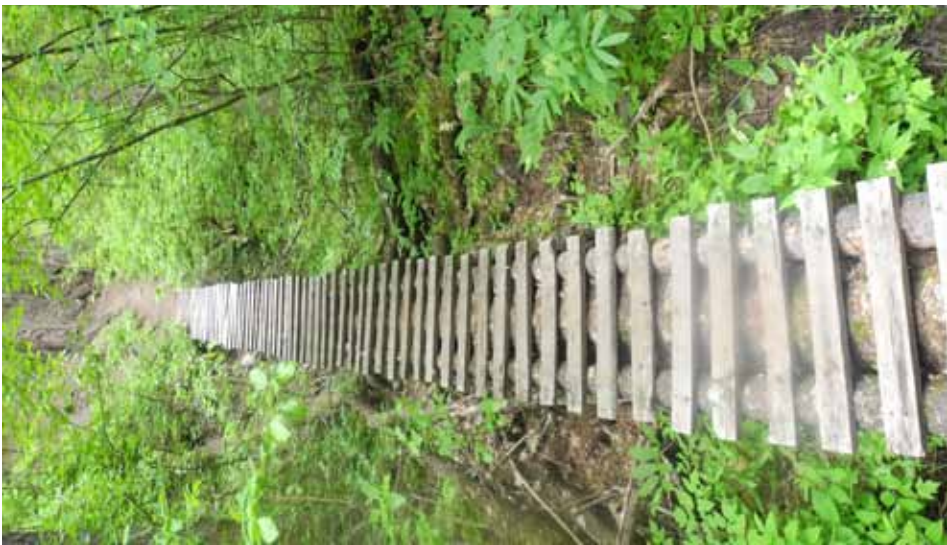
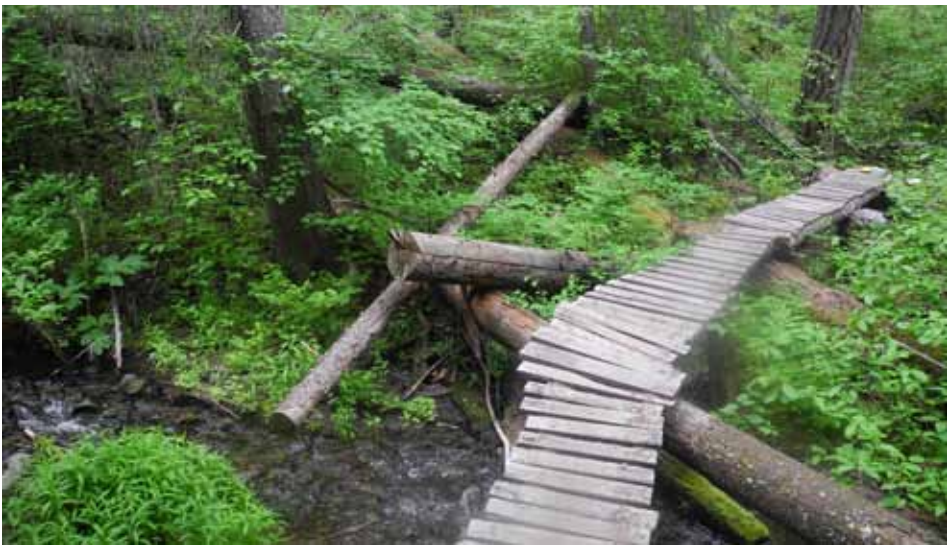
| NO. | ITEM | DIMENSION (MM) | PRESCRIPTION | IMPROVEMNT | MEETS STANDARD | LIFE (YEARS) | MANDATORY | FALL_ZONE (1 - POOR, 5 - GOOD) | IMAGE | NORTHING (UTM10) | EASTING (UTM10) | HEIGHT ABOVE MSL (m) |
|---|---|---|---|---|---|---|---|---|---|---|---|---|
| 57 | bridge | 700w x 1410h x 21400l | replace | stringers deflect under foot traffic, could remove and re-route trail and build smaller crossing | n | 2 | y | 1 | DSCN6713 - 21 | 5549139 | 662125 | 908 |

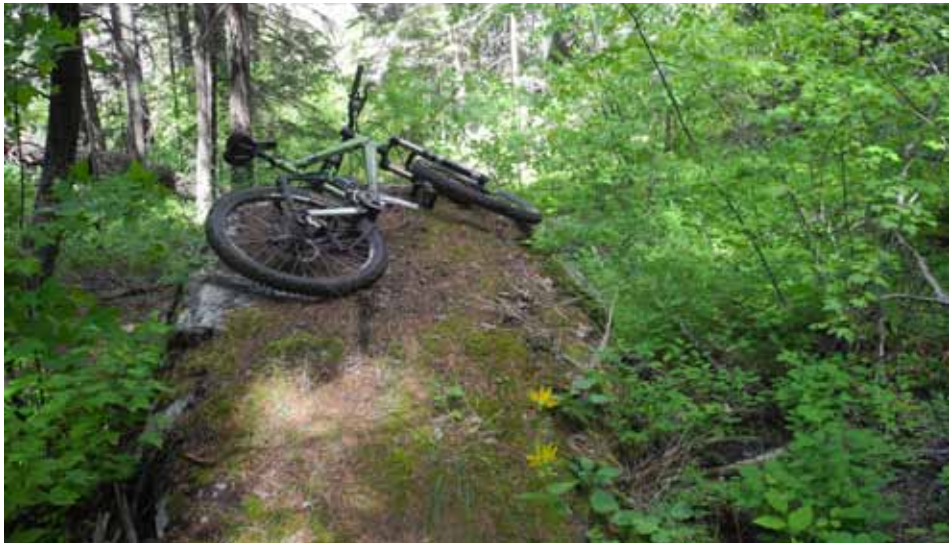
| NO. | ITEM | DIMENSION (MM) | PRESCRIPTION | IMPROVEMNT | MEETS STANDARD | LIFE (YEARS) | MANDATORY | FALL_ZONE (1 - POOR, 5 - GOOD) | IMAGE | NORTHING (UTM10) | EASTING (UTM10) | HEIGHT ABOVE MSL (M) |
|---|---|---|---|---|---|---|---|---|---|---|---|---|
| 109 | log drop | | replace | complex stunt on fallen log, decking is decaying and stringers deflecting greatly. Recommend replacing or improving dirt trail adjacent to stunt. | n | 2 | n | 2 | DSCN7054.JPG | 5549255 | 661292 | 926 |

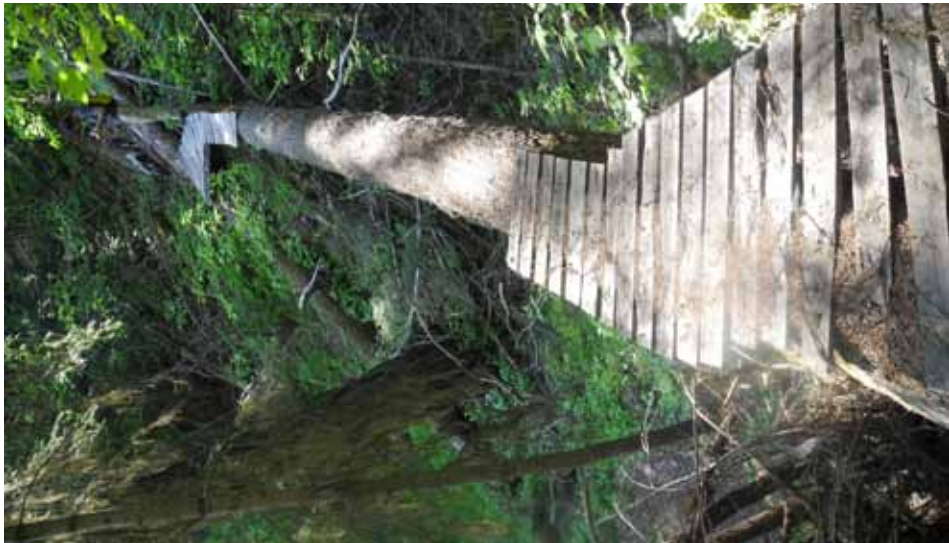
| NO. | ITEM | DIMENSION (MM) | PRESCRIPTION | IMPROVEMNT | MEETS STANDARD | LIFE (YEARS) | MANDATORY | FALL_ZONE (1 - POOR, 5 - GOOD) | IMAGE | NORTHING (UTM10) | EASTING (UTM10) | HEIGHT ABOVE MSL (m) |
|---|---|---|---|---|---|---|---|---|---|---|---|---|
| 98 | elevated bridge roll / log ride | | improve | complex stunt consisting of fallen logs, and boardwalk. Recommend replacing stringer on entry-ramp and increasing the size of stringers to minimize deflection. Improve fall zones. | n | 1 | y | 1 | DSCN6997.JPG | 5547968 | 661299 | 1320 |
