QC-7003

HONNA-STANLEY FSR 0.7km

2019 Inspection

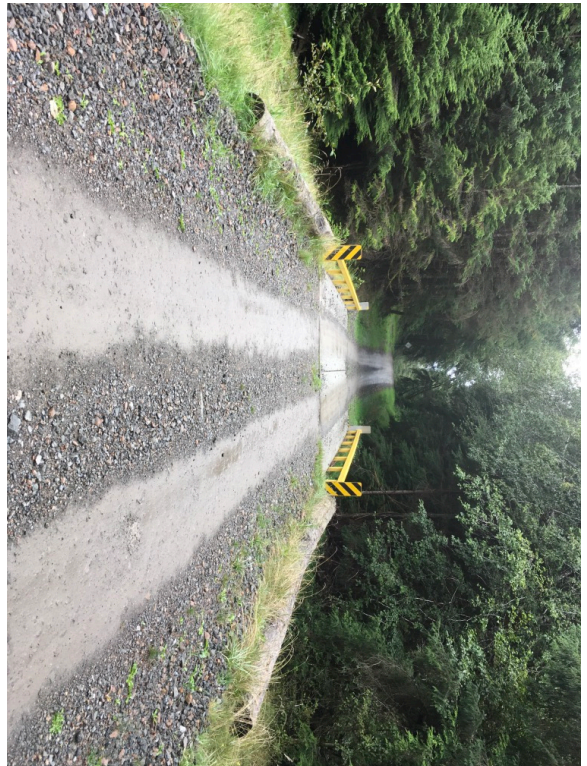
Approach from Right Bank when facing downstream

Fender Condition Poor Guidelogs are functional but nearing end of life. Consider replacement.

| Repair Item | Priority | Repair Description |
|---|---|---|
| 1 | Medium | Replace guidelogs on both approaches. |

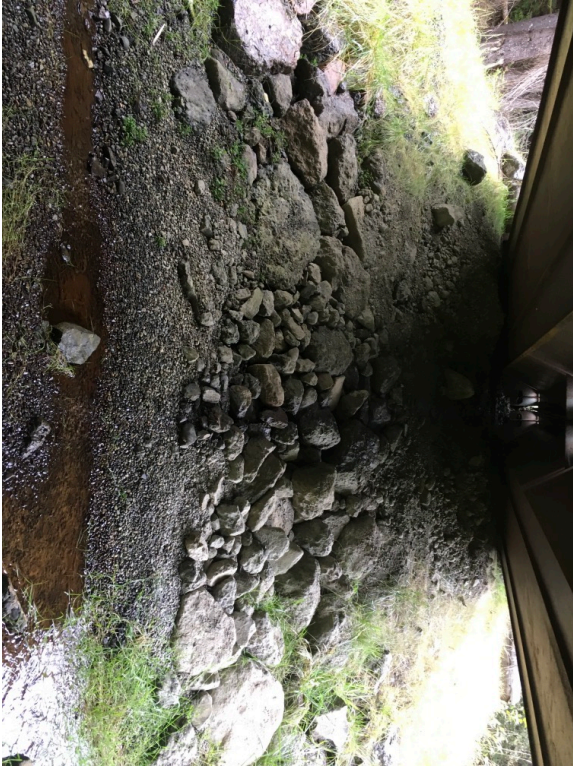
Right Bank Abutment when facing downstream

Log/Timber Cribs Good Single large sills that have been squared by a portable sawmill.

Ballast Wall Good Single larger diameter cedar logs used as ballast logs.

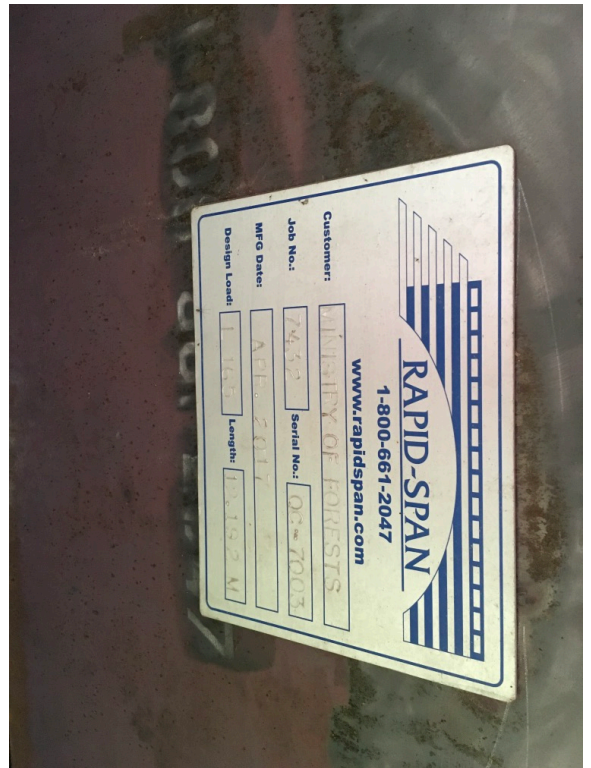
Structure ID

Inspector Comments Serial/ID Plate Rapid Span Job # 7432, Serial # QC-7003, April 2017, L165, 12.192m

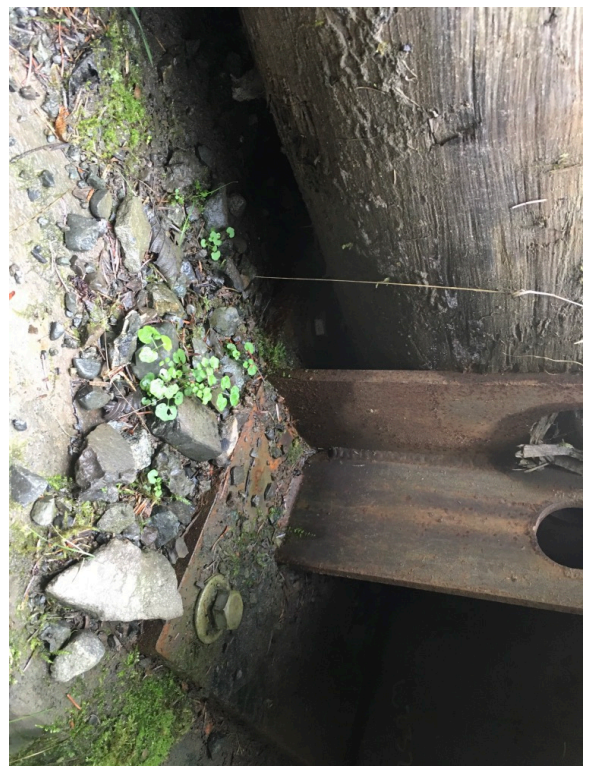
Hardware Good Bearing plates appear to be lag bolted to timber sills.
