QC-7004

HONNA-STANLEY FSR 1.7km

2019 Inspection

Crossing Name Turundle Creek

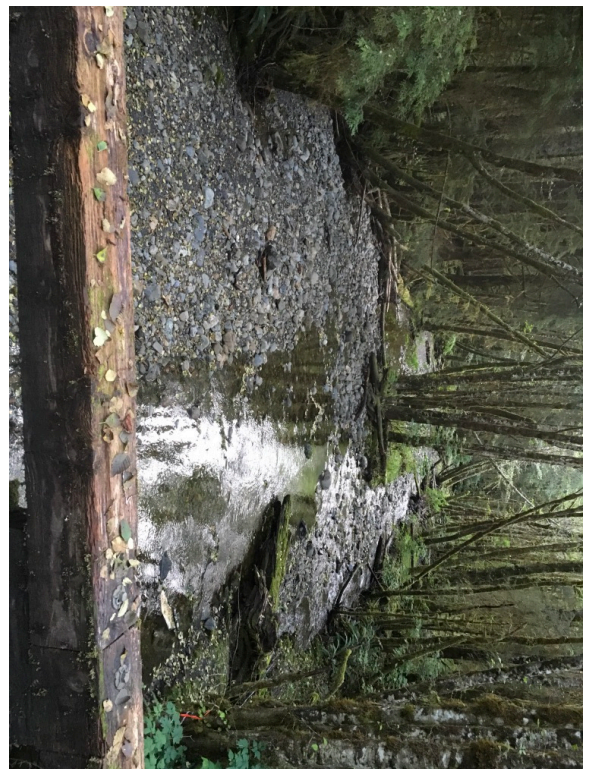
Guard Rail

Guardrails still have some firm wood at centres but heavy rot on outer edges. No lag bolts in bearing plates and one missing tie clip under downstream deck panel.

Guardrails need replacement prior to industrial activity

Curb Rail/Blocks/Posts Poor Guardrails need replacement prior to industrial activity

| Repair Item | Priority | Repair Description |
|---|---|---|
| 1 | Medium | Replace guardrails in 2 years or less. |

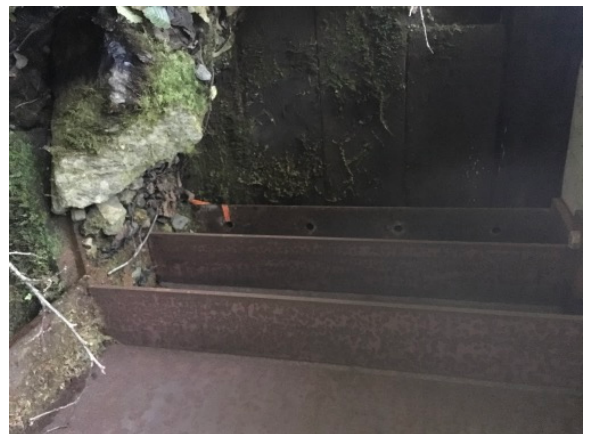
Ballast timber connection

Timbers secured by gravity alone

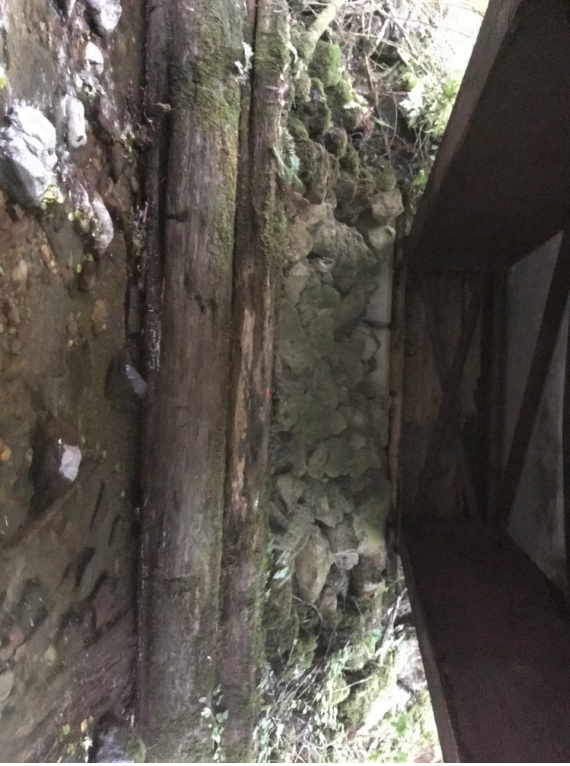
Right Bank Abutment when facing downstream

Two high lock block abutments set back from original log cribs. George is visible between

Untreated timber do not appear pinned to lock blocks

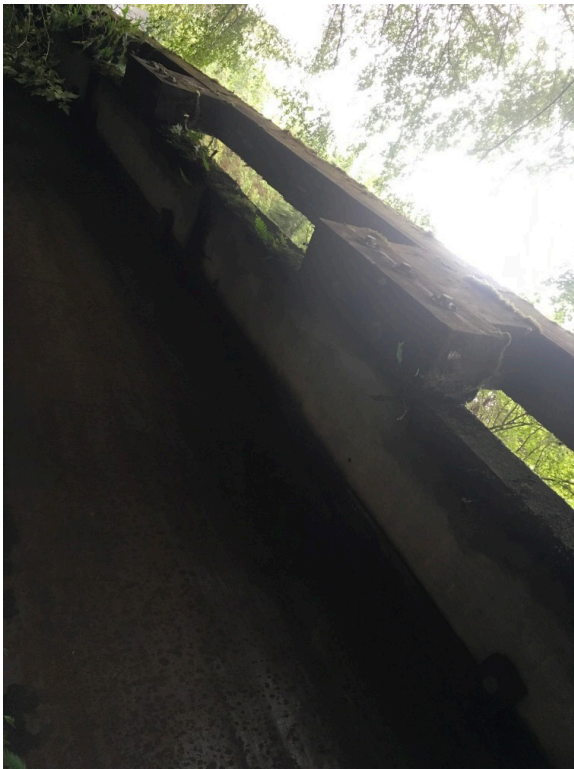
Missing tie clip

One tie clip missing on downstream side of bridge

| Repair Item | Priority | Repair Description |
|---|---|---|
| 2 | Medium | Add missing tie clip |

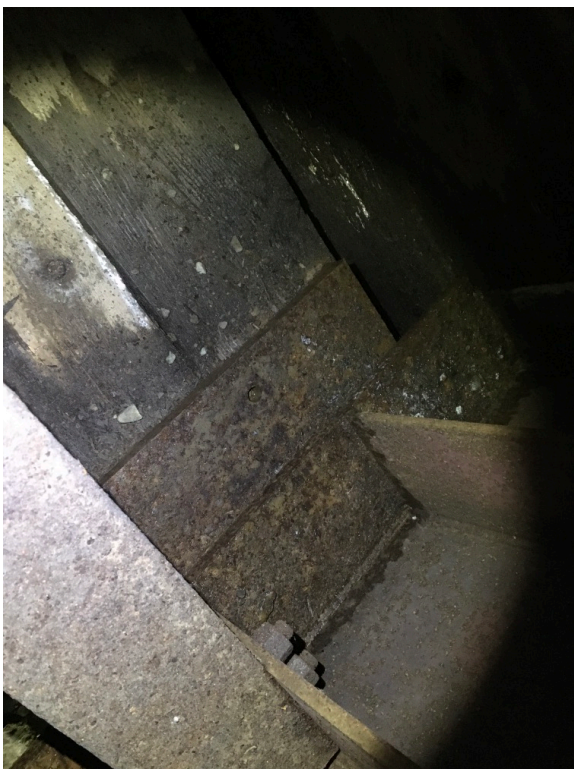
Bearing

No lag bolts, gravity connection only. No signs of movement

| Repair Item | Priority | Repair Description |
|---|---|---|
| 3 | Medium | Attach lag bolts on bearing plates |

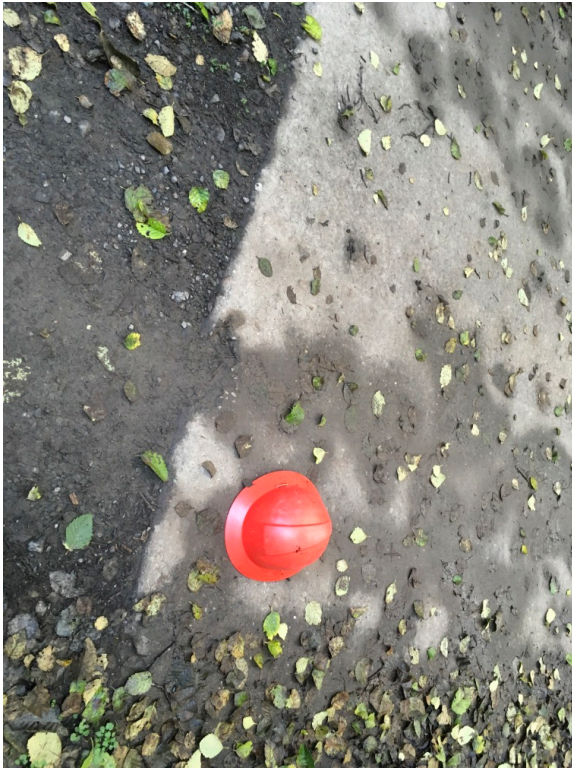
Structure ID

Inspector Comments Serial/ID Plate 'MBS 63ft, #829, L100, 08/01'
