QC-7006

HONNA-STANLEY FSR 7.4km

2019 Inspection

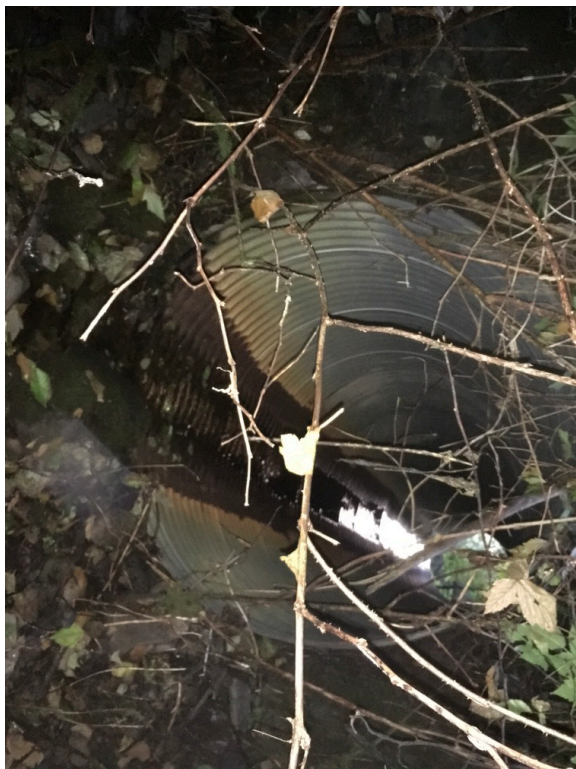
| Inlet | Good | |

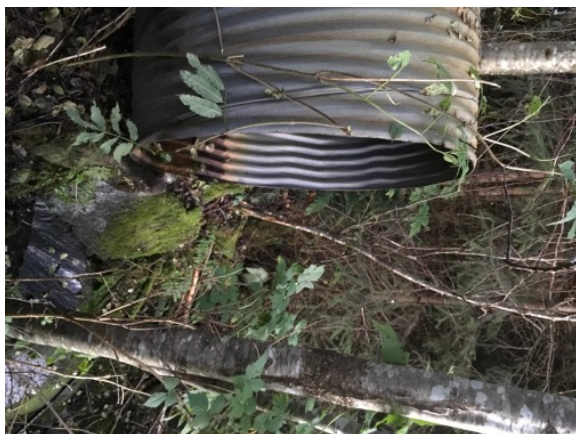
Culvert is perched at outlet but everything stable.

| Outlet | Good | Perched at outlet above large stacked rock fill, approx 4m high. No scour observed. |
