QC-7007

QC\_GLD1000 0.24km

2019 Inspection

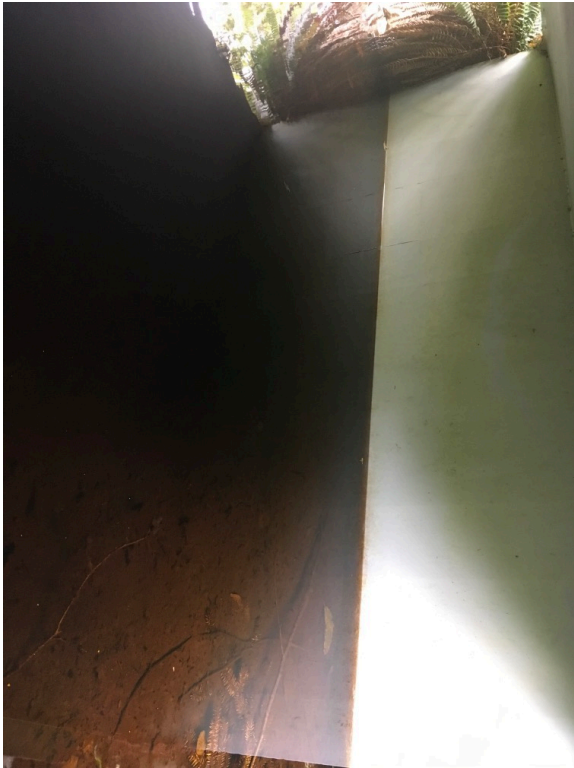
Right Bank Abutment when facing downstream

Bin Wall Fair Appears to be a steel bin wall at both abutments. Connected to superstructure (all one

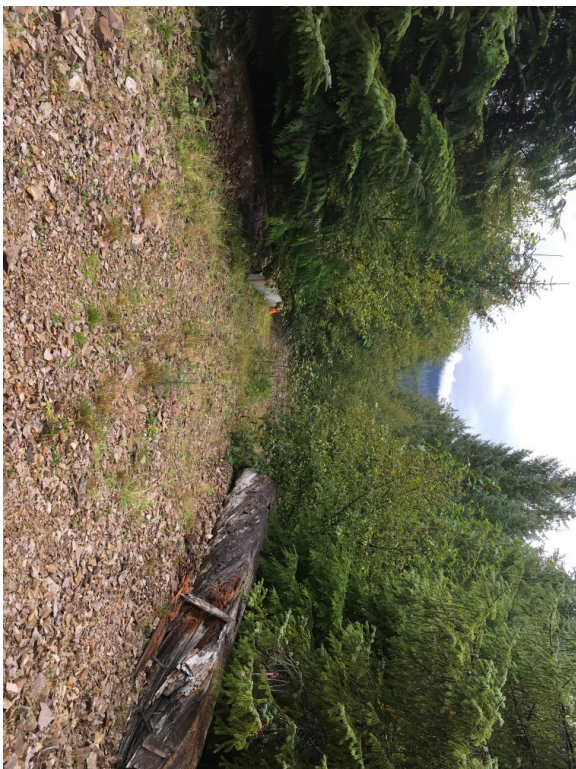
Approach from Right Bank when facing downstream

Fender Condition Poor Large rocks and rotten logs used to guide traffic onto deck.

| 1 | Medium | Brush out road and approaches |

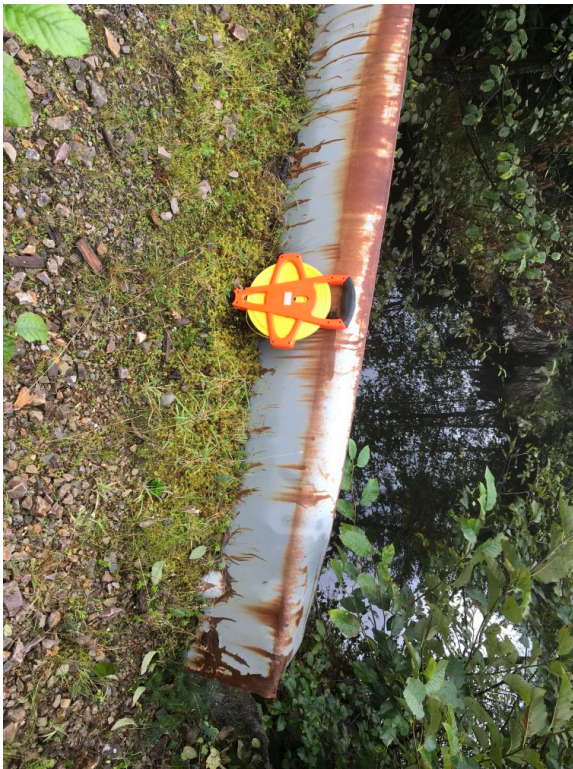
Guard Rail

Corrosion Protection Fair Steel is coated/painted but worn on edges of guardrails.

| Curb Rail/Blocks/Posts | Fair | Steel extends 50cm above surface of gravel. |

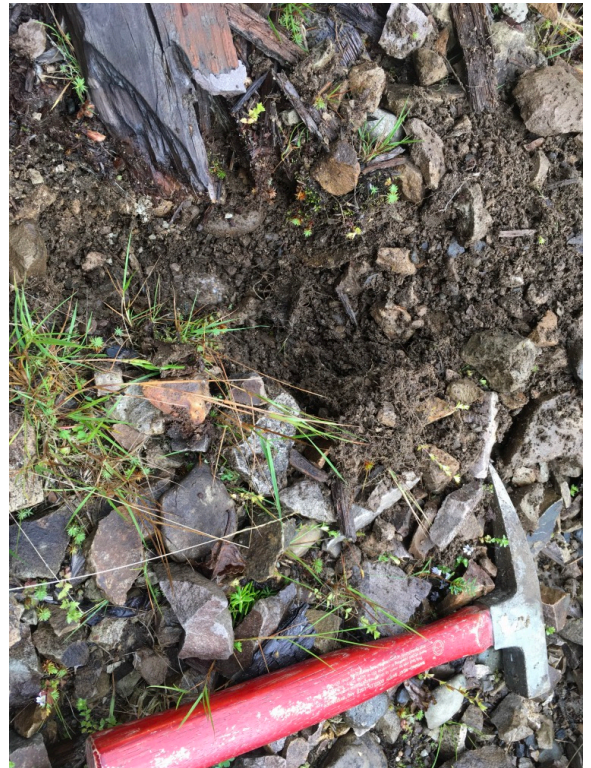
Deck

| Running Surface | Fair | Coarse angular rock |
