QC-7012

BONANZA 13.5km

2019 Inspection

Road Name BONANZA

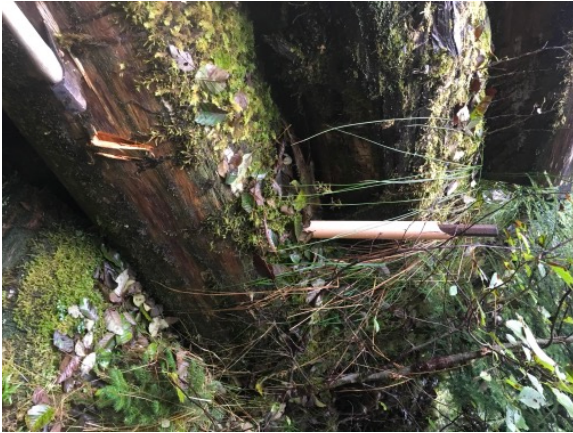
Bearing

Bearings Good

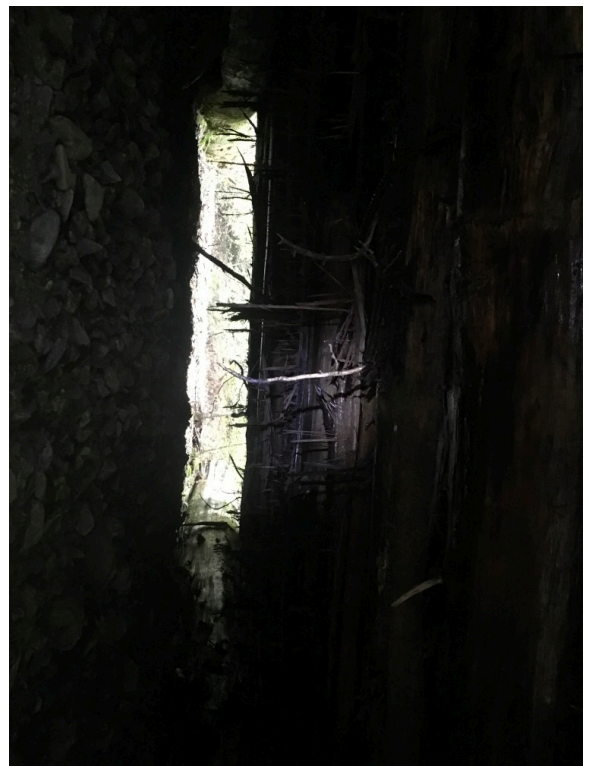
Stringers

| Stringer<br>Number | Species | Peeled | Diameter<br>(mm) | Rot Depth<br>(mm) | Condition | Comment |
|---|---|---|---|---|---|---|
| 4 | Cw | N | 800 | 50 | Fair | 50mm defect - poor form |
| 10 | Cw | Y | 590 | 50 | Fair | 50mm defect - deep saw cut |

| Item | Monitor Description | Frequency |
|---|---|---|
| 1 | Rot in stringers. | Routine Inspection |

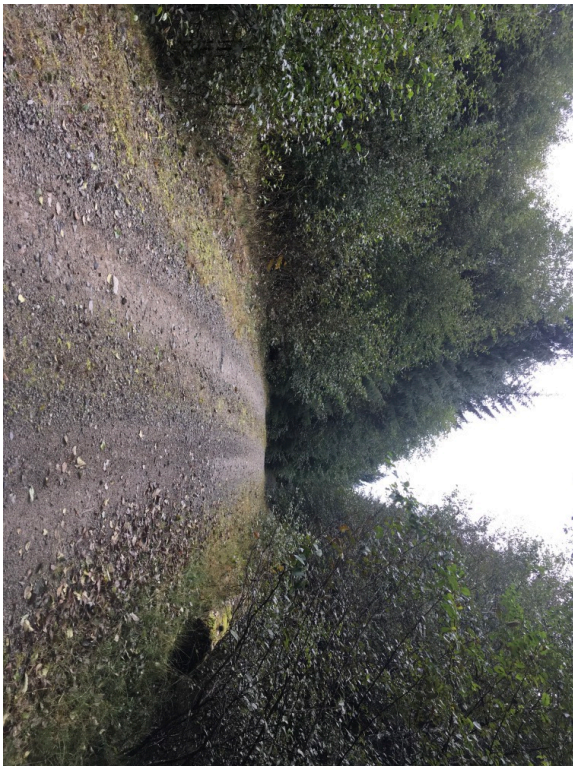
Approach from Right Bank when facing downstream

Large speed bump on road due to WBC.

Rotten curbs logs

Log Curbs    Poor    Replace upstream curb logs

| 1 | Low | Replace upstream curb log |
