QC-7021

HONNA-STANLEY FSR 4.9km

2019 Inspection

Structure Class Woodbox/Log Culvert

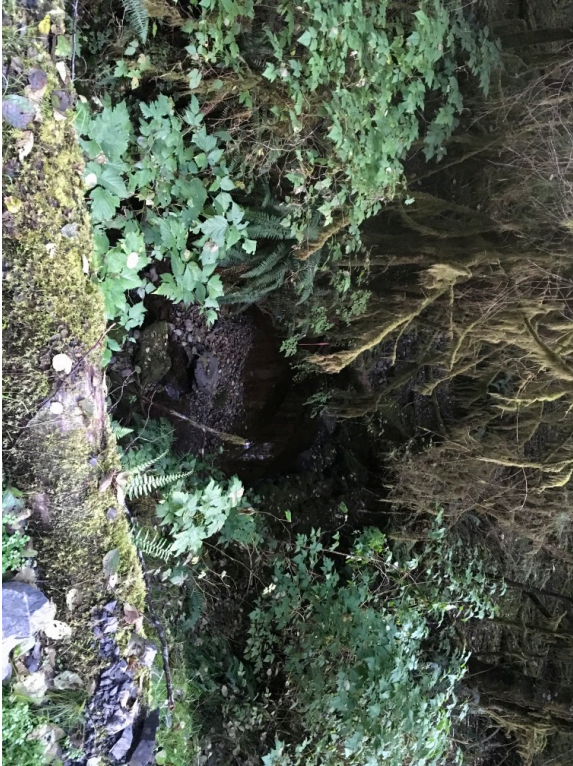
Upstream from Crossing

Comments    Inlet partially plugged with debris.

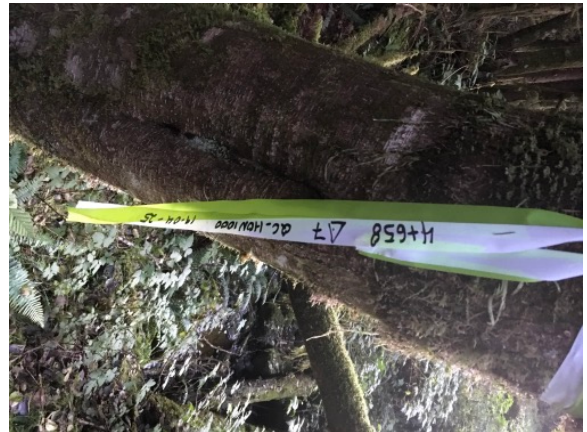
Typical stringer condition

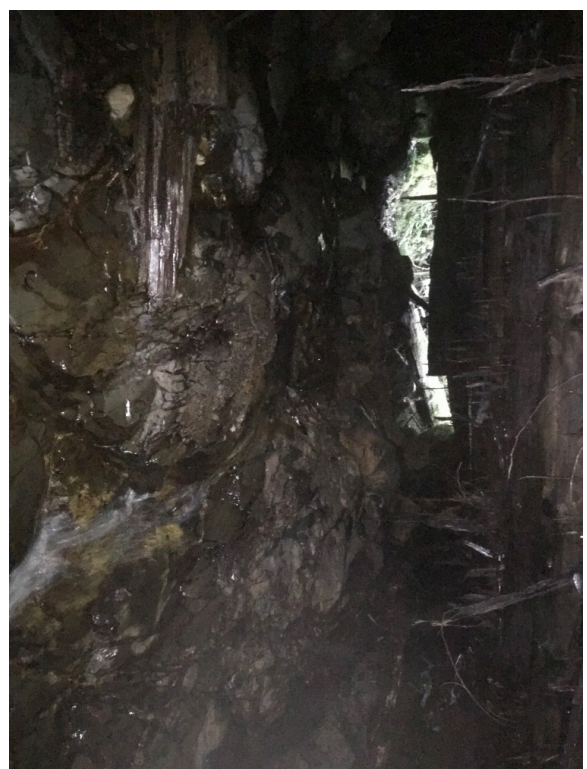
WBC in better condition than it looks from road surface. Sills are scoured but appear stable and are bearing on bedrock.

Single cedar sills, actively being scoured but stable.

Upstream under wbc.

| Item | Monitor Description | Frequency |
|---|---|---|
| 1 | Monitor scour under both sills | Routine Inspection |

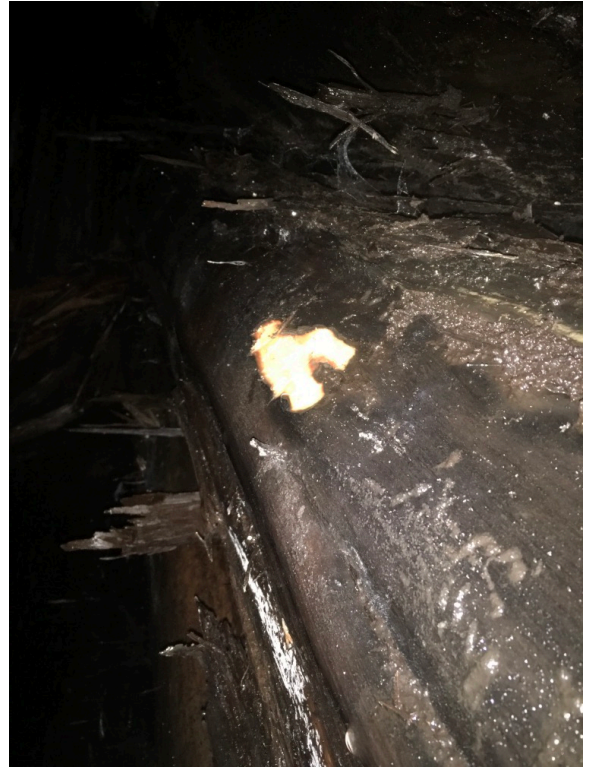
Stringer #5

| Stringer<br>Number | Species | Peeled | Diameter<br>(mm) | Rot Depth<br>(mm) | Condition | Comment |
|---|---|---|---|---|---|---|
| 5 | Cw | N | 385 | 10 | Fair | Outside bark |
