QC-7023

MORESBY 1.7km

2019 Inspection

| Structure Class | Major Culvert | | |

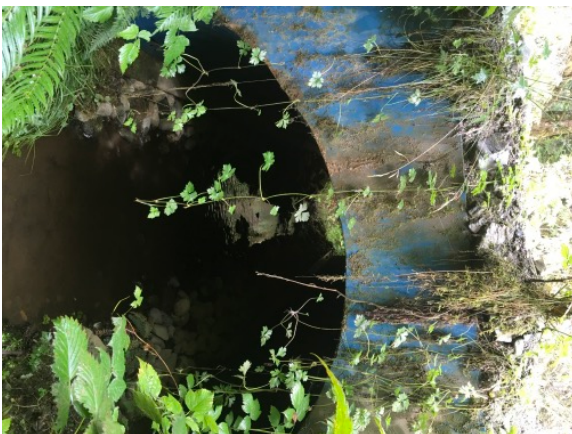
Downstream Profile

Footing Fair Perched footing and subject to scour, although none present due to limited flows.

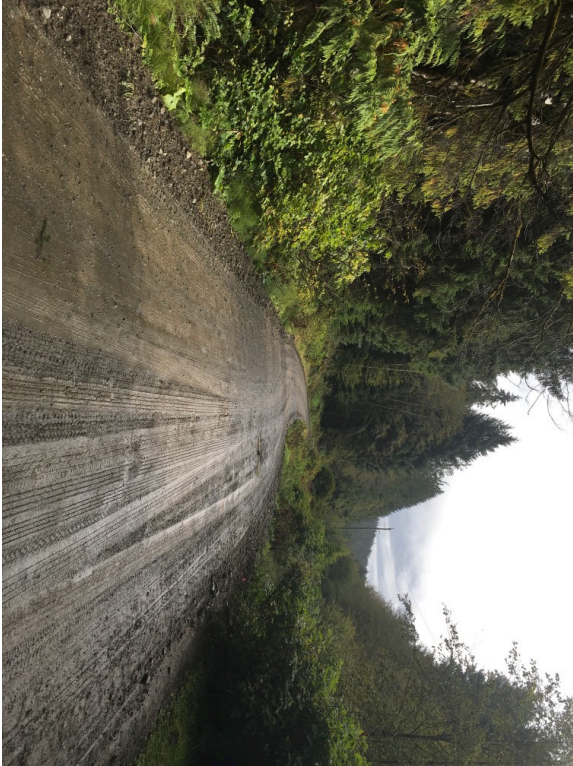
Approach from Right Bank when facing downstream

Fender Condition Unrated Add guidelogs

1 Medium Add guidelogs on both sides of road above arch.
