QC-7034

BEACH/RENNELL HILL 8km

2019 Inspection

## Inspection

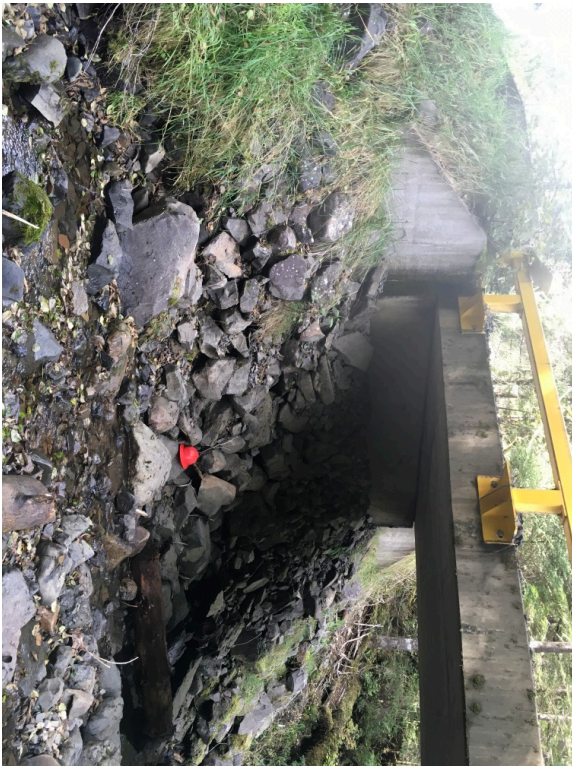
Left Bank Abutment when facing downstream

Riprap Fair Left bank riprap is actively being scoured and has moved. Currently oversteepened but no part of footing is yet visible.

Comments Left bank abutment is scouring and riprap is moving.

Scoured riprap on left bank

| Item | Priority | Repair Description |
|---|---|---|
| 1 | Medium | Consider addition of riprap to left bank abutment to redirect water away from toe of existing slope. |

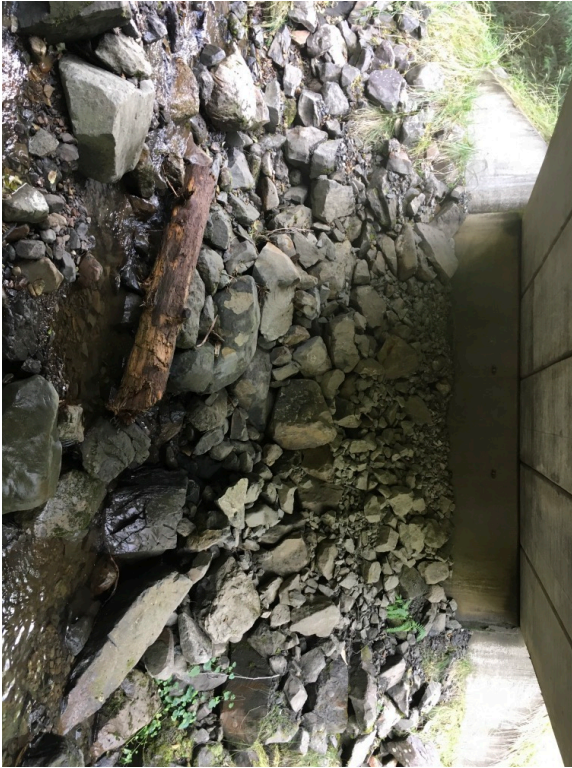
Scoured riprap on left bank
