QC-7035

MORESBY 5.29km

2019 Inspection

Load Rated by: FLNRORD, J. Harvey P.Eng., February 11, 2020

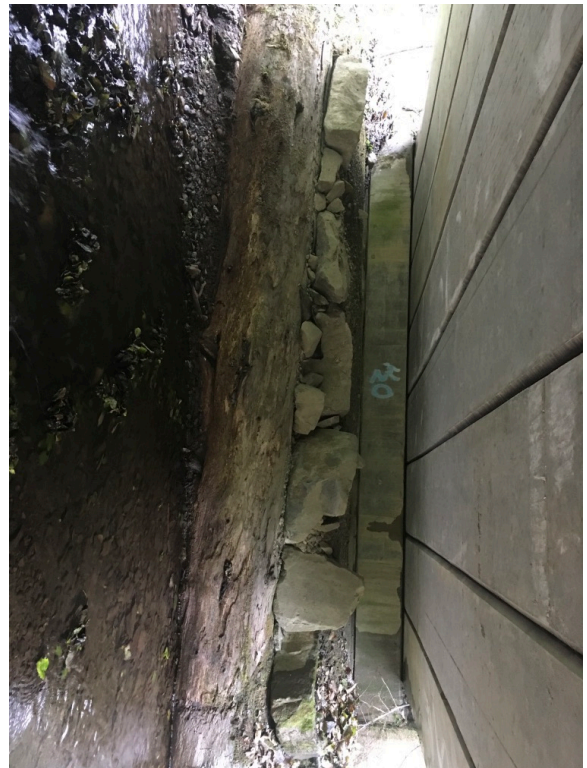
Right Bank Abutment when facing downstream

Riprap N/A Old sill logs acting as scour protection

Bearings Good Precast cap beam on single row lock blocks

| Item | Monitor Description | Frequency |
|---|---|---|
| 1 | Long term stability of original sill logs (will eventually scour and/or rot away). | Routine Inspection |

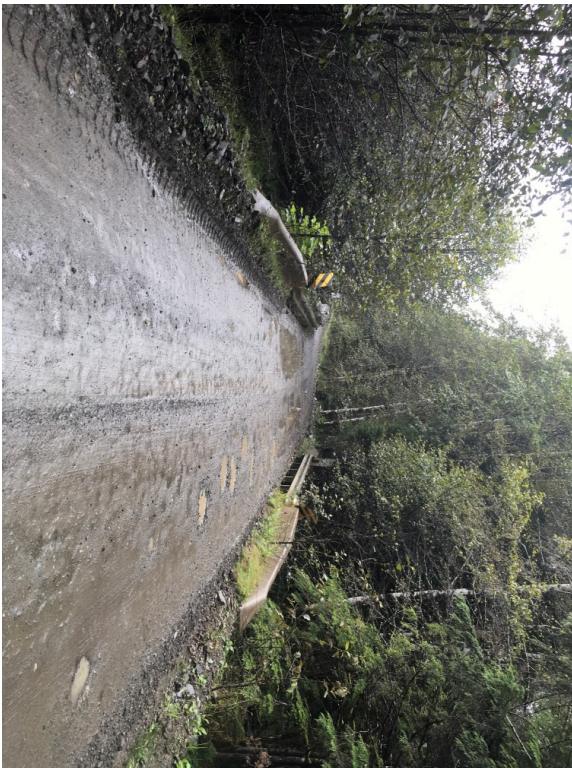
Approach from Left Bank when facing downstream

Brushing Required Y Just around bridge

Delineator Missing  
Left ☒ 0 ☐ 1 ☐ 2Delineator Missing  
Right ☐ 0 ☒ 1 ☐ 2

| 1 | Low | Replace missing delineator and post load rating. |

| 2 | Low | Brush out immediate vicinity of bridge. |
