QC-7037

BONANZA 8.4km

2019 Inspection

| Crossing Name | Beaverguard Creek | | |

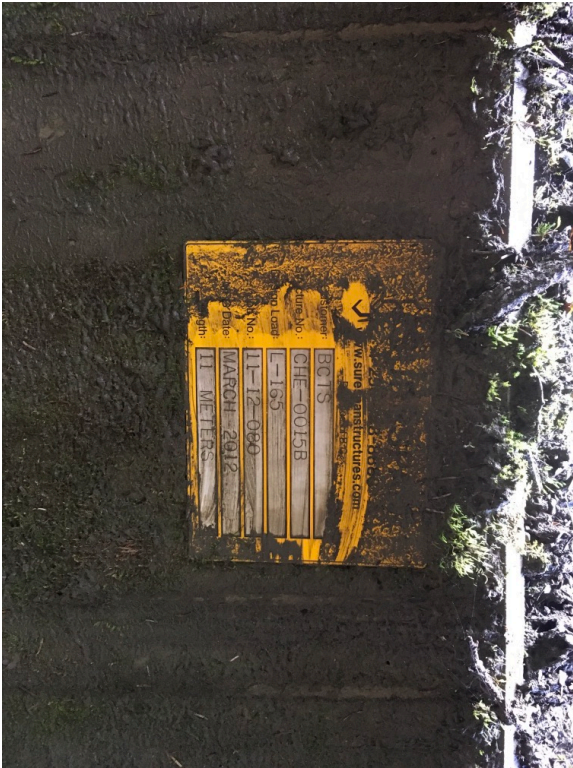
Structure ID

Inspector Comments Serial/ID Plate 'BCTS, CHE-0015B, L165, 11-12-080, March 2012, 11 Meters'. Surespan  
See notes.

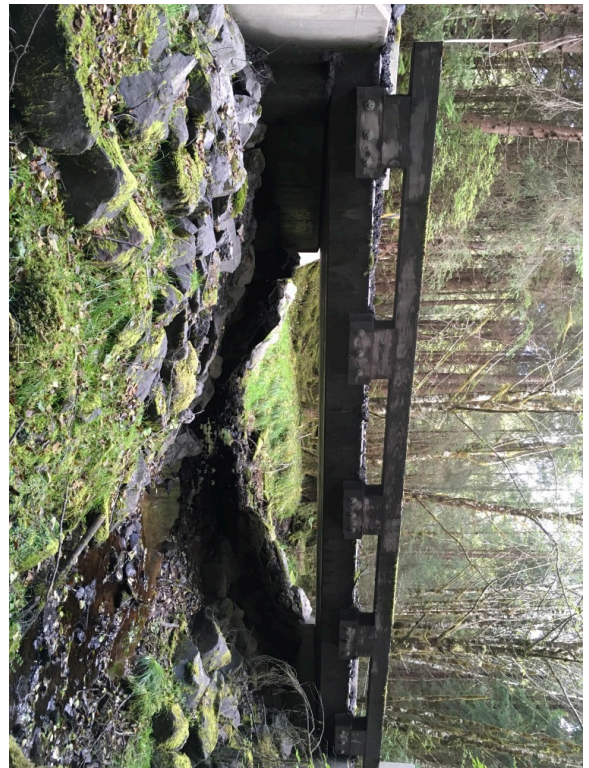
End of girder, right bank

| Concrete Deck | Fair | Ends of girders are being impacted and are chipping. No rebar exposed yet. Suggest adding gravel to both approaches. |

| Repair Item | Priority | Repair Description |
|---|---|---|
| 1 | Medium | Add fill to patch pot holes on approaches in an attempt to limit further damage to ends of slab girders. Patch ends as required. |

| Item | Monitor Description | Frequency |
|---|---|---|
| 1 | Monitor further damage to ends of girders. | Routine Inspection |
