QC-7040

QC MAIN 0.75km

2019 Inspection

Crossing Name Crabapple Creek

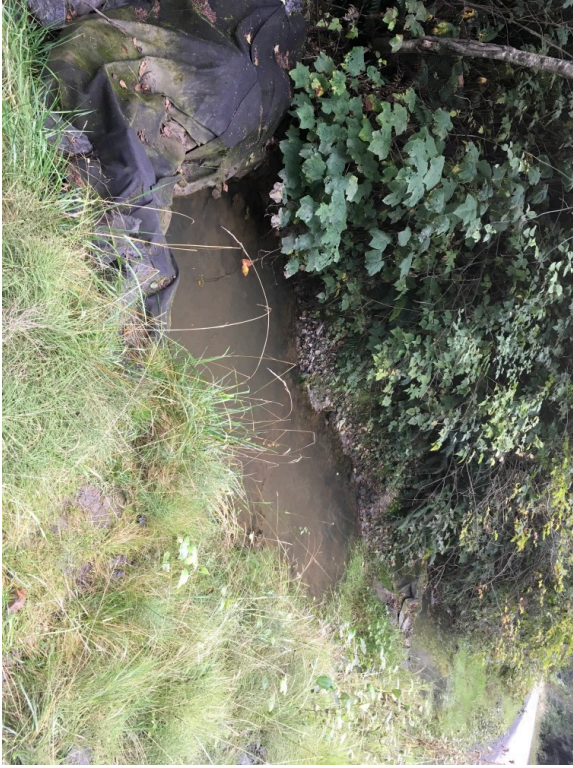
Settling ponds in ditchline
