QC-7041

QC MAIN 4.8km

2019 Inspection

| Structure Class | Major Culvert |

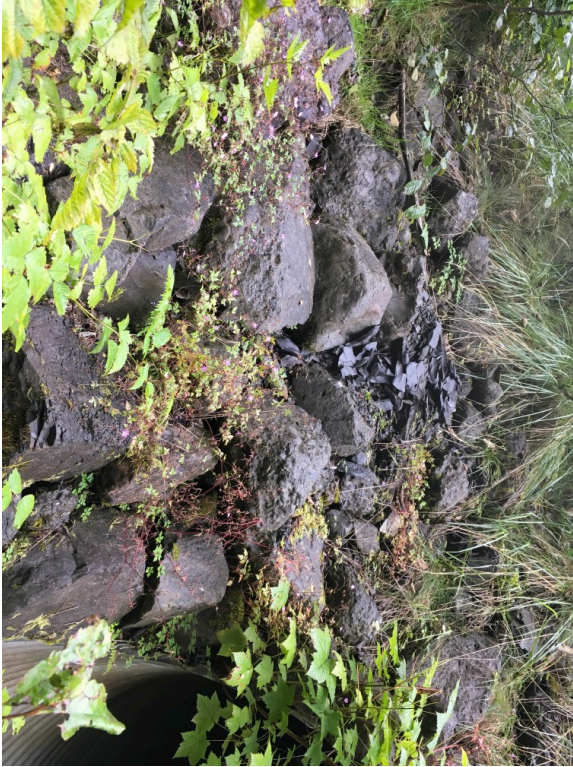
| Item | Monitor Description | Frequency |
|---|---|---|
| 1 | Weathering of riprap. Shale is breaking down. | Routine Inspection |

Weathered riprap

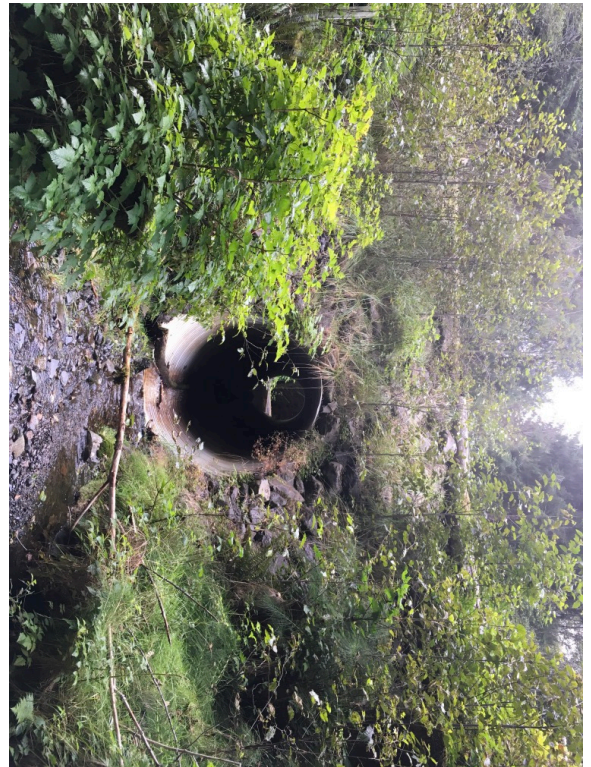
Inlet Good Bevelled inlet

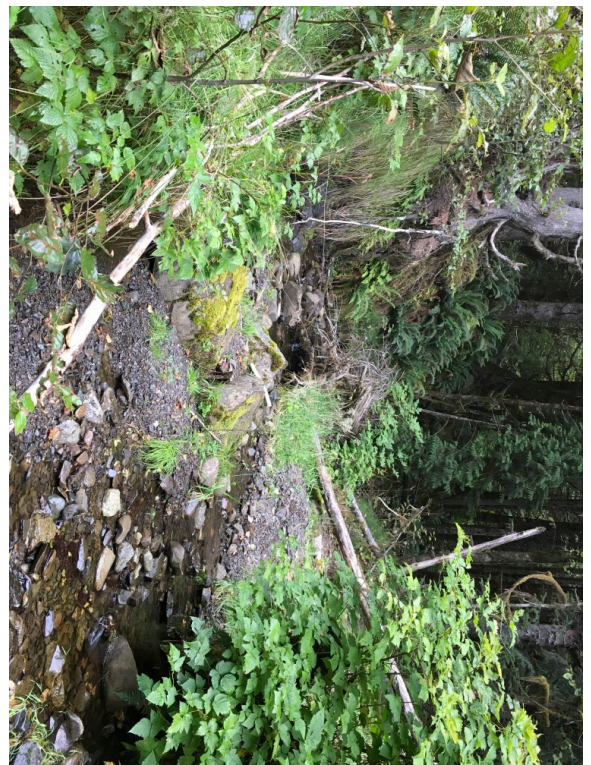
Upstream from Crossing

Comments Minor debris being moved in channel but not significant.

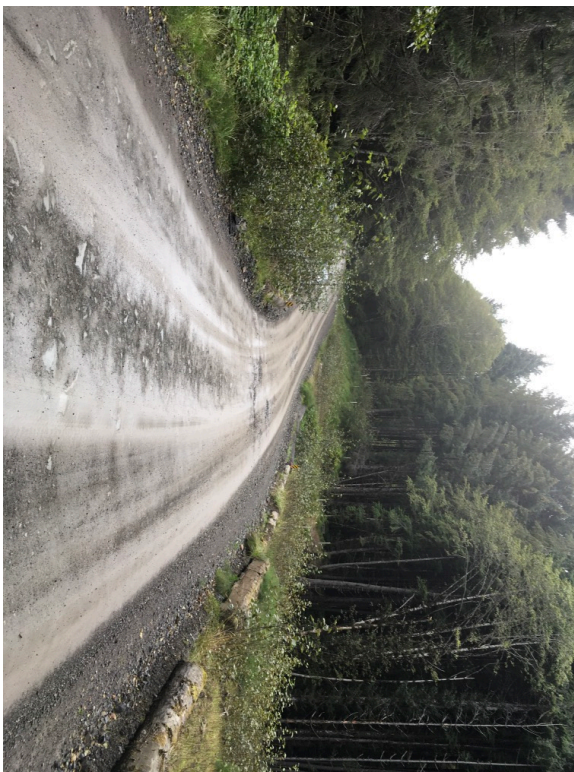
Approach from Left Bank when facing downstream

Guidelogs along road surface should be replaced in 5 years or less

| Item | Priority | Repair Description |
|---|---|---|
| 1 | Medium | Brush out approaches and above culvert in next 2 years or less. |
| 2 | Low | Replace guidelogs in 5 years or less. |

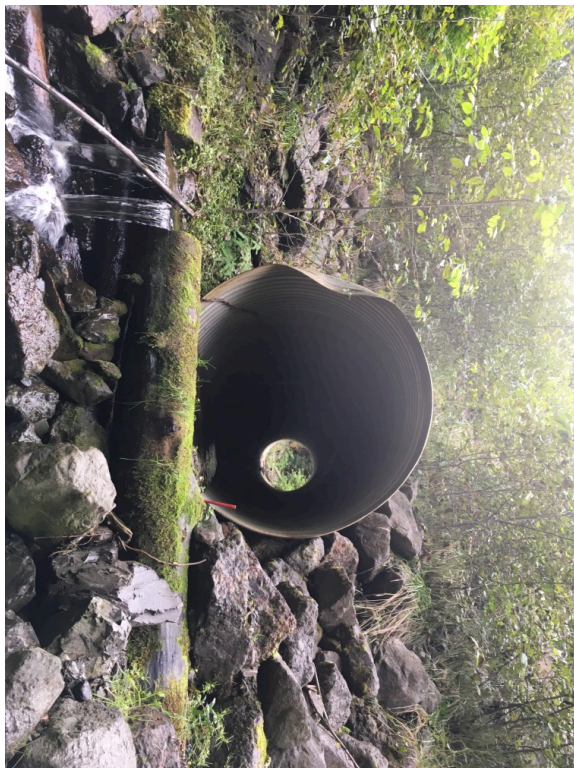
Outlet Good
