QC-7105

HANGOVER 10.7km

2019 Inspection

Crossing Name Bonanza Creek

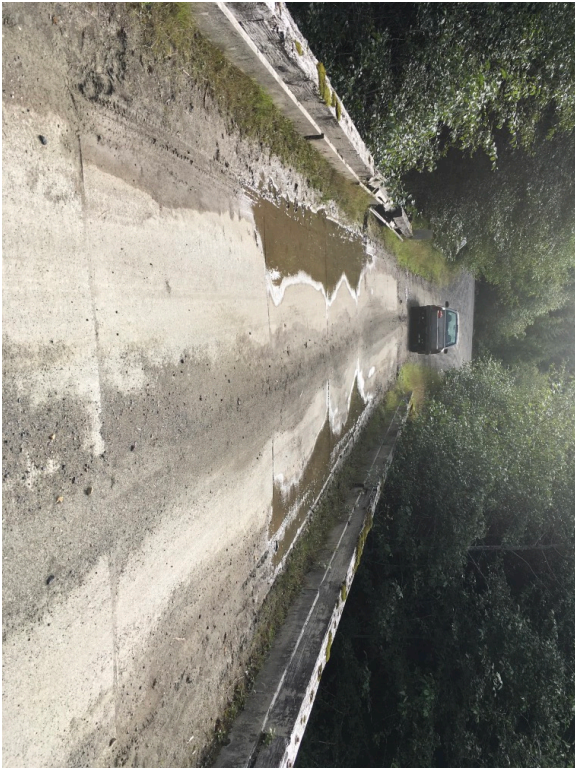
Guard Rail

Guardrails need replacement. Large impact on upstream side and significant rot observed throughout. Replace sediment catch boards on sides as well.

| Repair Item | Priority | Repair Description |
|---|---|---|
| 1 | High | Replace all timber guardrail components. |

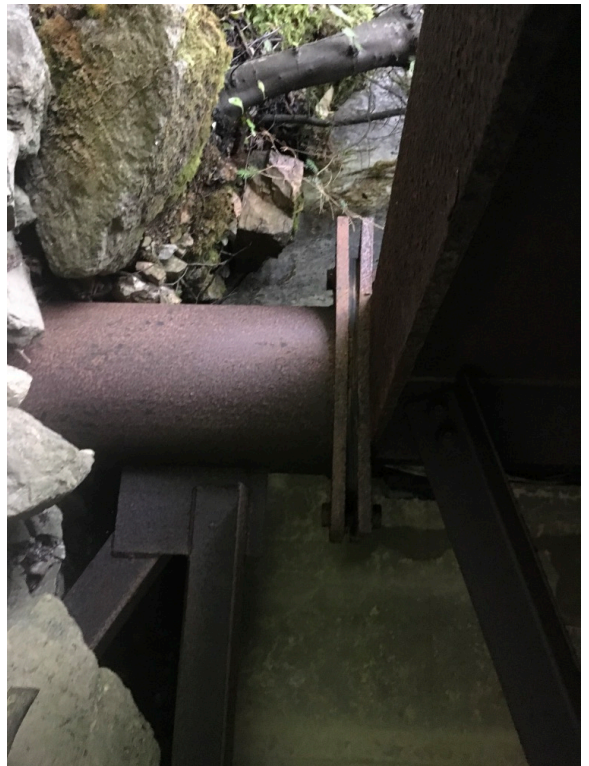
Bearing

Minor wear observed

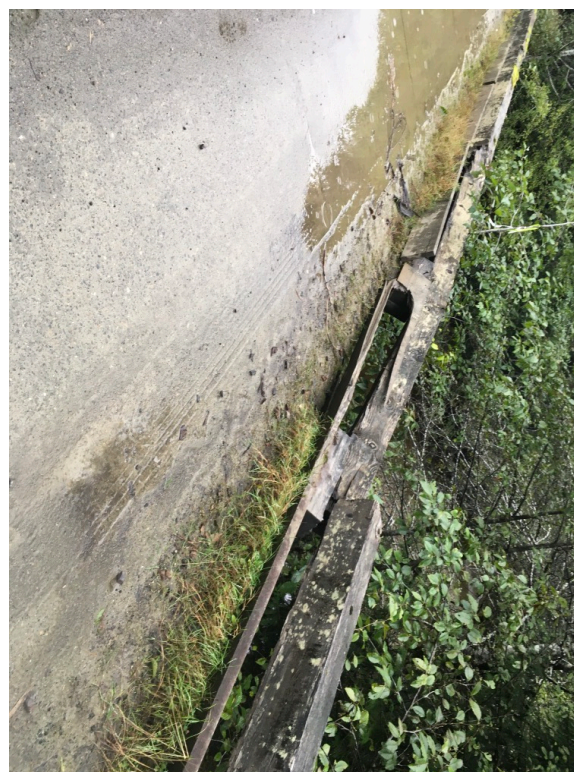
| Deck Joints | Fair | Grout has worn through in places and should be patched. |

| Repair Item | Priority | Repair Description |
|---|---|---|
| 2 | Medium | Patch deck joints with grout |
