QC-7109

BONANZA 20km

2019 Inspection

Inspection Company Chartwell Consultants Ltd.

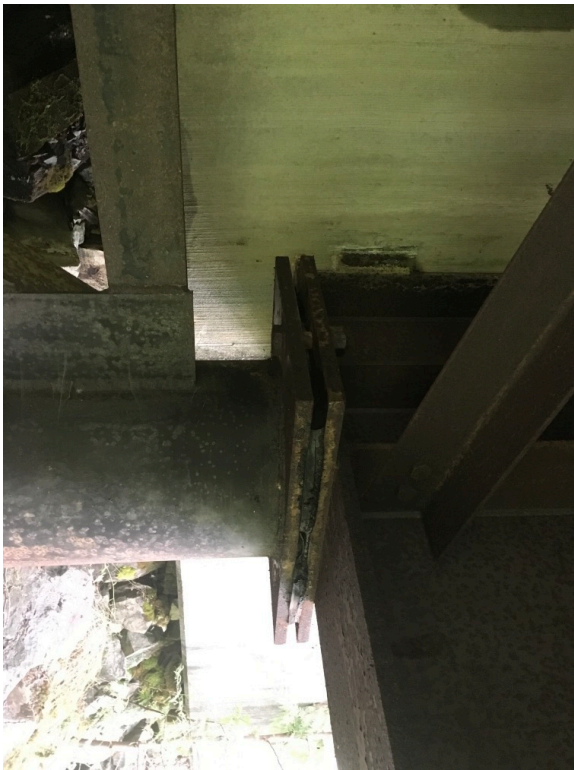
Bearing

Bearings Fair Rubber bearings are starting to wear and bulging present. Still 20mm of rubber left.

| Item | Monitor Description | Frequency |
|---|---|---|
| 1 | Monitor bulging bearing pads | Routine Inspection |

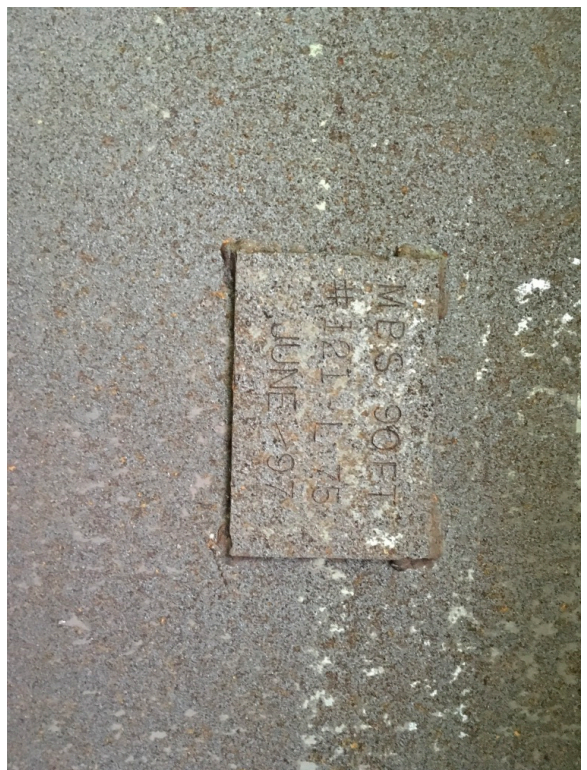
Structure ID

Inspector Comments Serial/ID Plate MBS 90FT, #121 L75, JUNE 97

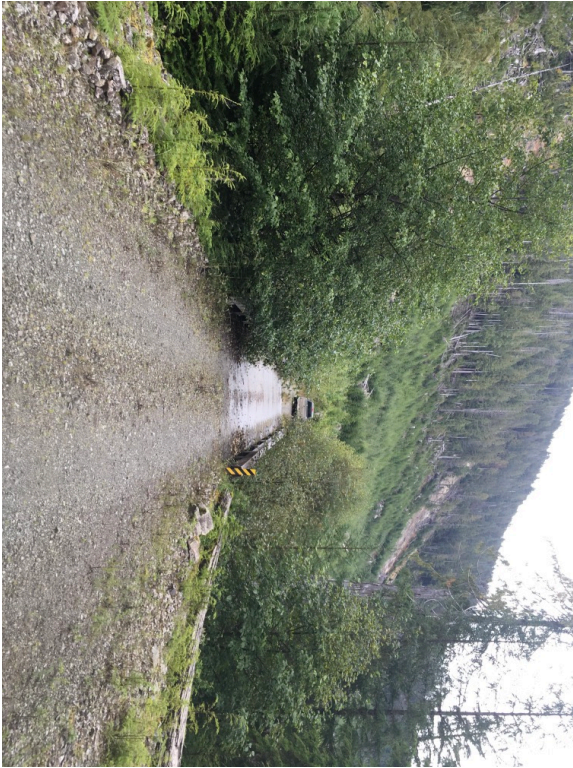
Approach from Right Bank when facing downstream

Bridge Ahead Signs  
Missing ☐ 0 ☐ 1 ☒ 2

Brushing Required Y

| 1 | Low | Brush road and install bridge ahead signs. |

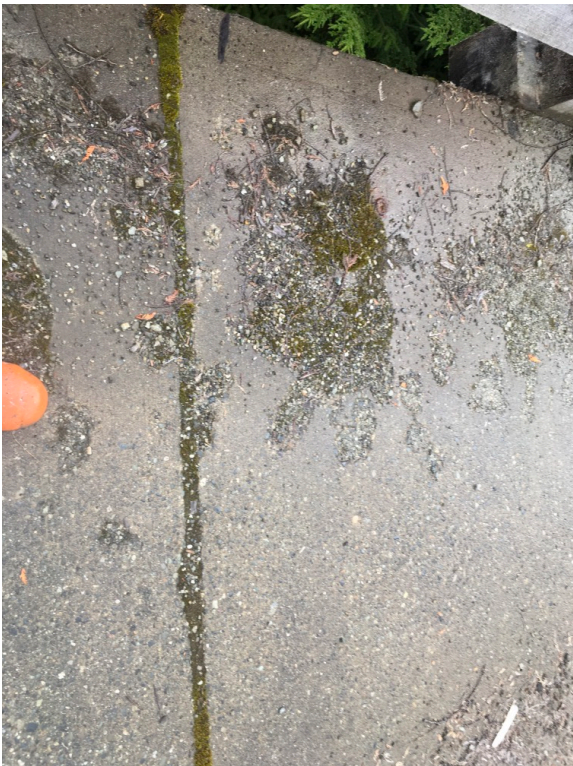
Concrete Deck      Fair      Damage from tracked equipment walking across, Minor.

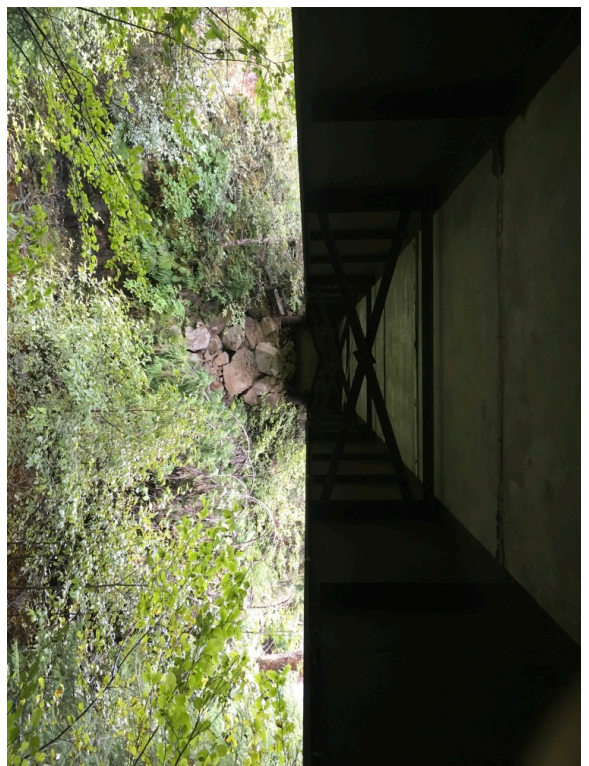
Left Bank Abutment when facing downstream

Riprap Fair Stacked very steep on left abutment.

| 2 | Riprap is stacked very steep on left abutment - no movement observed but should be monitored. | Routine Inspection |
