QC-7113

BONANZA 21.2km

2019 Inspection

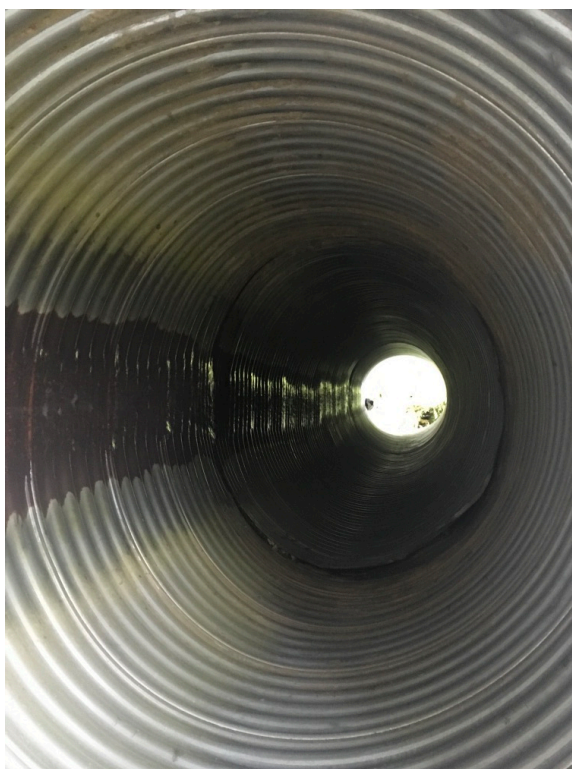
Looking upstream through culvert

| Roof | Good | Shape is elliptical due to deformation from road fills. |
| Sidewalls | Fair | Shape is elliptical due to deformation from road fills. |

1 Monitor for further deformation

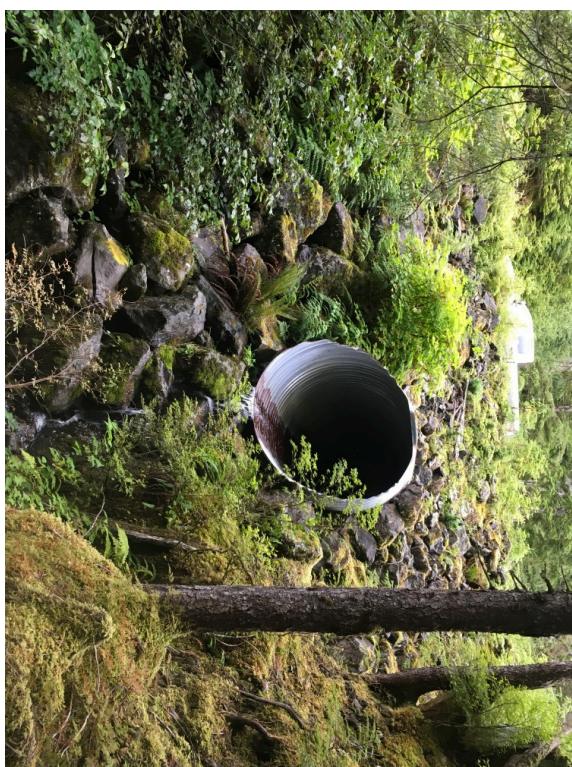
Downstream Profile

| Outlet | Good | Bevelled outlet, bedrock below outlet. |

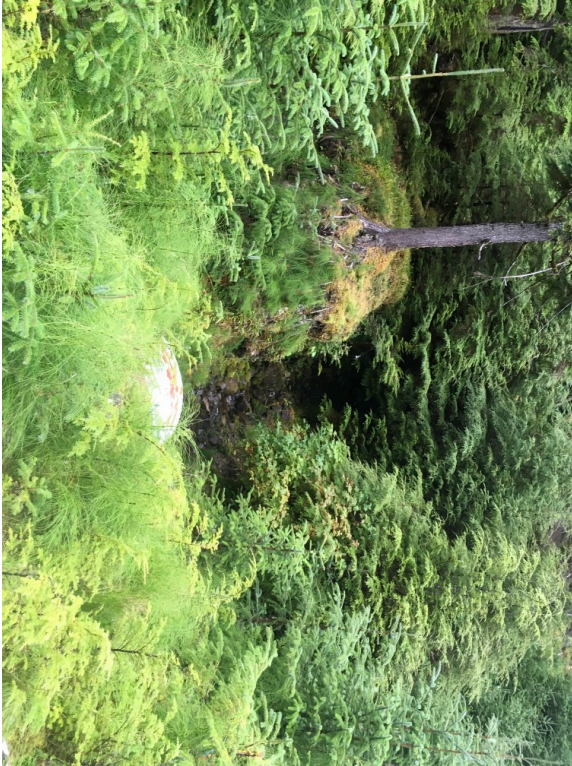
Upstream from Crossing

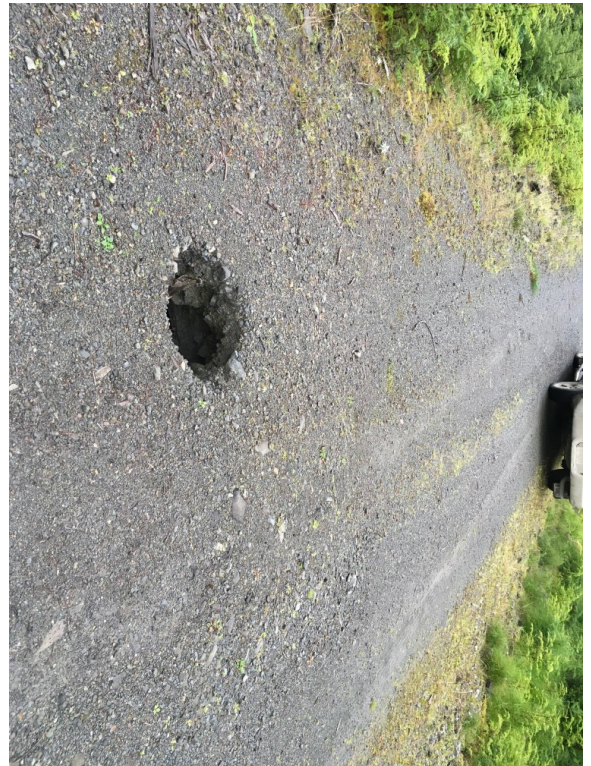
Road Surface Fair Hole in road from failed cross puncheon, 5m past cmp on high chain side.

Hole in road

Comments: Fill hole in road
