QC-7131

CHADSEY MAIN 1.7km

2019 Inspection

Inspection Company Chartwell Consultants Ltd.

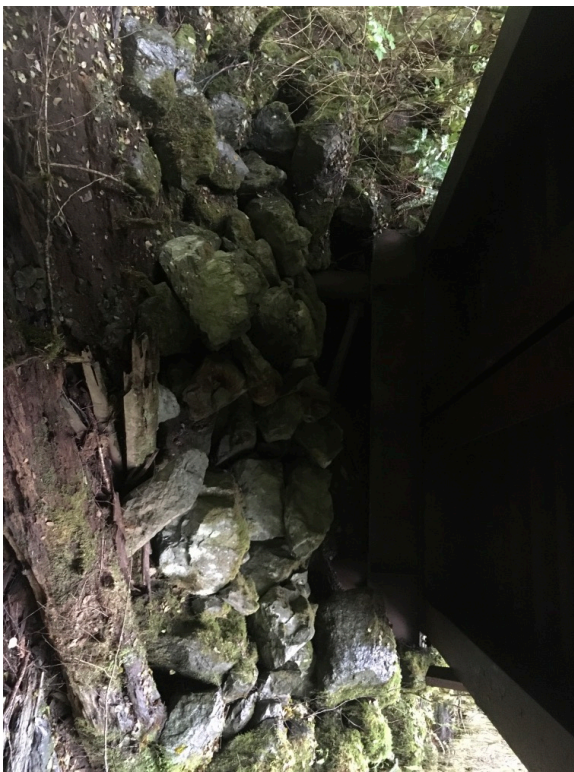
Left Bank Abutment when facing downstream

Caps or Sills Fair Steel I-beam cap, typical corrosion and pitting.

Ballast Wall Fair Log ballast on low chain abutment.

Corrosion Protection Poor None present

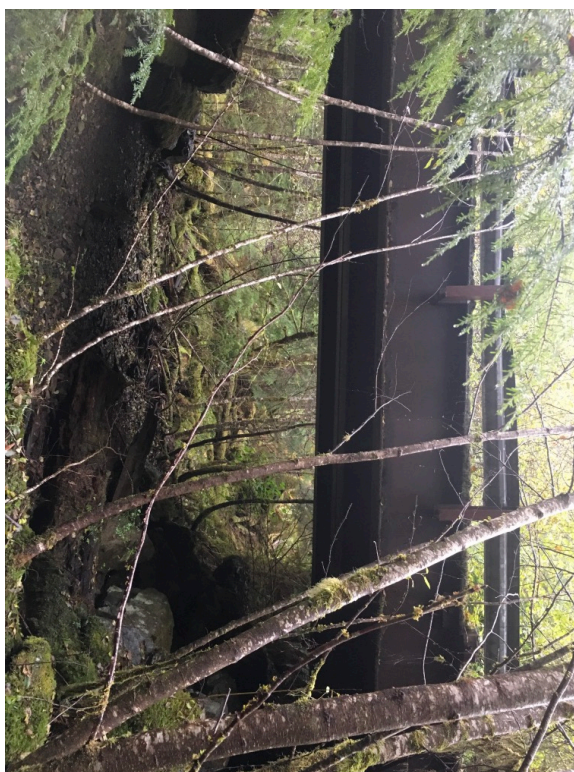
Downstream Profile

Girders Fair Typical pitting and corrosion.

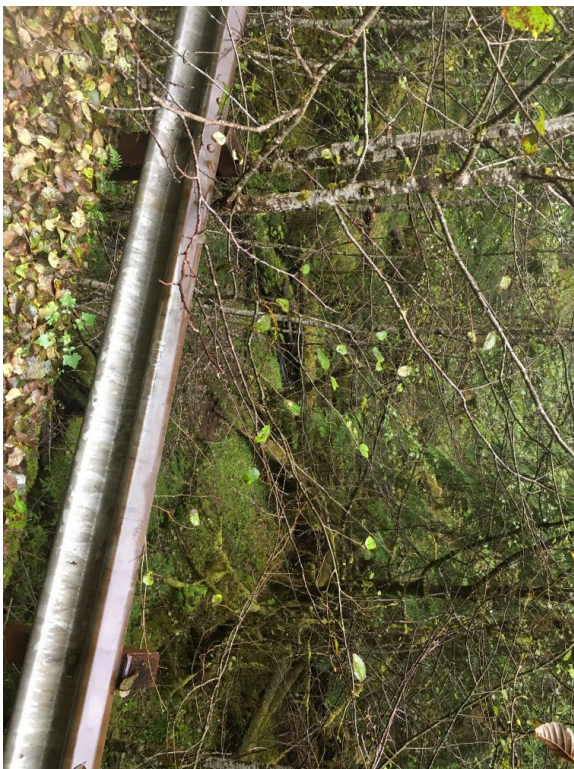
| Curb Rail/Blocks/Posts | Poor | Downstream guardrail is only connected by two bolts and missing a riser post. |

Guard Rail missing riser post

| Item | Priority | Repair Description |
|---|---|---|
| 1 | Low | Repair guardrails. Replace guidelogs once industrial activity resumes. |
