QC-7132

CHADSEY MAIN 2.1km

2019 Inspection

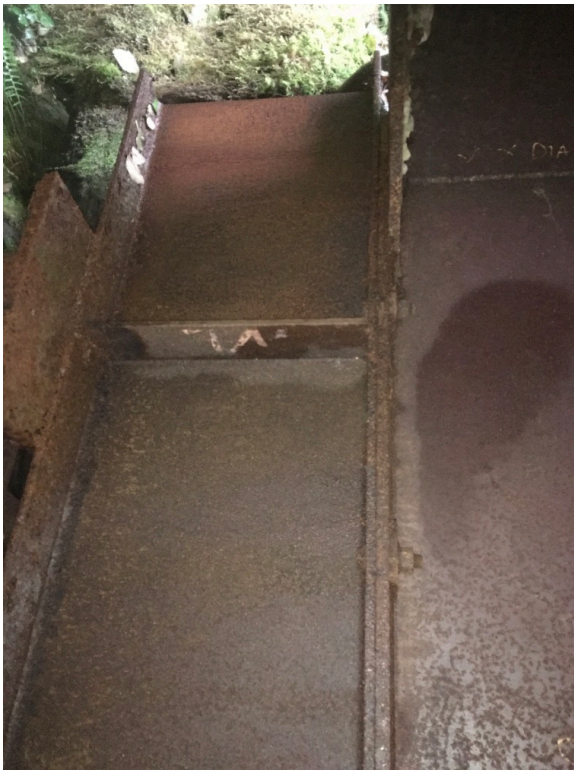
Bearing

Bearings Fair

Bolted connection at bearings is suffering from corrosion.

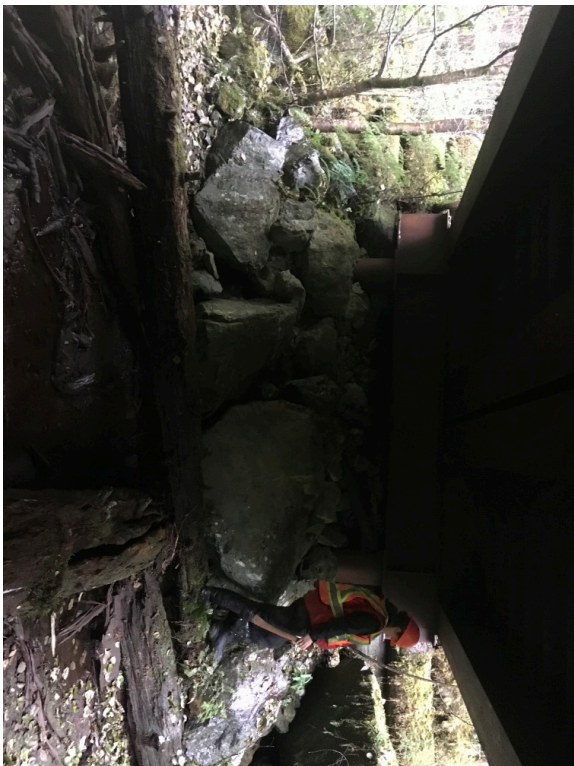
Right Bank Abutment when facing downstream

Caps or Sills Fair Ty local corrosion and pitting. Welded to tops of steel pipe.

Ballast Wall Fair Large logs with rot. Stable.

Corrosion Protection Poor None present. Typical pitting and corrosion.

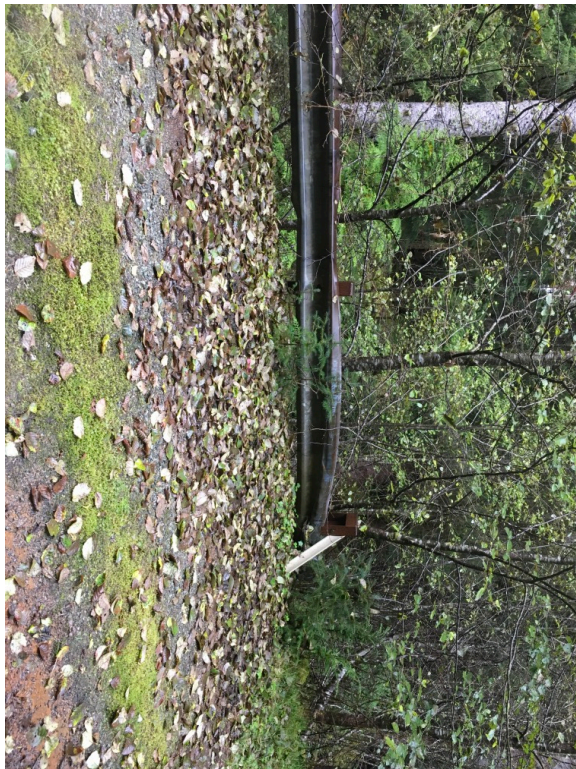
Guard Rail

| Curb Rail/Blocks/Posts | Fair | Galvanized W-Beam, damage on one section. |

| Item | Priority | Repair Description |
|---|---|---|
| 1 | Low | Damaged guardrail section on downstream low chain side of bridge. |

Repair guardrail at next industrial activity.
