QC-7133

CHADSEY MAIN 2.5km

2019 Inspection

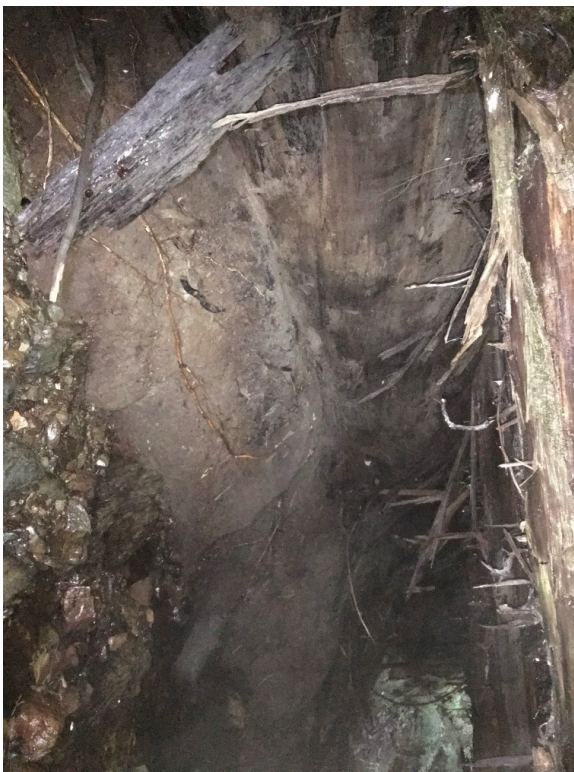
Left Bank Abutment when facing downstream

Log/Timber Cribs Fair Single sills, severe scour near downstream end

| Item | Monitor Description | Frequency |
|---|---|---|
| 1 | Monitor scour below sills | Routine Inspection |

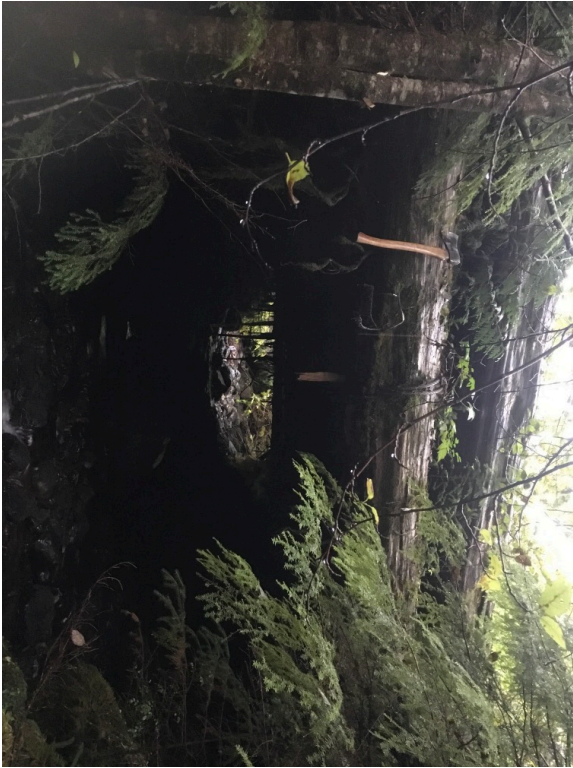
Downstream Profile

Comments Heavy scour present under sills. Channel is bedrock controlled.

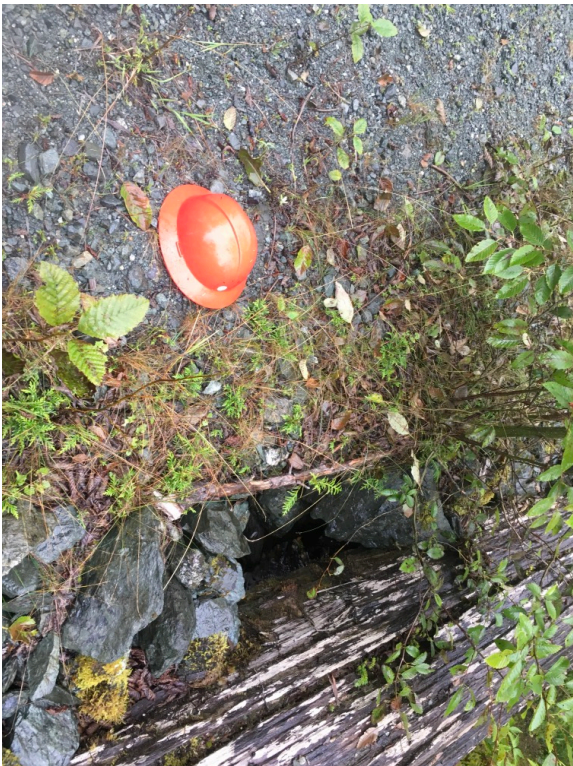
Deck

| Gravel Surface | Fair | Void in deck on upstream bush side |
