QC-7140

BM2700 0.3km

2019 Inspection

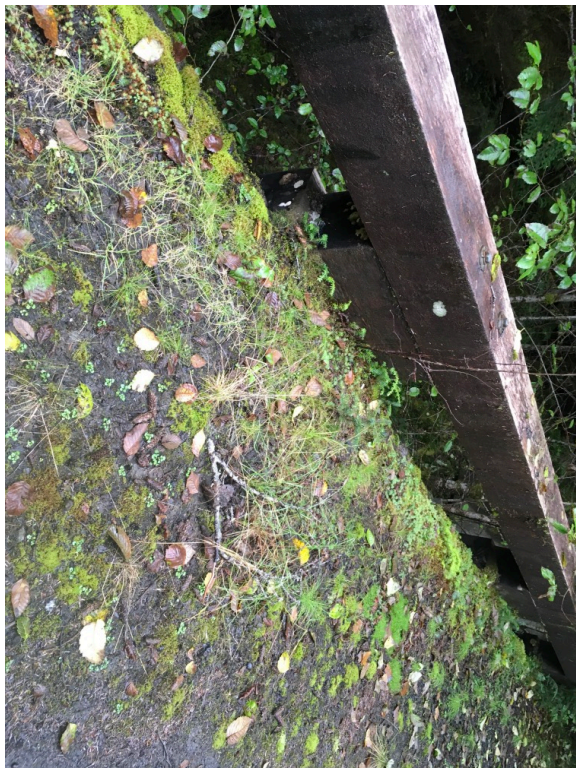
Overall Deck Condition Fair

| Repair | | Repair Description |
|---|---|---|
| 2 | Low | Clean debris off deck and brush out road. |

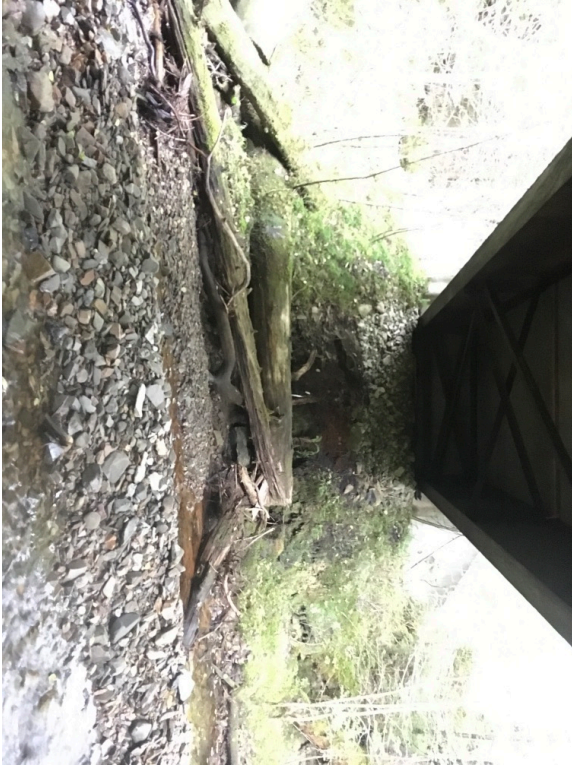
Right Bank Abutment when facing downstream

Riprap Fair Right bank abutment has scoured but does not pose a threat to bridge currently. Original sill log left in place and has winced collapsed into channel.

Comments Minor scour issue on right bank, not immediate threat to footings.

| Item | Monitor Description | Frequency |
|---|---|---|
| 1 | Monitor scour on right bank | Routine Inspection |
