QC-7610

EAS1800 0.28km

2019 Inspection

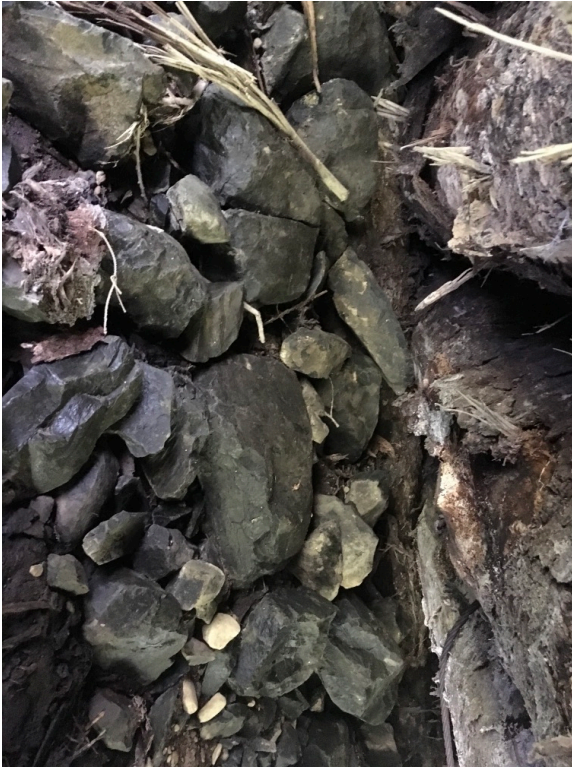
Right Bank Abutment when facing downstream

Sill logs are spruce and have lots of decay 60mm+. No crushing yet but likely to happen during next industrial cycle.
