QC-7701

HANGOVER 2.4km

2019 Inspection

Crossing Name Side Creek

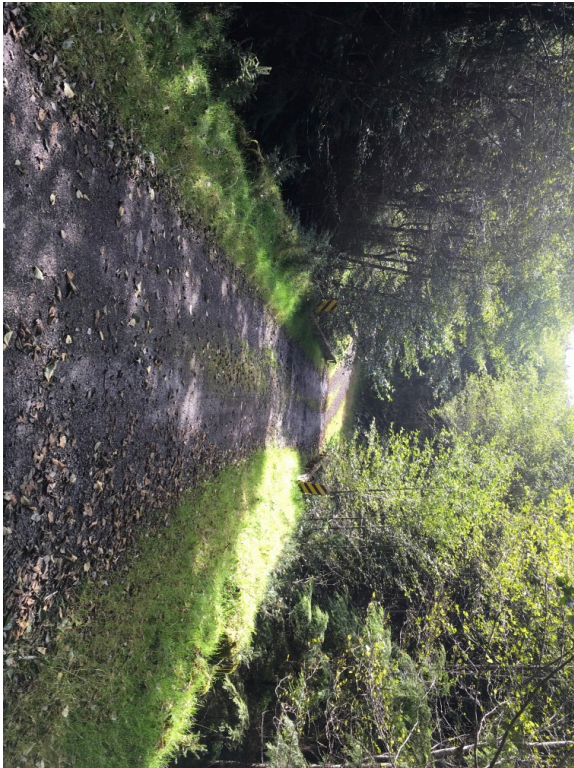
Approach from Left Bank when facing downstream

Tight corner on low chain approach

Guidelogs are rotted away and require replacement

| 2 | Low | Brush out road and approaches |

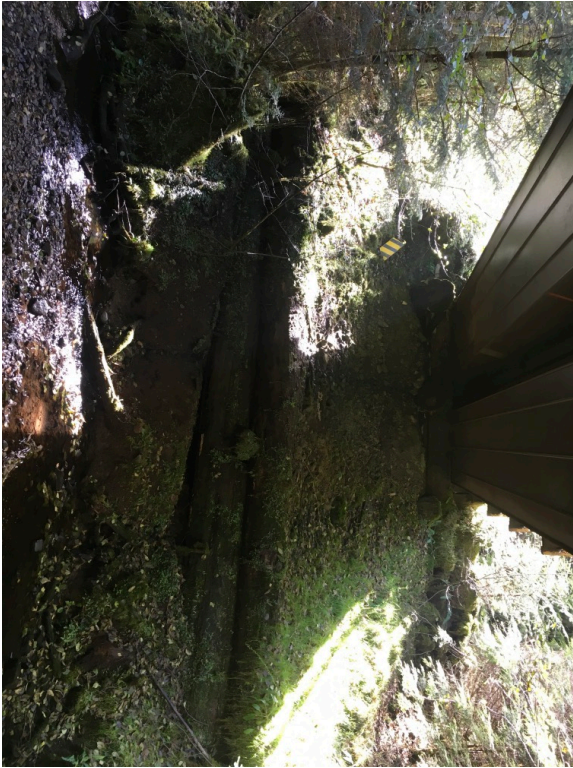
Right Bank Abutment when facing downstream

Both abutments have two high log cribs setback significant rot present in crib logs but lots of sound wood left in crib.

50mm rot but lots of wood left in tie backs. Tiebacks not cantered under bridge girders but

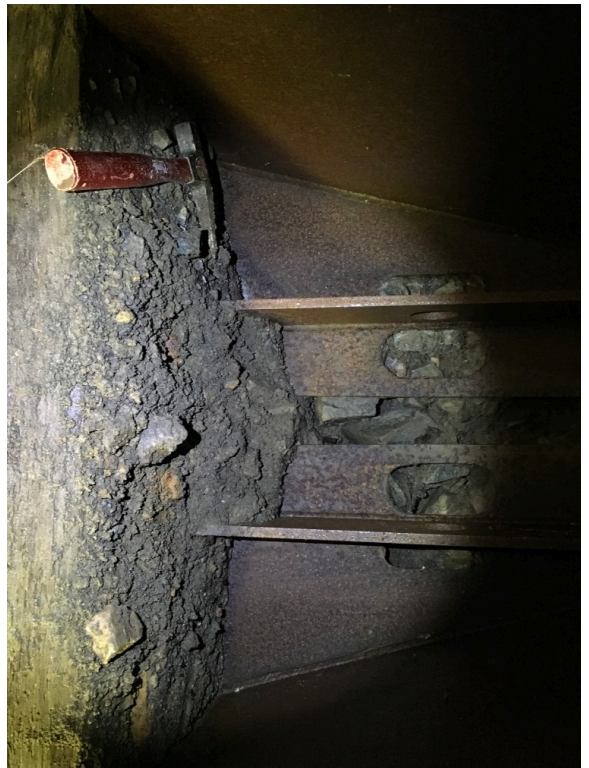
Bearing

Some rot in top sill but everything is still level

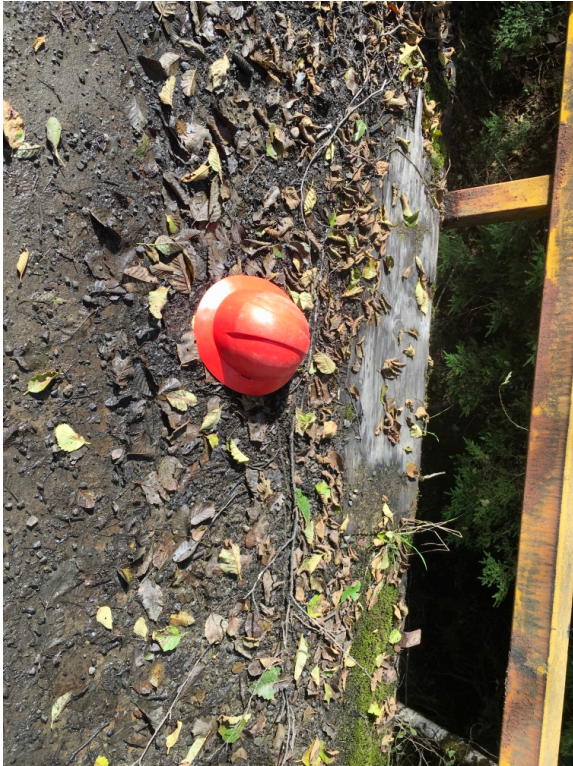
| Steel Deck Plate | Fair | Lots of debris accumulated, sediment catch boards rotted away. |

| Item | Priority | Repair Description |
|---|---|---|
| 1 | Low | Clean debris off deck and replace sediment catch guards on edges of bridge. |

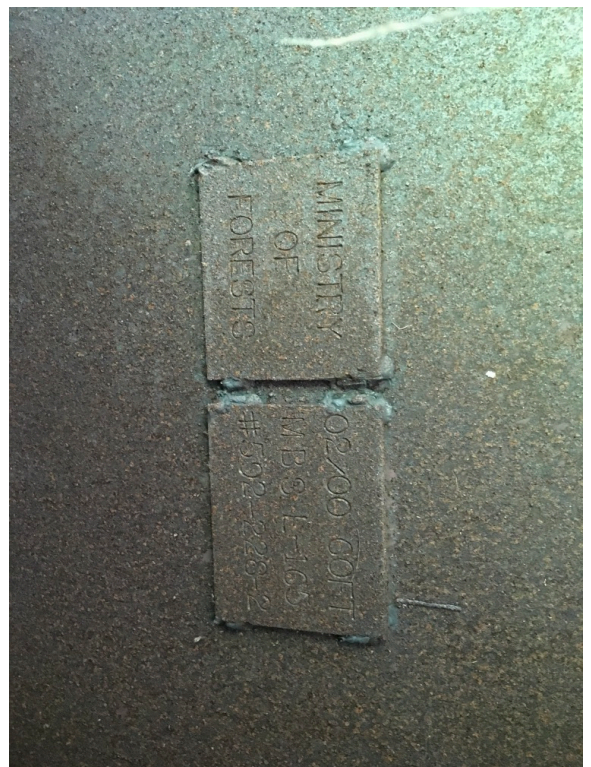
Structure ID

Inspector Comments Serial/ID Plate '02/00, 60FT, MBS L-165, #592-229-2'
