QC-7702

HANGOVER 7.5km

2019 Inspection

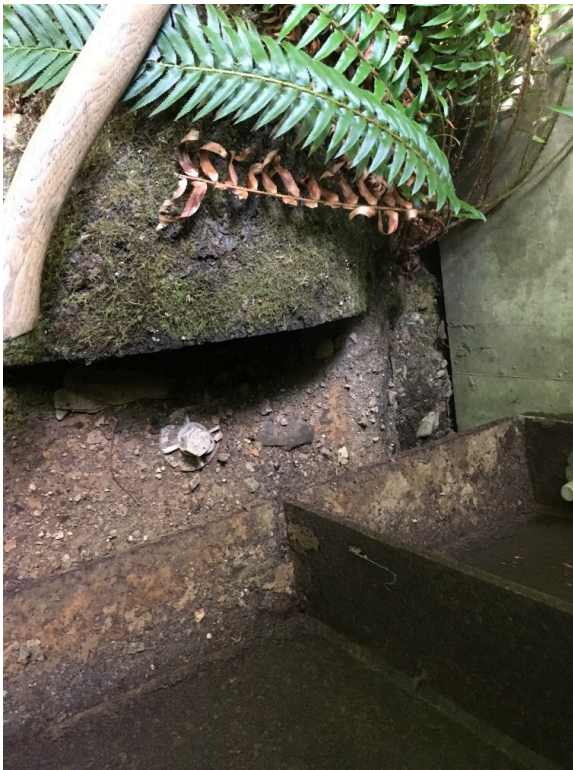
Bearing

Bearings Good Level bearings with full support below plates.

| Item | Monitor Description | Frequency |
|---|---|---|
| 1 | Rubber bearing between deck joints. | Routine Inspection |

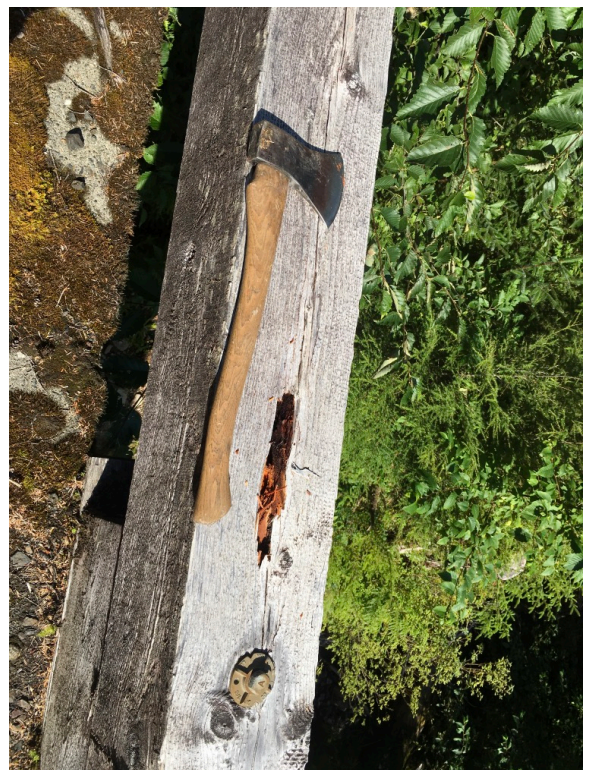
Guard Rail

Road Surface Fair Small amount of rot on downstream end guardrails section

| Curb Rail/Blocks/Posts | Fair | One section of guardrail needs replacement (10"x10"x16') |

| Item | Priority | Repair Description |
|---|---|---|
| 1 | Low | Replace rotten guardrail section. Road to nowhere...do not replace until activity planned beyond bridge. |

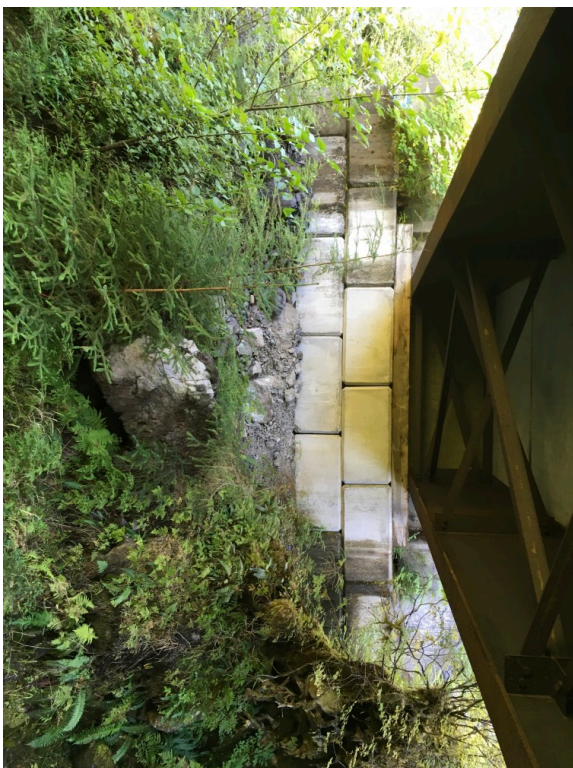
Right Bank Abutment when facing downstream

Log/Timber Cribs Fair Single spruce sill on left abutment, three high lock block abutment on right with untreated timber sill (pinned to blocks).

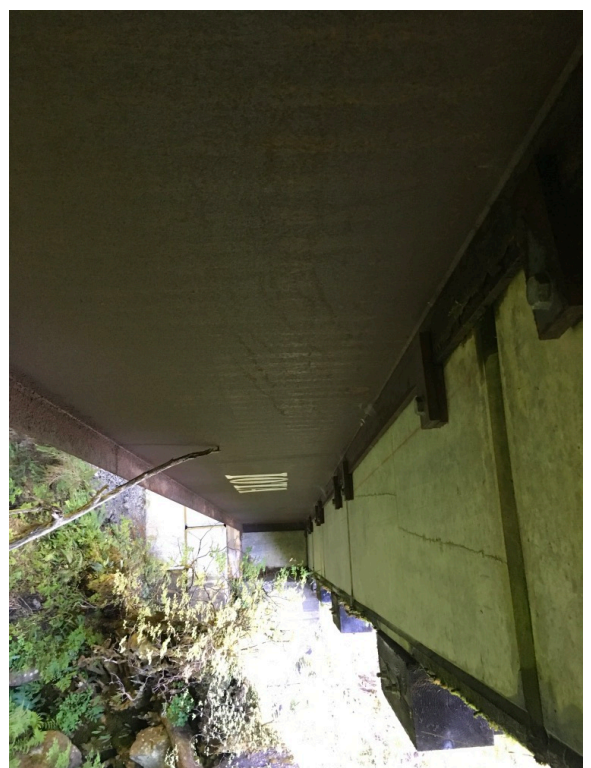
Superstructure

Girders Fair Typical pitting and corrosion present

Bracing Fair Bolted connections
