QC-7703

QC\_LGS1000 0.9km

2019 Inspection

CBR iPad Offline Ver

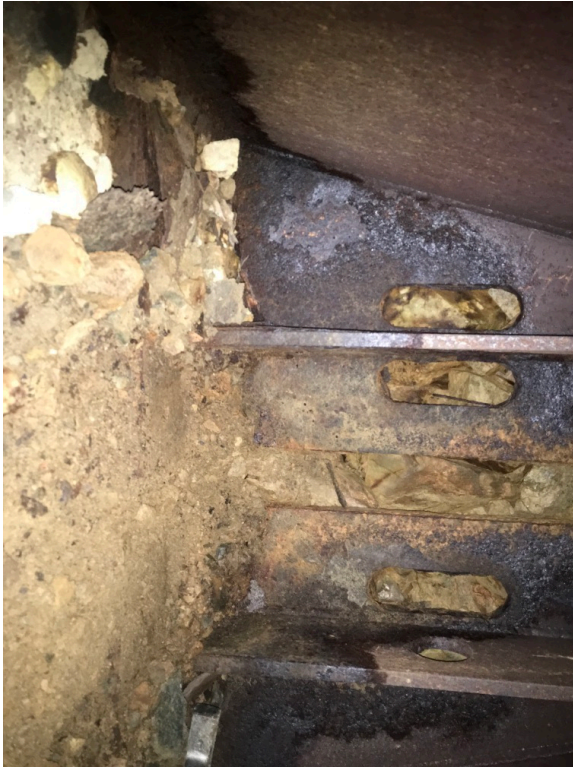
Right Bank Abutment when facing downstream

Cedar construction. Single sill left abutment, three high crib on right abutment. Outside corners appear to be pinned with undersized rebar.
