QC-7801

WATT LAKE MAIN 5km

2019 Inspection

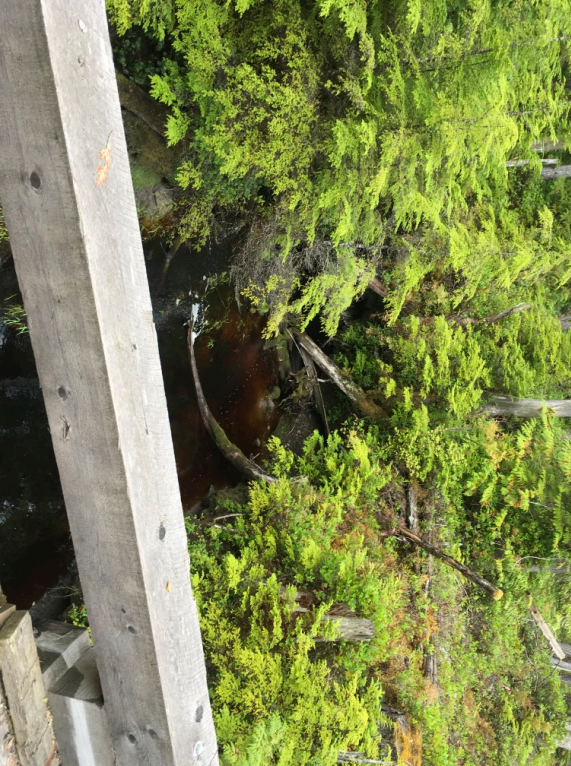
Upstream from Crossing

Comments Water levels raise by 1.0m but scour and debris not currently a concern.

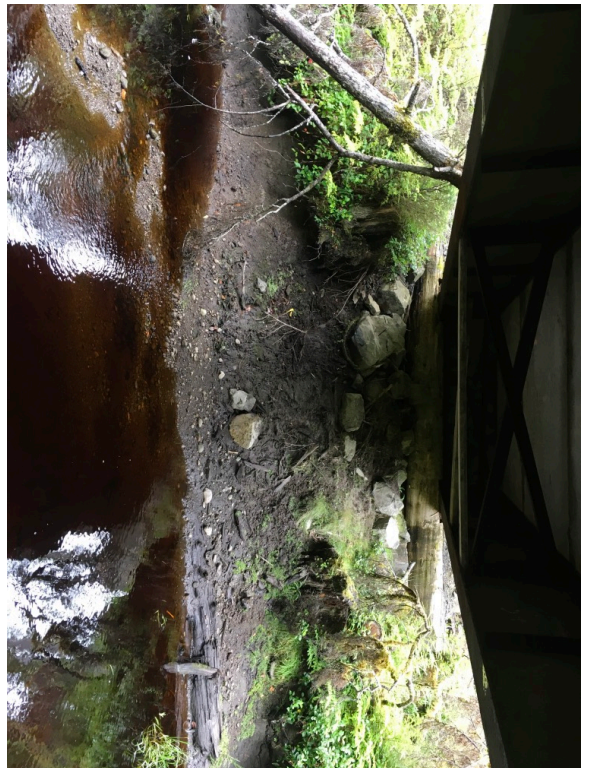
Left Bank Abutment when facing downstream

Minor riprap on left bank but no scour observed

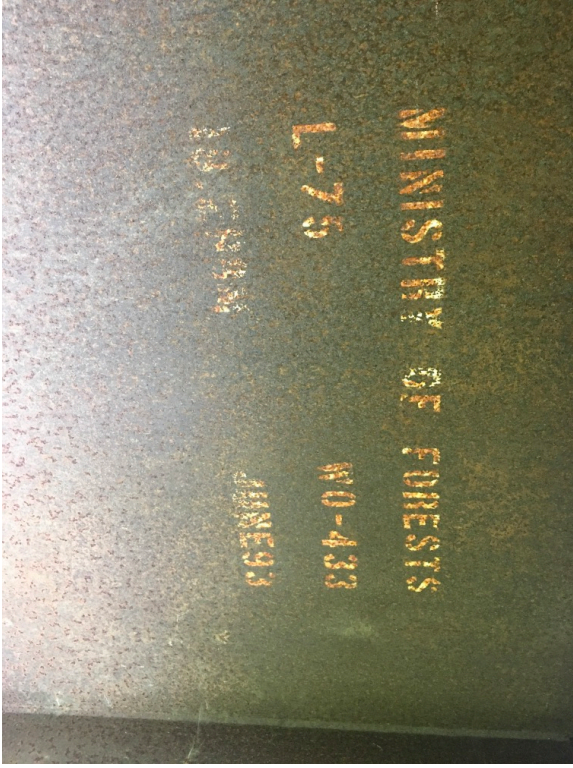
Structure ID

Inspector Comments Serial/ID Plate L75 WO-433, 18.288M, June93
