QC-7827

MORESBY 0.09km

2019 Inspection

| Crossing Name | Parsons Creek | | |

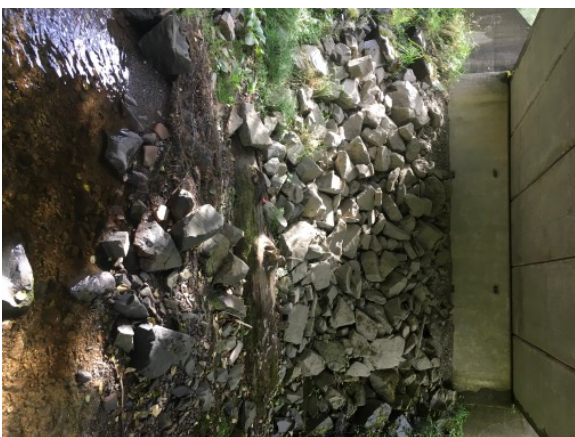
Right Bank Abutment when facing downstream

Scour on downstream left bank, being undermined from below and old log sill appears to be moving resulting in a void in riprap.

Comments Riprap is actively moving on left abutment (low chain).

Riprap actively being scoured.

| Item | Monitor Description | Frequency |
|---|---|---|
| 1 | Monitor scour on left abutment and confirm original sill log remains intact. Road fills will be affected as riprap continues to erode from below. | Routine Inspection |
