QC-7833

QC\_MOS1000 3.7km

2019 Inspection

| Crossing Name | Jovo Creek | | |

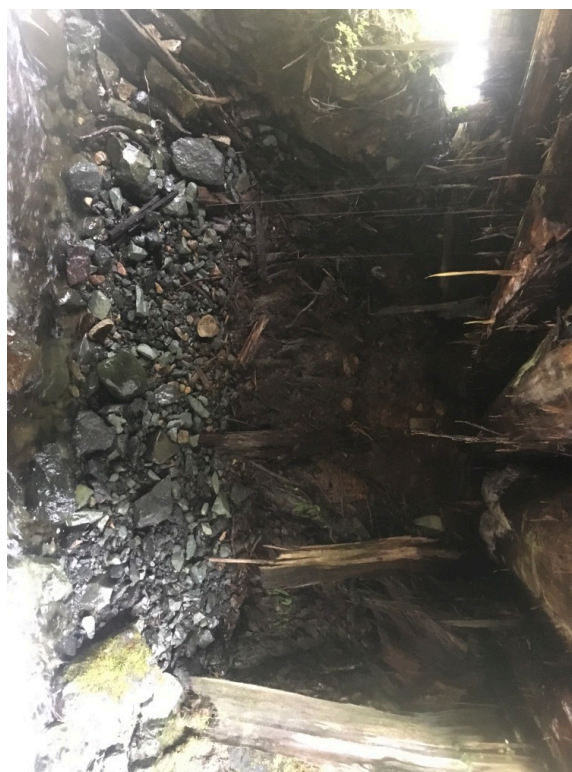
Right Bank Abutment when facing downstream

Single sills are at risk of scour

Actively being scoured.

| Item | Monitor Description | Frequency |
|---|---|---|
| 1 | Sill logs for continued scour | Routine Inspection |

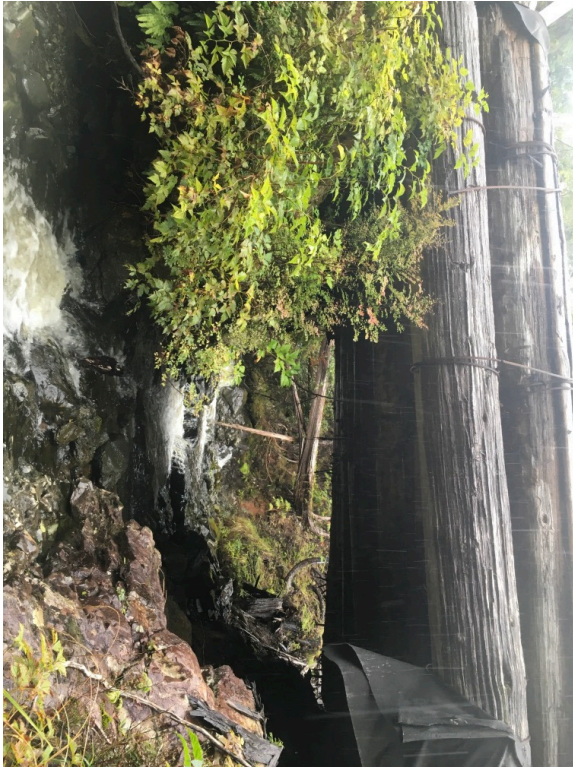
Comments Scour threatening sill logs, channel is bedrock controlled.

Scour

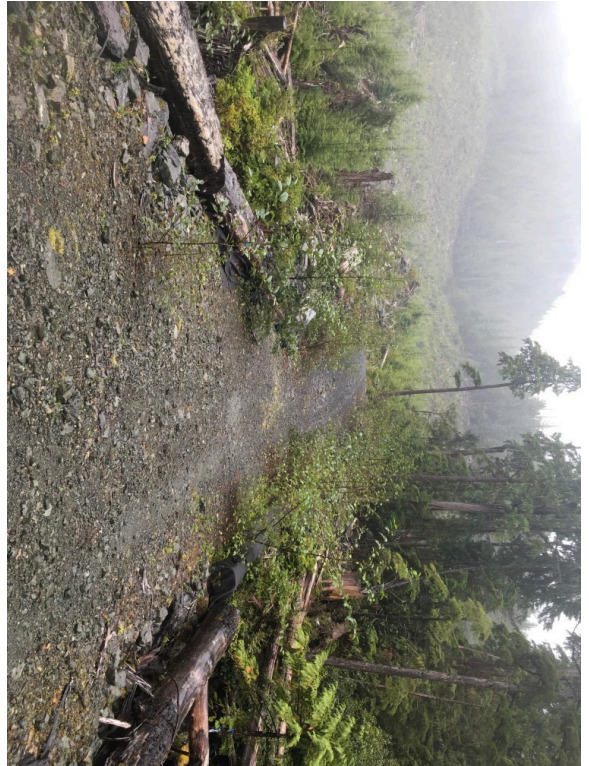
Approach from Left Bank when facing downstream

Bridge Ahead Signs  
Missing
☐ 0
 ☐ 1
 ☒ 2

Delineator Missing  
Left
☐ 0
 ☒ 1
 ☐ 2
Delineator Missing  
Right
☐ 0
 ☒ 1
 ☐ 2

| 1 | Low | Post signage and missing delineators. |
