QC-7834

QC\_NEY1000 1.3km

2019 Inspection

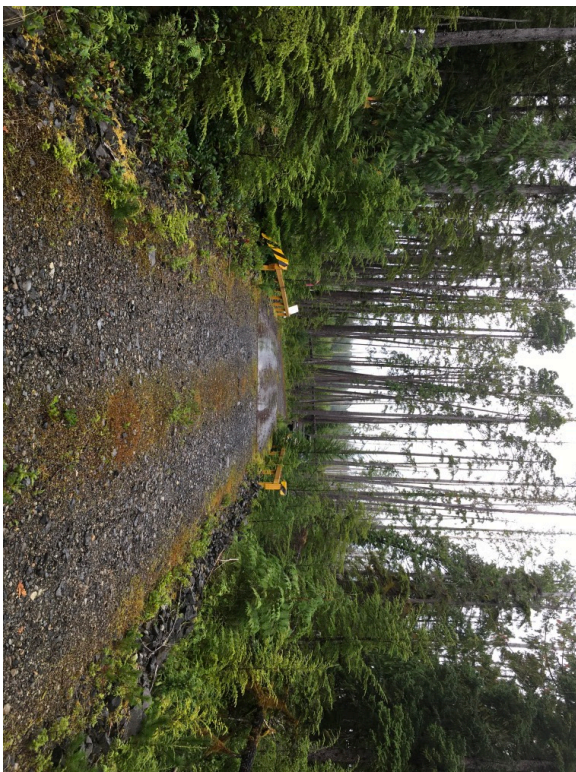
Approach from Right Bank when facing downstream

Tight corner on low chain approach

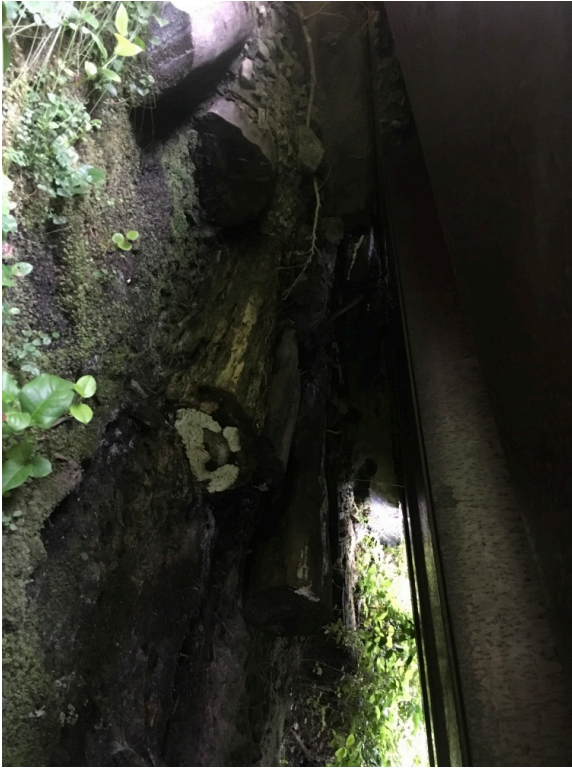
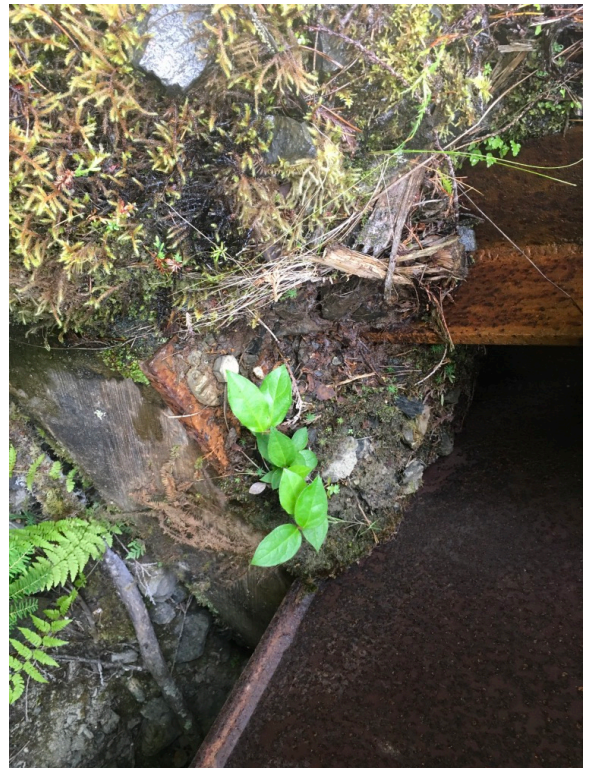
Left Bank Abutment when facing downstream

Both sills are supported by a number of mud sills/corduoy logs.

Woods bearing plate slightly unsupported, only lag bolted on outside edge as inside edge overhangs sill slightly.

Comments: Shim or replace log with level fully bearing with portable bridge

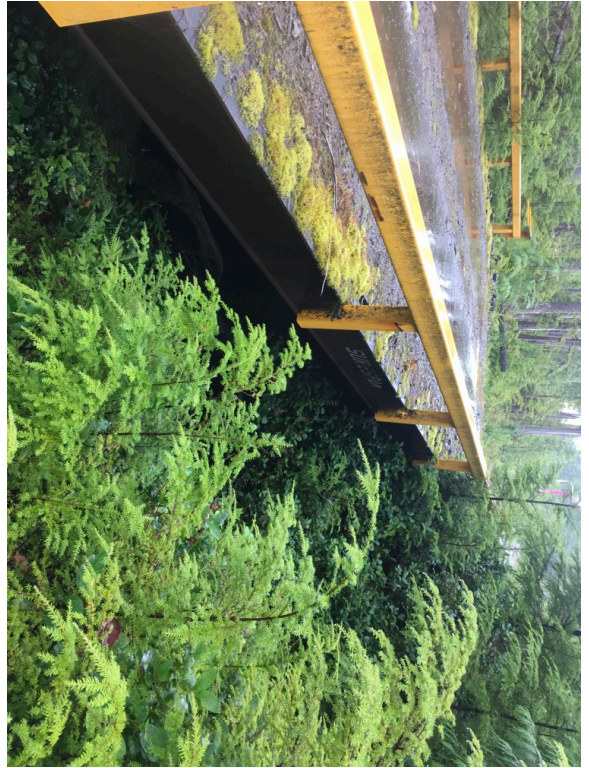
Upstream Profile

Comments Low profile crossing with limited clearance but appears to be adequate for creek.
