QC-7838

QC\_NEY2000 0.74km

2019 Inspection

Structure Class Temporary Bridge

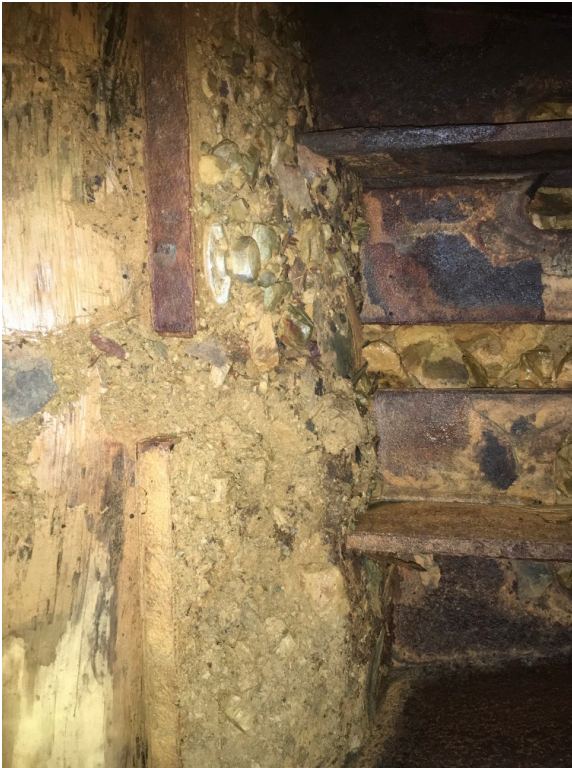
Structure ID

Inspector Comments Serial/ID Plate Surespan, 6-11-370, L100, MAR '07, WT#21,000, TCH-0703

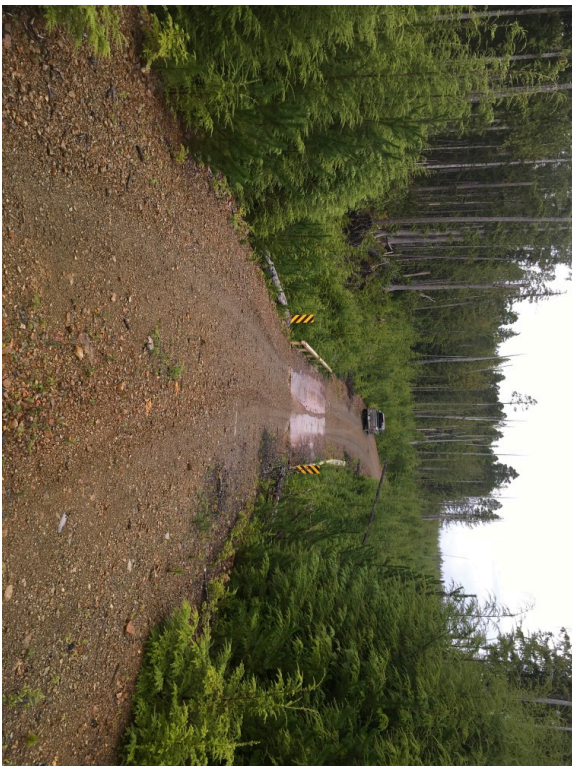
Approach from Left Bank when facing downstream

Guidelogs are at or below level of running surface.

Replace/repair guidelogs prior to industrial activity. Consider addition of ballast logs to help retain road prism on both abutments.

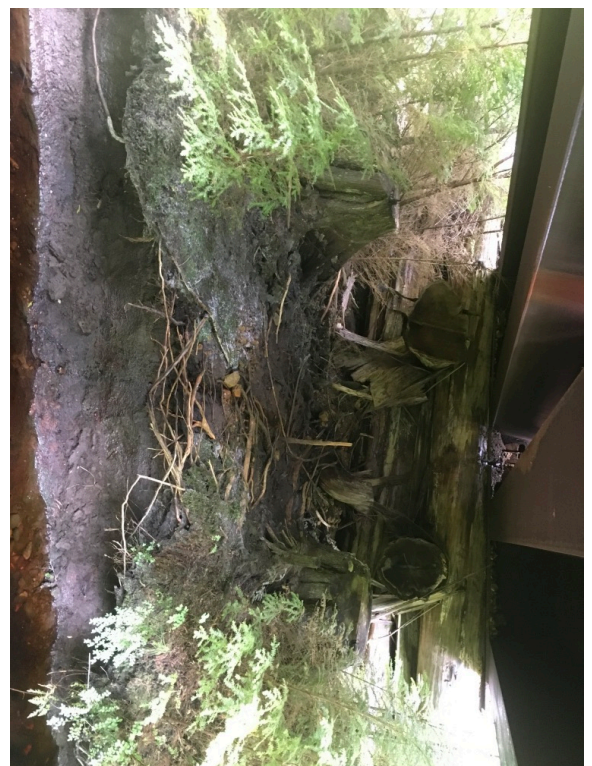
Right Bank Abutment when facing downstream

Two high crib on both side, cedar construction

No ballast logs installed. Material sloughing off corners of bridge deck, artificially narrowing
